INSPECTION OF MECHANICAL FEATURES

**Helmand Valley
Development Project**

AFGHANISTAN

May 1964

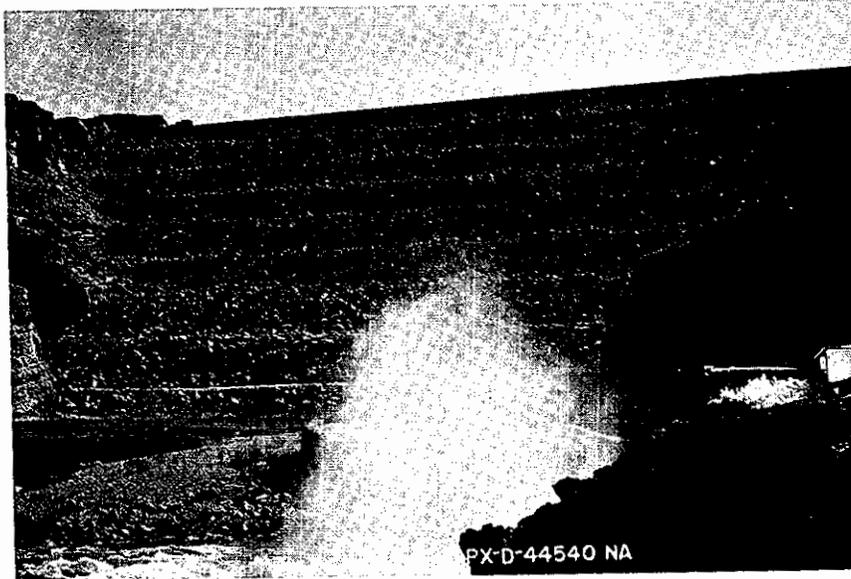
Figure 1.--Kajakai Dam. The downstream face of Kajakai Dam with the three 84-inch hollow-jet valves discharging 90 percent open.

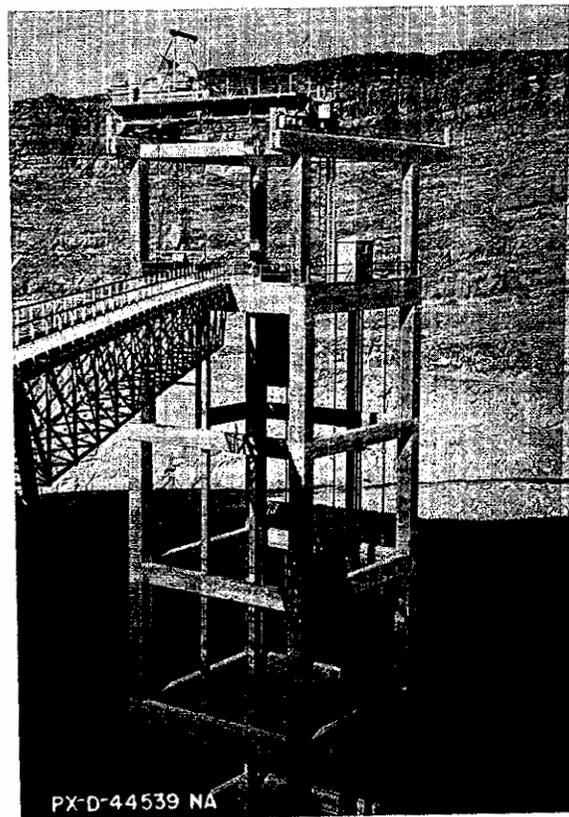
Figure 2.--Kajakai Dam. Open frame intake structure showing the walkway bridge, hoist, and intake gates in the storage position.

The concrete intake structure, access bridge, gantry crane, and all miscellaneous metalwork on the structure appeared to be in excellent condition. Equipment has been kept painted and generally clean. The wheel gate and bulkhead gate are kept in storage position on the gate structure, ready for use. The bulkhead is well painted and in good operating condition. The upstream side of the wheel gate is of open construction and the beam flanges form pockets that do not have drain holes. Accumulation of dirt, bird nests, and moisture in these pockets accelerates paint deterioration and rusting. Roller bearings are used on the wheel of the wheel gate. Indications are that grease has dried and hardened through the years as the wheels could not be turned by hand. None of the equipment on the gate intake structure has been used since the dam was constructed. Neither gate has ever been closed since initial installation, the trashracks have never been taken out for inspection, and the hoist has never been used.

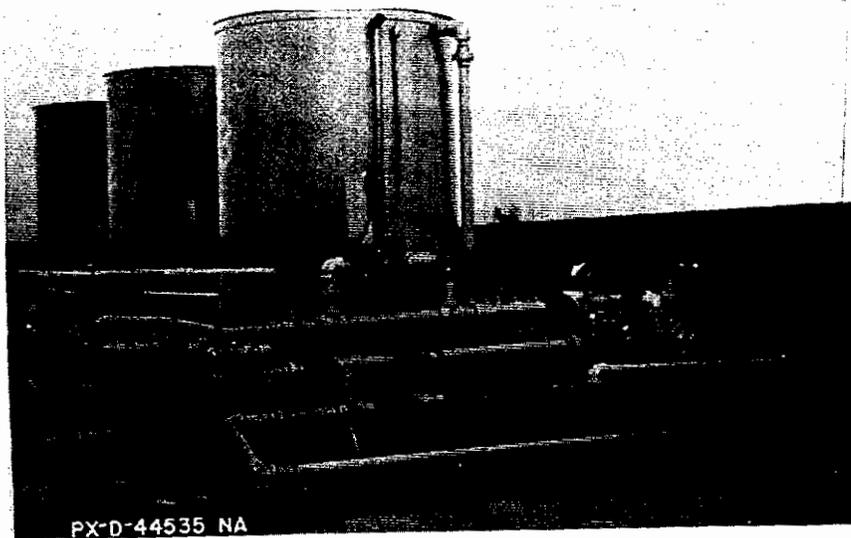
Figure 6.--Kajakai Dam. Hydraulic control units for the hollow-jet valves. Note the four-man pump handles for manual operation, and the number of hand valves on the piping system.

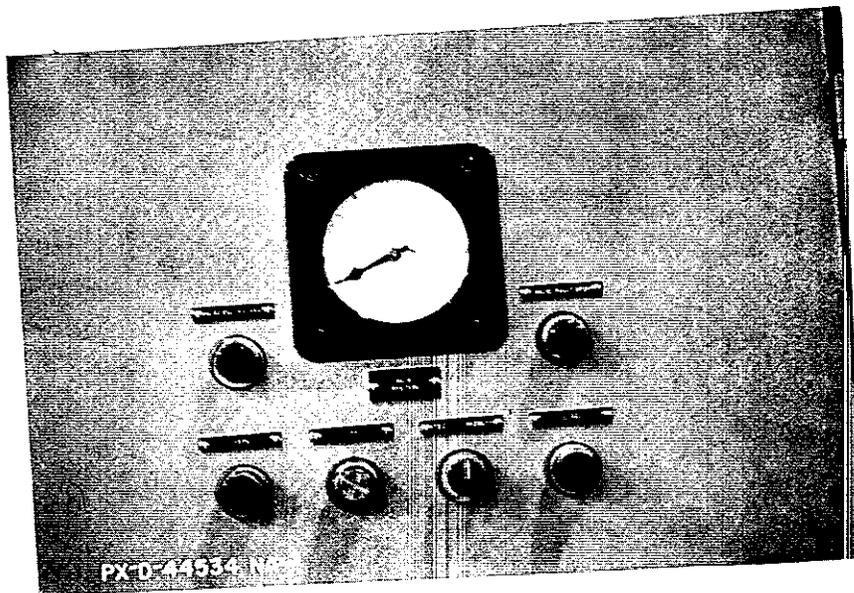
Figure 7. --Kajakai Dam. Control panel showing indicator, indicating lights, and pushbutton station for one hollow-jet valve.

3. The electric control instruments (Figure 7) including the pushbuttons, selector switch, indicating lights and indicator for each hollow-jet valve should be moved from the present control board to a small panel located on the wall adjacent to the hydraulic controls. This will give the operator a more convenient control system. The installation of an ammeter on the control panel for the gear unit motor would aid the operator in the operation of the hollow-jet valves. To give the operator better access to the hollow-jet valve controls, the valve operating unit should be moved into the control house. The shaft could be passed through a packing gland in a sleeve through the wall of the control house. Shaft connections between the hollow-jet valve and valve operating unit could be made with two sets of miter gear as shown on Drawing No. 3.

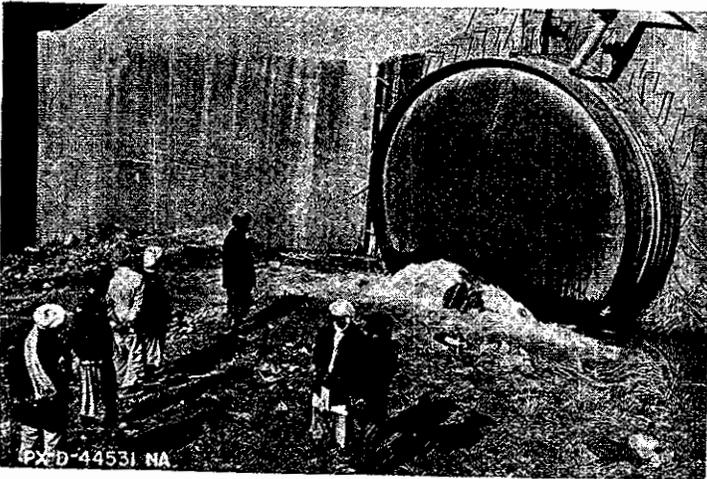
With the ring-follower gate open and the tunnel intake gate closed, the Howell-Bunger valves were opened to drain the tunnel. About half the tunnel drained through the Howell-Bunger valves, and the remaining water was drained by removing a 16-inch-diameter (41-centimeter) cover from the penstock bulkhead. The 48-inch-diameter (122-centimeter) outlet pipes were in excellent condition; there was no evidence of cavitation, erosion or

Figure 10.--Arghandab Dam penstock bulkhead. Draining the tunnel through a 16-inch-diameter manhole cover.

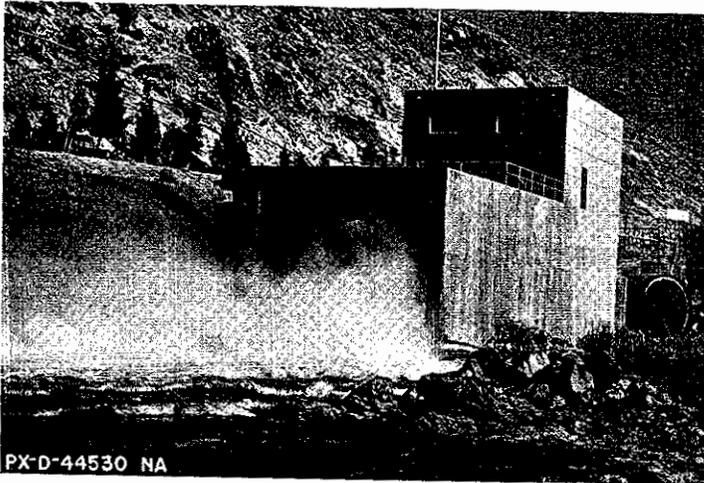
Figure 11.--Arghandab Dam. The valve house with the Howell-Bunger valves discharging at 30 percent opening.

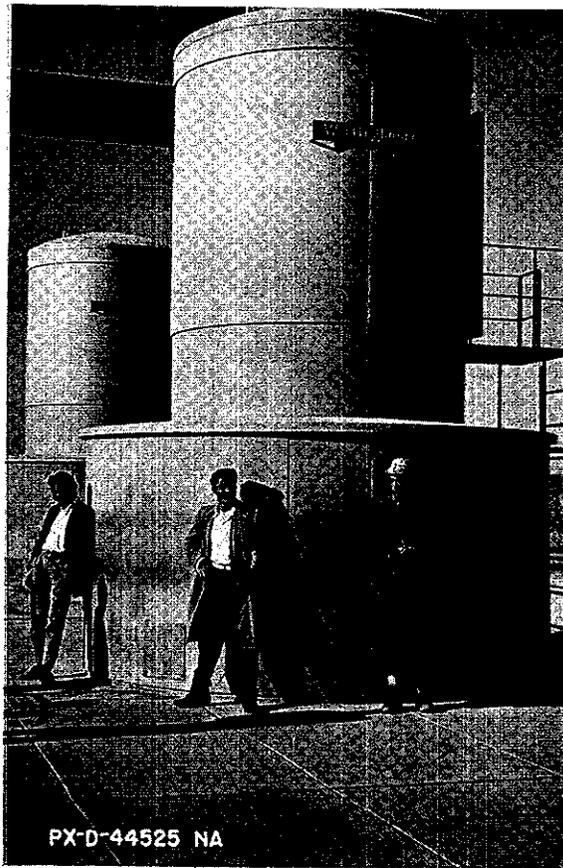
The generators (Figure 16) are of the outdoor-enclosed vertical type with a rated capacity of 1,500 kilovolt-amperes each, 80-percent power factor, 3 phase, 50 cycles at 187.5 revolutions per minute. The generators were furnished by Westinghouse Electric Corporation.

Figure 16. --Girishk Powerplant Generators. Outdoor enclosed-type 1, 500-kilovolt-ampere generators.

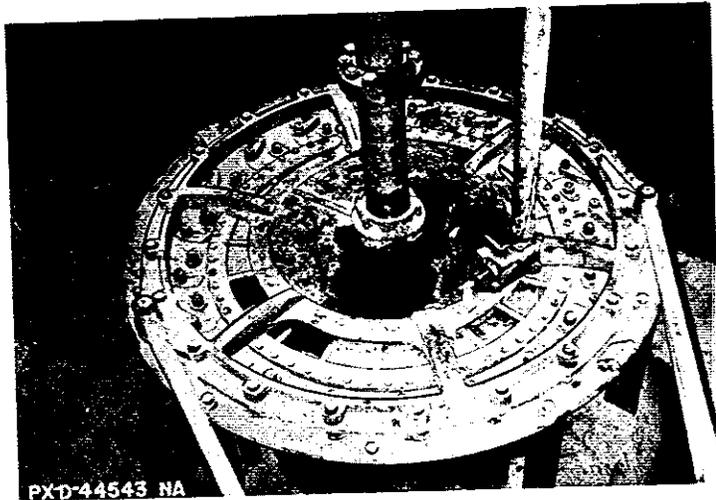
Figure 17. --Girishk Powerplant Unit 2.
Top view of turbine showing the speed
ring, turbine shaft and lower shaft
coupling.

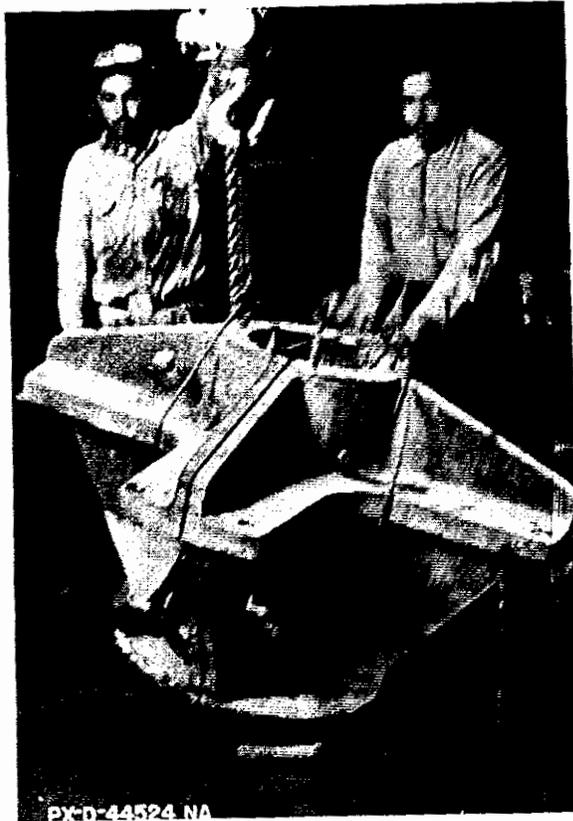
Figure 22. --Girishk Powerplant Unit 1. The turbine shaft bearing bracket assembled on the floor to measure the bearing diameter.

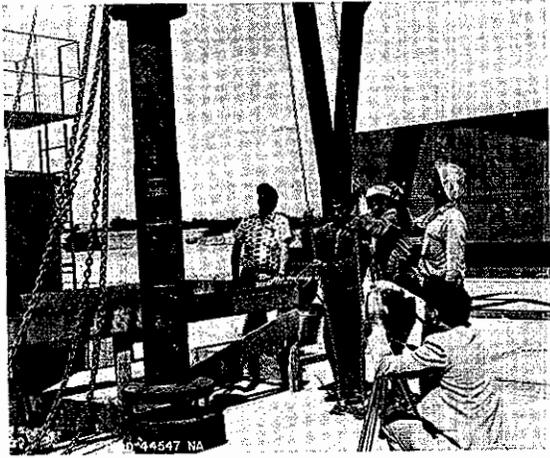
Figure 24.--Girishk Powerplant Unit 1. Workmen raising the turbine shaft to the surface deck of the powerplant. Shaft is 8.2 feet long and 12 inches in diameter at the bearing area.

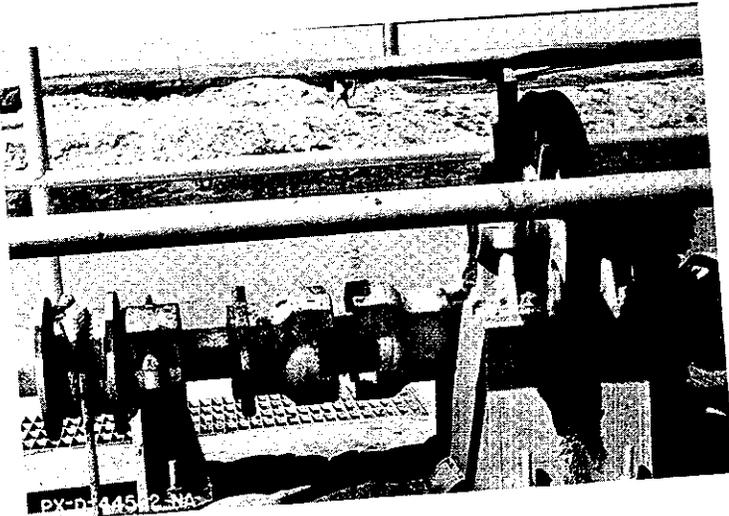
Figure 31. --Boghra Canal Wasteway. The notch-type clutch is used to change from manual to automatic control of the wasteway gates.

not go down. After prying the weight loose from the guides and dislodging the rope drum shaft from its bearings with a bar, the automatic mechanism began to work, but very sluggishly. The clutch (Figure 31) on the end of the rope drum shaft which should slide freely by hand could not be shifted even by forcing it with a bar. In examining the shaft it was found that lack of greasing and accumulation of dirt, grit and hardened grease had bound the bearings to the shaft so tight that it required tremendous force to turn it.

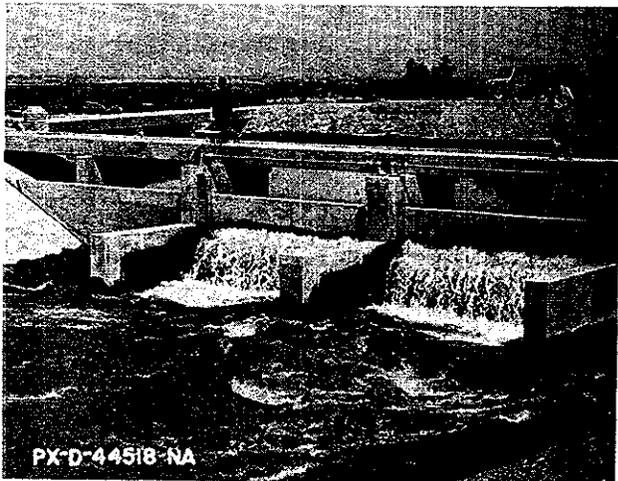
Figure 35.--Canal checkgates. Water flowing through a partially opened top-seal tainter gate which has a corrugated skinplate.

Other similar small structures, such as canal checks, branch canal outlets, and wasteways were examined on the canal system. Many of the small tainter gates (Figure 35) in check structures were top-seal types with corrugated galvanized skinplate. When these gates operate at any intermediate opening, extensive leakage occurs at the top seal because the seal is tight only in the closed position. The amount of leakage is of no consequence, but the continuous flow of water over the back side of the gate is causing considerable deterioration of paint and corrosion of the galvanized skinplates. Many of the hoisting mechanisms have been damaged by heavy traffic passing on narrow bridges over the structures. Small parts of hoisting mechanisms such as nuts, bolts, clamps, and grease fittings are missing.

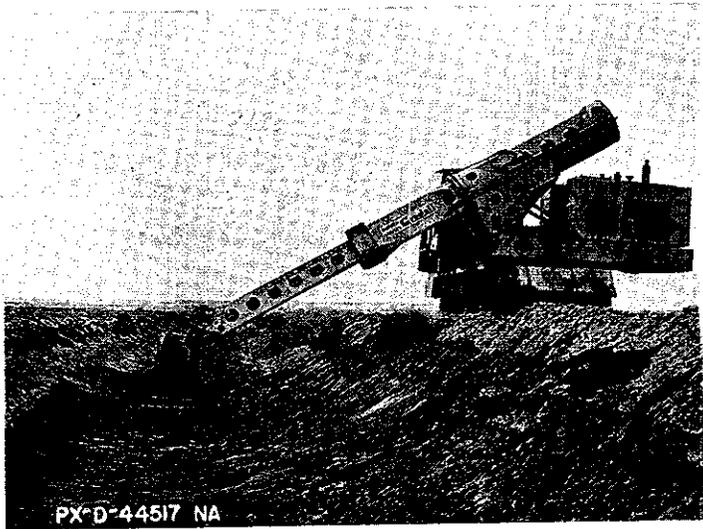
Canals in general are being kept in satisfactory serviceable condition. Heavy equipment such as draglines and a Gradall (Figure 36) is being used in the cleaning and repair work of canals. An objectionable feature of the cleaning operation of canals is that large, tall and irregular piles of material are left on canal banks. This condition is not only unsightly but leaves material where it can easily wash or blow back into the canal. The material also forms mudholes which are destructive to the canal banks and roadways (Figure 37). Some canals have been lined with compacted earth and other portions are being lined with compacted earth for more efficient irrigation operations. Most canal banks have fair roads on at least one side and are used for public traffic (Figure 38). Roads on the main canals are gravelled and in good condition.

Figure 36. --Canal cleaning. A Gradall being used to clean a canal.

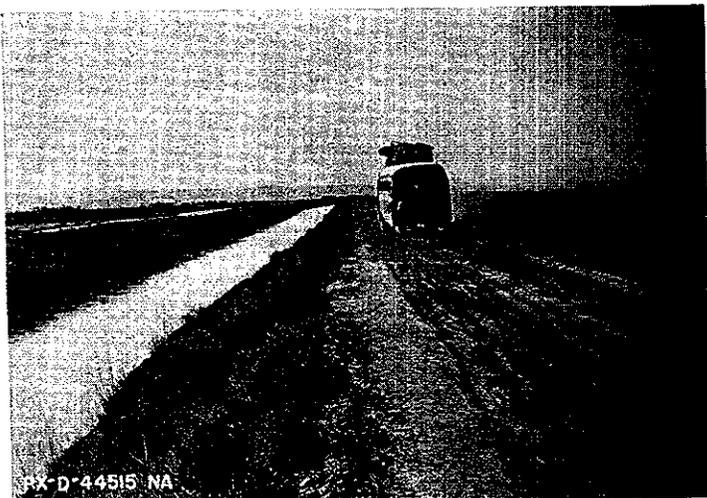
Figure 38. --Canal roadway. Narrow road on the bank of a small canal used for a public highway.
