**Structural Vulnerability Assessment of Selected  
Government Facilities:  
Antigua and Barbuda**

**Post-Georges Disaster Mitigation Project  
in Antigua & Barbuda and St. Kitts & Nevis**

**July 2001**

This report was prepared under contract with the OAS by Everton Cornelius of VEC Consulting, with review assistance by the Antigua/Barbuda National Office of Disaster Services and Public Works Department.

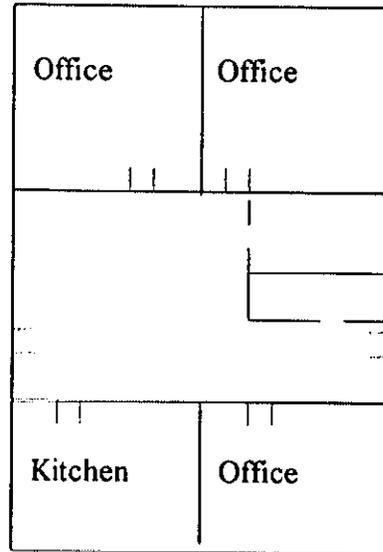
## Bishop Gate street Clinic

- 1. Built in 1994
- 2. Single building facility
- 3. Total square footage 800
- 4. Geographical location GR 233933

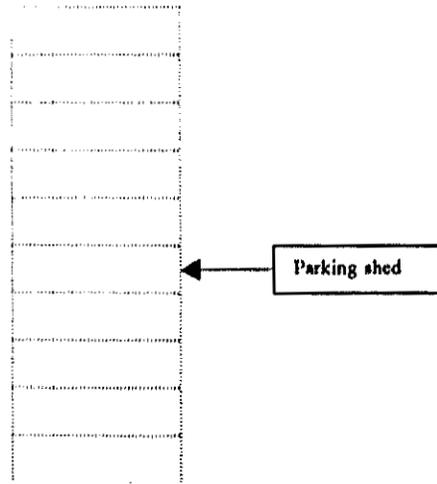
1. Total square footage 7,392
2. The Building has no shutters
3. Major repairs were carried out in 1991.
4. The building is Vulnerable to debris from its old parking garage
5. Single building facility
6. Geographical location GR233932
7. Built in 1837

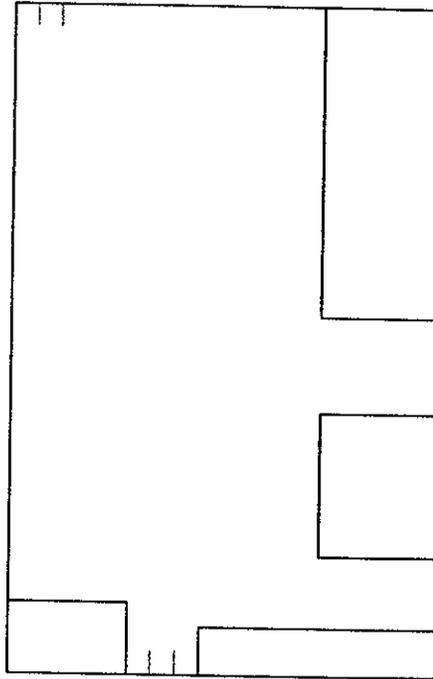
# Freemans Village Primary School

- 1. Built in 1962
- 2. Total square footage = 3,069
- 3. Geographical location GR292887
- 4. # Of persons to this shelter = 110
- 5. Two building facility
