# Umm Qasr Port Assessment

USAID TRN-03-009

## Draft Report

April 2003

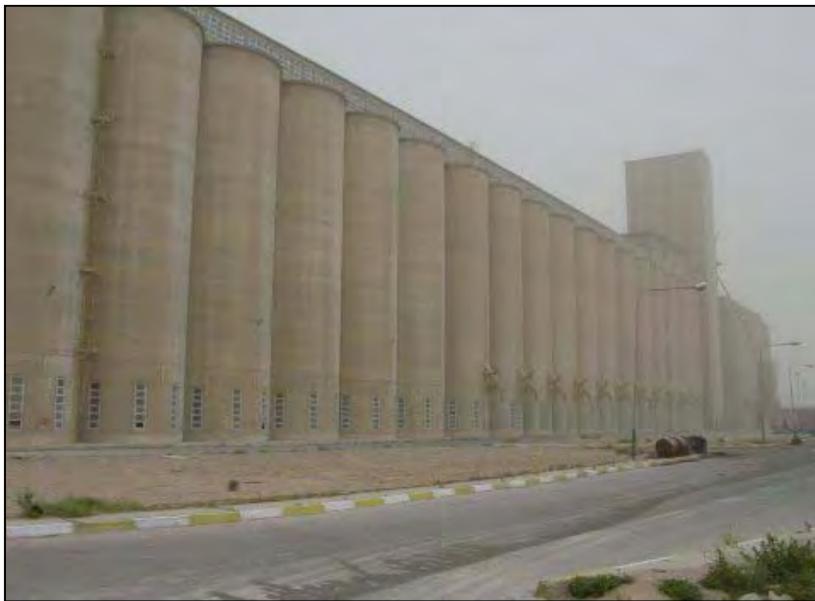
**Photo 4.1.1.1.1-1 Grain Silos.**

This facility consists of 48 silos with approximately 45,000 MT of storage. See Photo 4.1.1.1.1-1.

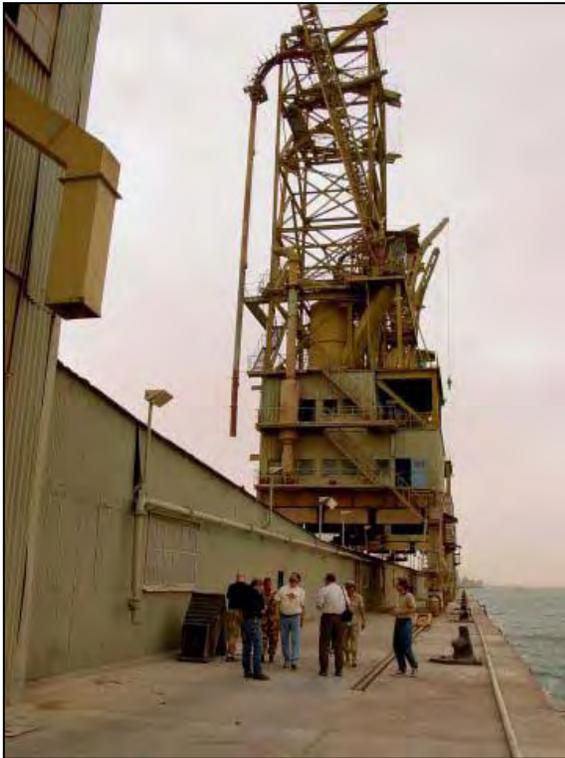
**Photo 4.1.1.1.1-3 Ship Unloader at Berth 10 Wharf**

The wharf and lifter tower appear to be in reasonable condition but with component wear and severe lack of appropriate maintenance. Lifter

No. 5 in the wharf receiving/shipping tower was discovered to have an electrical problem whereby it would start but not shut down, even if the main breaker was disengaged. This is a

serious potential operational and/or safety issue, which must be addressed before the facility is placed into operation. In addition, the short shipping conveyor in this tower will not start, the reason has not been identified but this is not considered to be a major problem providing it does not become necessary to provide a vessel load-out feature. It is noted that throughout the facility numerous repairs, preventive maintenance, and house cleaning is required.

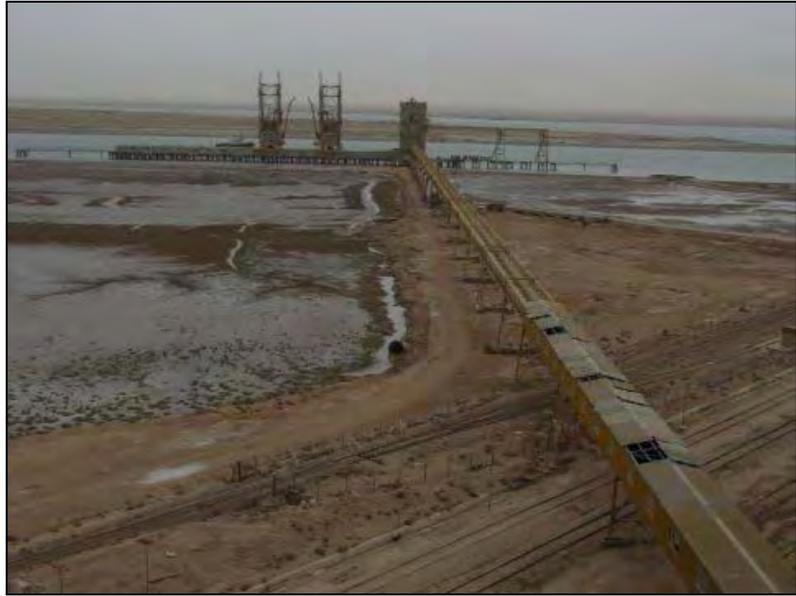
**Photo 4.1.1.1.1-2 Ship Unloaders and Conveyor System to the Grain Silo.**

There are two reversible receiving/shipping belts connecting the wharf and silo area, only one is operating at the present time and the problem with the remaining belt has not yet been identified. The incoming product to the silo is received by one or two bucket lifters and directed to storage or load-out. One of these lifters is out of service awaiting repairs to spouting and distributor components, which is presently in progress by the Royal Engineers, see Photo 4.1.1.1.1-5. The repairs, though large in scale, are quite minor and we can anticipate the lifter to be in operation soon. There are two in-house lifters that are functional and appear to be in good order.

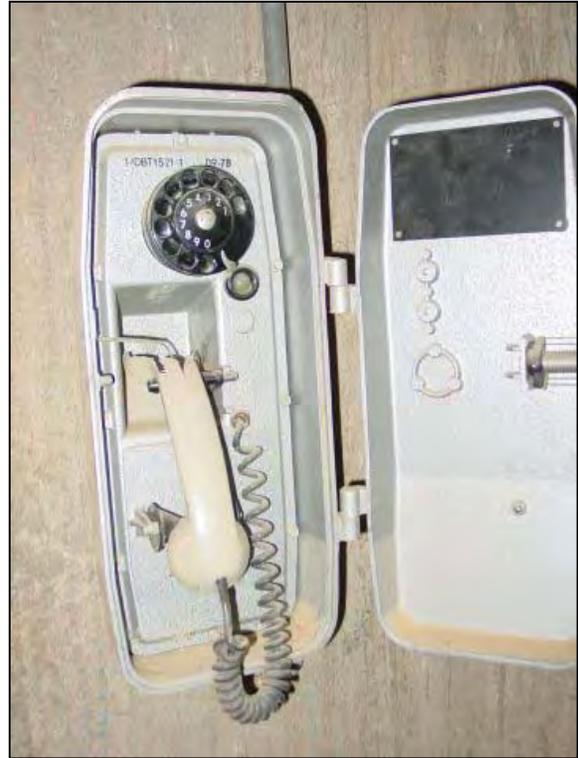
**Photo 4.1.1.1-6 Communication System.**

Communications throughout the facility are nonfunctional; many of the handsets are missing or broken creating an unacceptable compromise to efficiency and safety of the plant. See Photo 4.1.1.1.1-6.

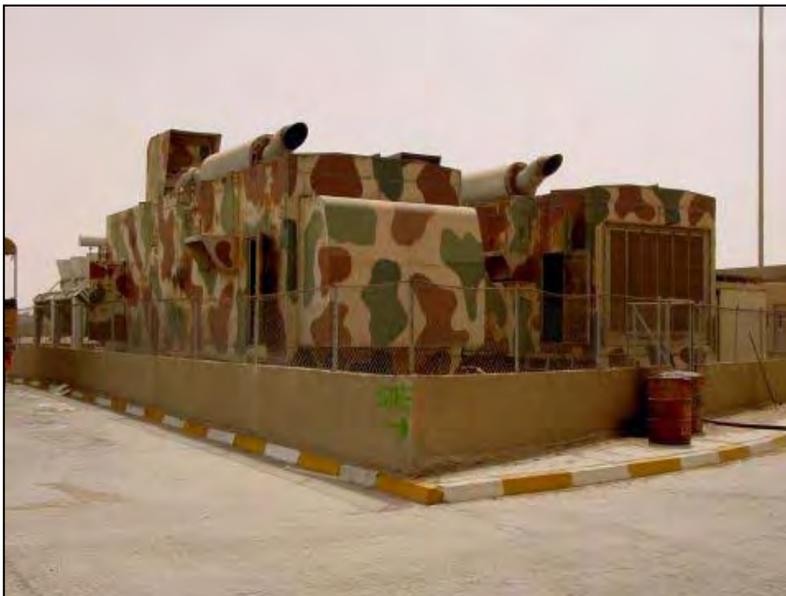
**Photo 4.1.1.1-7 Two Standby Generators, each 2.5MVA**

Electrical HV power to this facility was not available during the period of inspection and is not anticipated to come on stream for several months. Standby power is supplied by two stationary diesel generators, each of 2.5MVA capacity, see Photo 4.1.1.1.1-7. One has produced intermittent power during the equipment testing but has proved to be an unreliable source. The other unit has been nonfunctional during SSA's entire visit. Recommendations for electrical power solutions are addressed elsewhere in this report.

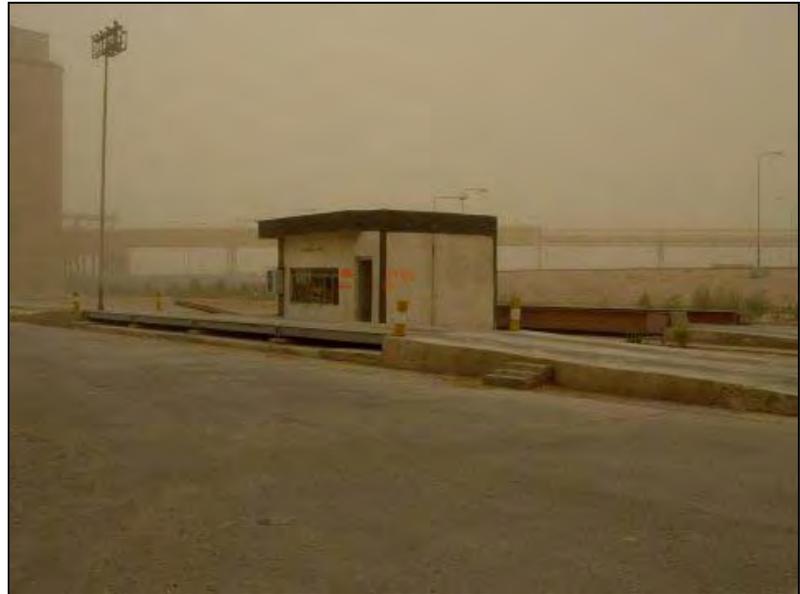
**Photo 4.1.1.1-8 60-Foot Weighbridge Facilities Comprised of an Inbound and Outbound Scale at the Grain Elevator.**

There are no rail or truck weighbridges that are functional at the present time. No other facilities for output inventory control are available. See photos 4.1.1.1.1-8 and 4.1.1.1.1-9.

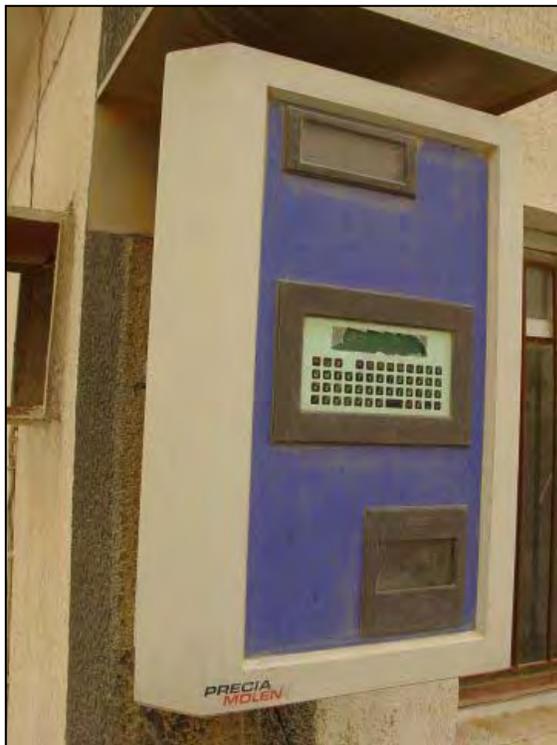
**Photo 4.1.1.1-9 Weighbridge Components Damaged.**

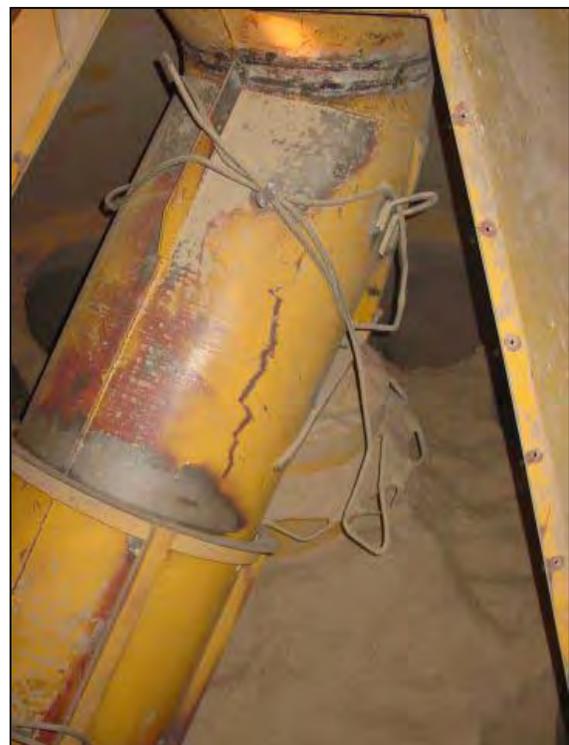
Maintenance and repairs have been lacking for an extended period of time, some repairs have been completed but at substandard level and do not meet codes or acceptable standards. See Photo 4.1.1.1.1-10. According to our visual observations, it appears that basic safety standards have not been met

**Photo 4.1.1.1-10 Hot Work Near to Grain Dust.**

(i.e., evidence of cigarette smoking in lifter house and basement, missing handrails at access shafts, and welding repairs being made in a dust laden environment). Substantial work will be required in this area prior to operations to ensure a safe working environment.

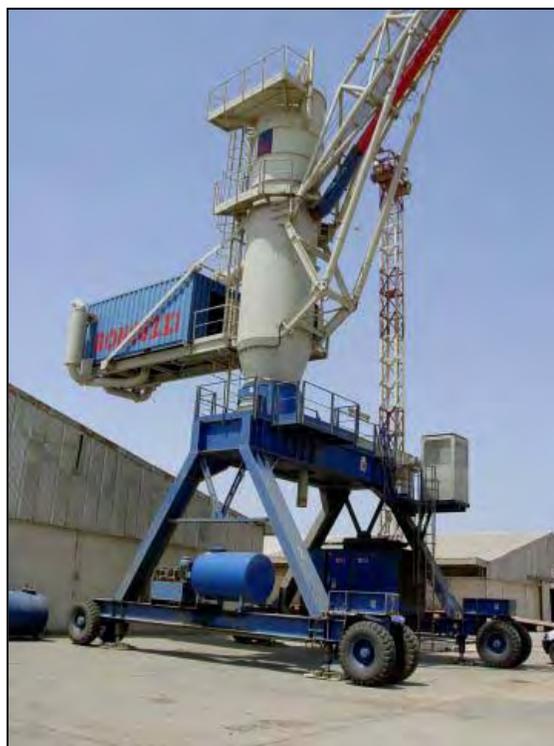
The manufacturer of this equipment, Roncuzzi of Italy, declares the target design capacity of each unit to be 280MT per hour for wheat. Considering the condition of the flexible rubber hoses and allowing for the normal set-up and movement, realistic production is anticipated to be 100MT per hour, yielding a maximum berth production of 10,000MT per 20-hour day for the five units. Of course, this production could increase to a maximum of 12,000MT per day if the sixth vacuator is brought back into operation. The mode of operation is to transfer grain directly from the unloader into awaiting trucks, there is no feature for grain storage in this operation but the unloaders do have a diverter gate that permits uninterrupted grain flow when exchanging trucks.

***Photo 4.1.1.1.2-1 Mobile Grain Vacuator at Berths 1 and 2.***

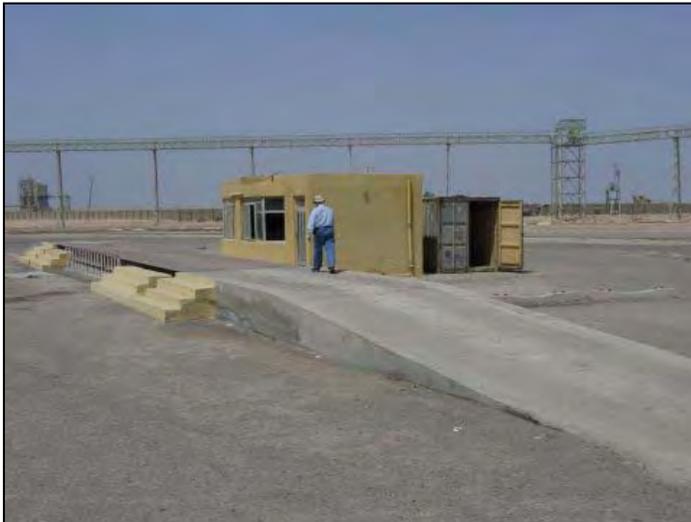
**Photo 4.1.1.1.2-3 Weighbridge in the Old Port for Berths 1 and 2.**

Three weighbridges are available within the "old" port to weigh grain trucks in both directions. See Photo 4.1.1.1.2-3. Unfortunately, all sustained damage during the conflict or by looting, which may have taken place afterwards. Repairs to the weighbridges, calibration and procurement of new computer equipment will be required to provide accurate measurements. This work is fairly minor and could be completed within a few months.

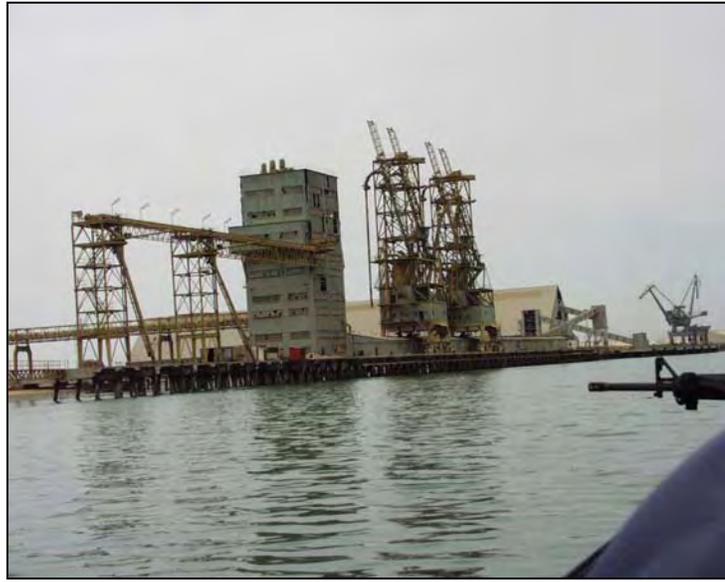
**Photo 4.1.2.1.4-1 Grain Berth with Two Fixed Vacuumators Forward and Two Crane-Mounted Vacuumators Behind.**

The wharf is comprised of two sections. The main wharf is 219 meters long and 16.2 meters wide. This wharf segment supports an 8-story building, 13.4 meters by 15.5 meters and a 183 meters long by 5.8 meters wide shed. It also supports two rail-mounted vacuator-type ship unloaders with an 11.2 meter gauge. See Photo 4.1.2.1.4-1 and Photo 4.1.2.1.4-2. The wharf structure is cast-in-place concrete supported by steel pipe piles. The deck is 200 mm thick and has a 50-mm-thick wearing surface. The deck is in fair condition, with distress located primarily along the slab edges. See Photo 4.1.2.1.4-3. The cap structures, located under the two crane rails and transversely at 3.5 meters on center, are in poor condition, with exposed or missing rebar predominant at the caps' bottom curtain of reinforcement steel. The cap concrete appears to be hard and sound and the extensive distress found appears to be due to insufficient concrete cover. It also appears that the concrete may have been in the process of being prepped for repair by the removal of all loose portions. See Photo 4.1.2.1.4-4. The pile sections above the waterline appear to be in fair condition.

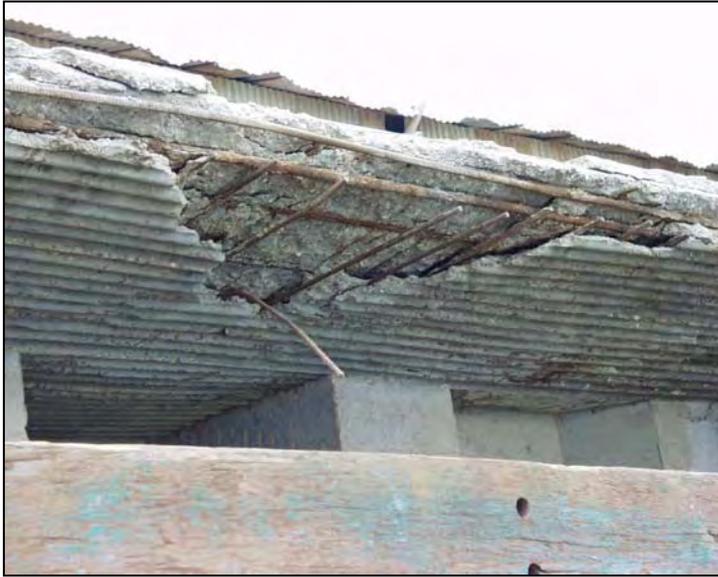
***Photo 4.1.2.1.4-3 Area of Exposed Rebar on Decking, Does Not Appear to be Prepped for Repair.***

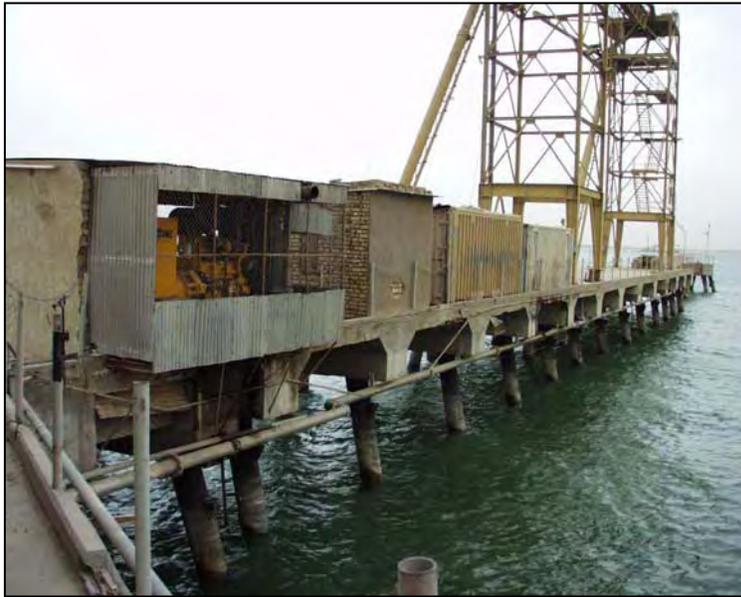
***Photo 4.1.2.1.4-5 Back Side of Second Wharf Section.***

The second wharf section is of lighter duty construction, similar to the trestle and supports two fixed loaders. It is 7 meters wide by 63.7 meters long. A cast-in-place concrete deck spans between cast-in-place caps located every 3.7 meters. The concrete and piles appear to be in good condition. Two vacuumators are fixed to the deck of this wharf segment. See Photo 4.1.2.1.4-5

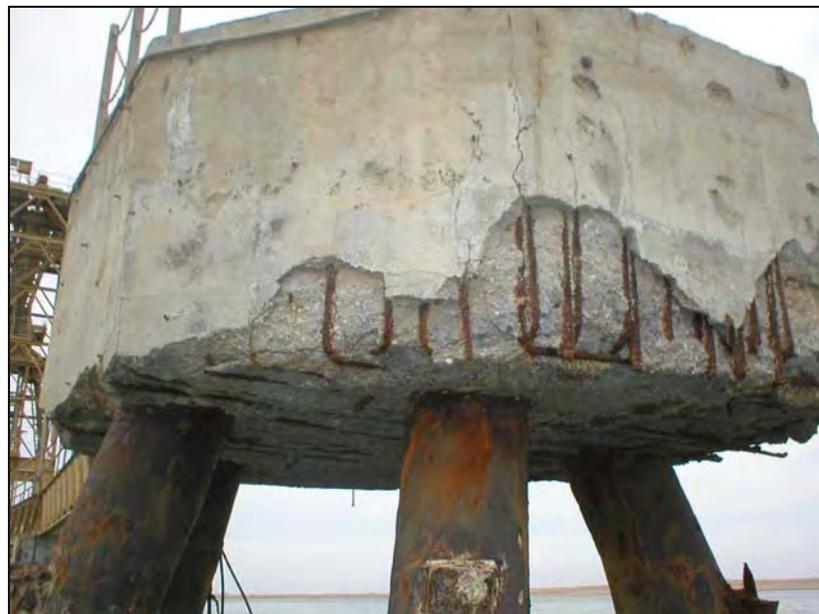
***Photo 4.1.2.1.4-6 East Dolphin Elevation.***

Off either end of the wharf is a mooring dolphin connected to the wharf by steel truss walkways. The east dolphin is octagonal with a 3.8-meter least dimension and has a center bollard. See Photo 4.1.2.1.4-6. It has a cast-in-place concrete cap that appears to be in moderate to poor condition and six steel pipe piles that appear to be in good condition. The west dolphin is octagonal with an 8.1-meter least dimension and has a center bollard. See Photo 4.1.2.1.4-7. It has a cast-in-place concrete cap that appears to be in poor condition and eight steel pipe piles that appear to be in good condition. The bottom curtain of steel is exposed and/or missing.

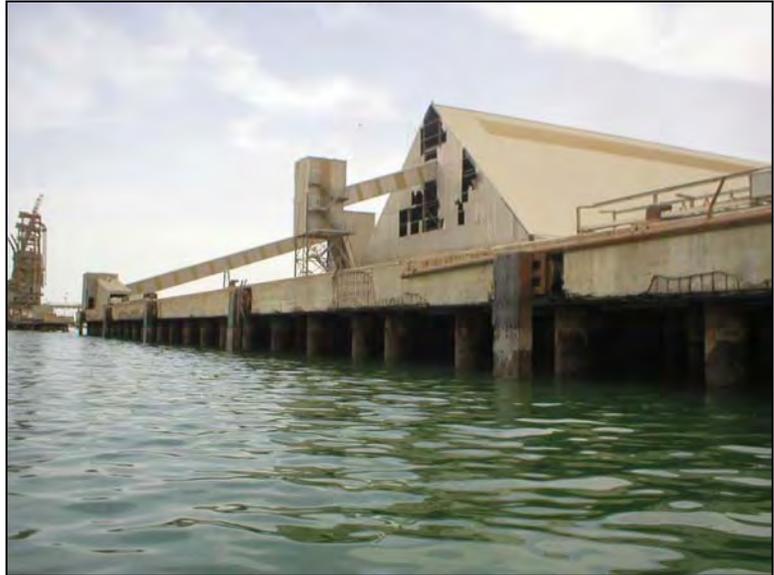
Bulk handling of sugar and vegetable oil occurs at Berth 11. It is a T-head pier and has not been evaluated because the facility is not required for the delivery of humanitarian aid products. See Photo 4.1.2.1.5-1.

*Photo 4.1.2.1.5-1 Sugar/Vegetable Oil Terminal; Eastern and Center Portion of the Front Elevation.*

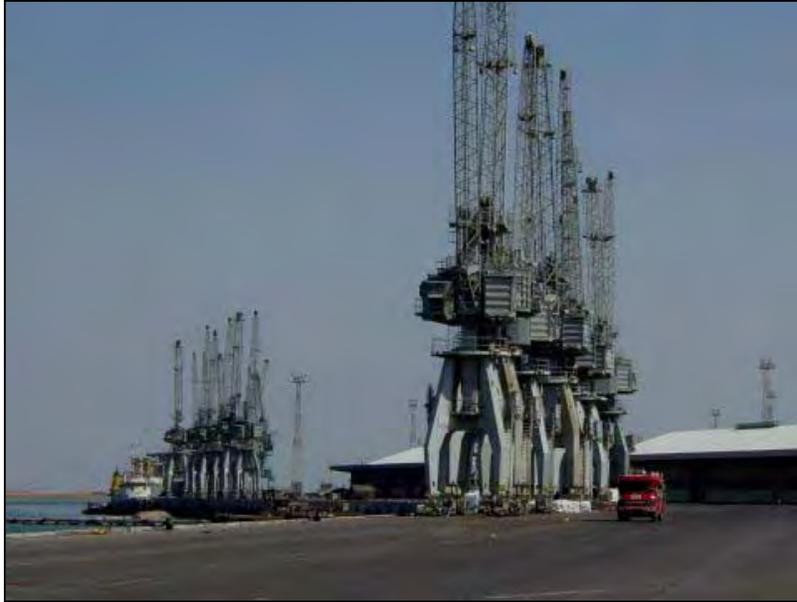
The ship to shore portal jib cranes along the berths offer a primary example of the equipment deficiencies. It is estimated that only 20 percent of these cranes can be put into service after a reasonable amount of repair. The rest are either beyond repair or not worth being repaired. Operations would be enhanced if these bad order cranes were simply removed from the terminal. These cranes are further limited in their restricted outreach for larger vessels and SWL capacity.

***Photo 4.2.1.1-2 General Purpose Portal Cranes in the “New” Port.***

In the near term, we recommend the use of self-contained vessels for the delivery of USAID-funded and humanitarian aid cargo because of the very limited number of working ship to shore terminal cranes.

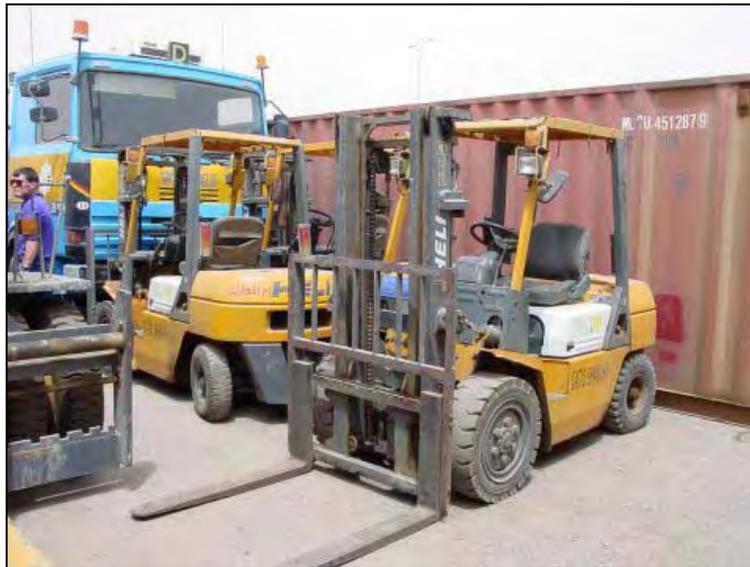
Multiple breakbulk vessel operations will also be severely restricted by the limited availability of operational forklifts. This is especially true for the smaller 3- to 5-ton forklifts, see Photo 4.2.1.1-3. As an example, if three vessels were working simultaneously with multiple gangs, up to thirty-six 3- to 5-ton forklifts would be required. When considering the total forklifts required for vessel, yard, and maintenance operations, the number of smaller lifts quickly multiplies.

***Photo 4.2.1.1-3 3-Ton Fork Lift Trucks.***

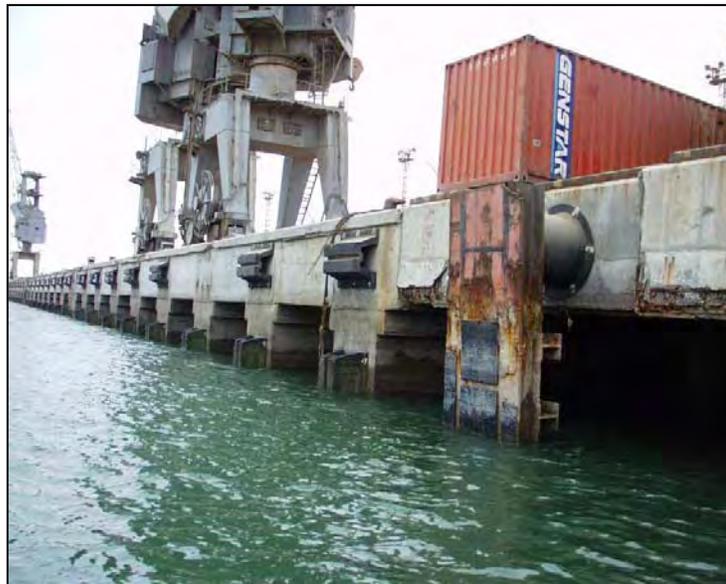
**Photo 4.2.2.1.1-3 V Fenders at Berth 1 and Buckling Column Fenders at Berth 2.**

Fendering at Berth 1 consists of two V fenders spaced at 6.1 meters on center bolted to the face of the wharf. The rubber fender elements are in poor shape with UV deterioration and high abrasion evident.

Fendering at Berth 2 consists of buckling column fenders spaced at 12 meters on center and are in poor condition. The facing panel is composed of three steel H piles and a UHMW wearing face.

Berth 1 structural repairs to the fendering system will require replacement. Berth 2 structural repairs to the fendering system will require replacement of half the rubber elements and refurbishment to half the frames.

Estimated cost of repair and replacement at Berths 1 and 2: US\$900,000.

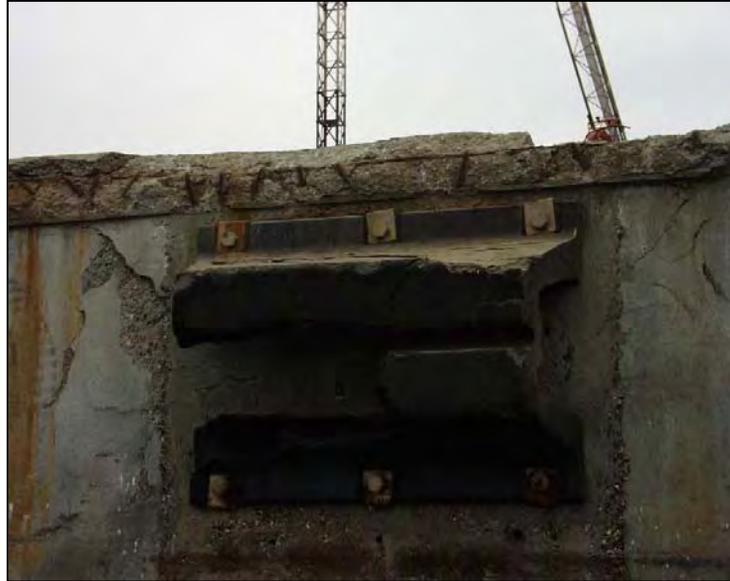
**Photo 4.2.2.1.1-4 Damaged Fender at Berth 1.**

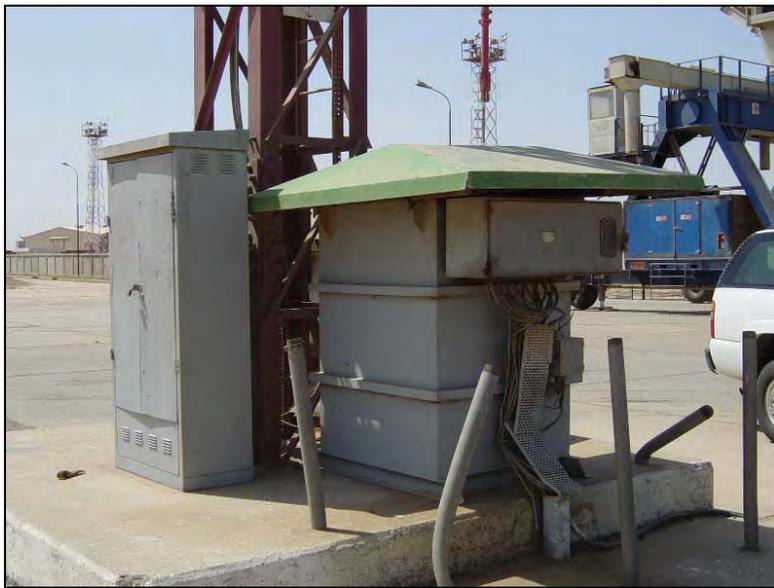
**Photo 4.2.2.1.1-5 Cathodic Protection Equipment.**

4.2.2.1.1-5). The status of the system is unknown.

There is an active cathodic protection system at these berths for the steel pipe piles (see Photo

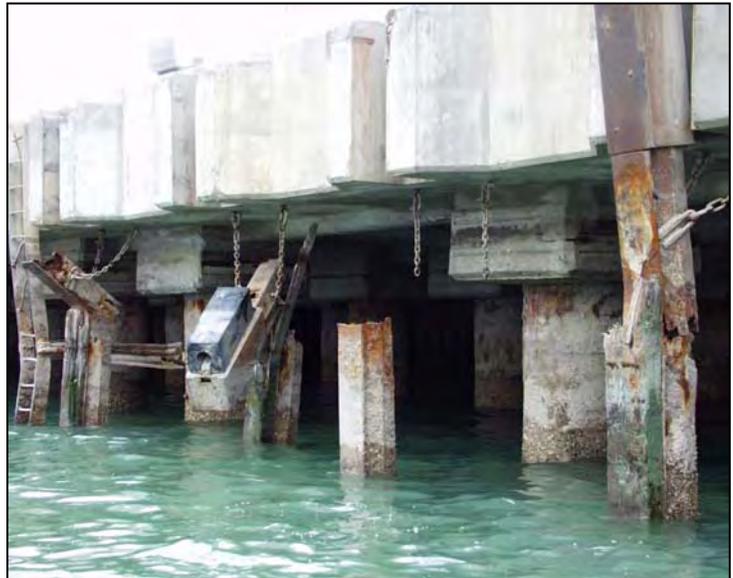
Fendering along the berths is light duty and consists of a timber-faced H pile with a square extruded rubber fender to the wharf spaced at just over 3 meters on center. The condition of the fendering system is poor at Berths 6 and 8 and fair at berth 7. About 40 percent of the fenders at berths 6 and 8 were non functional.

**Photo 4.2.2.1.2-2 Damaged Fenders.**

Berths 6, 7, and 8 structural repairs to the fendering system will require replacement.

Estimated cost of replacement at Berths 6, 7, and 8: US\$1,250,000.

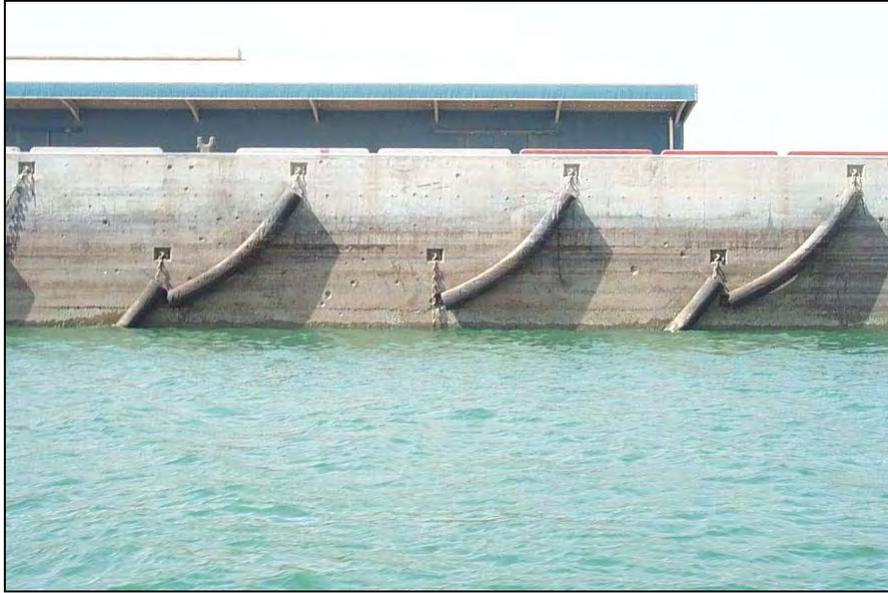
**Photo 4.2.2.1.3-3 "New" Port Fender System.**

The fender system consists of tubular rubber elements wrapped around galvanized chains that are slung in a diagonal manner along the face of the berth (see Photo 4.2.2.1.3-3). Fender elements are spaced at 8 meters along the wharf.

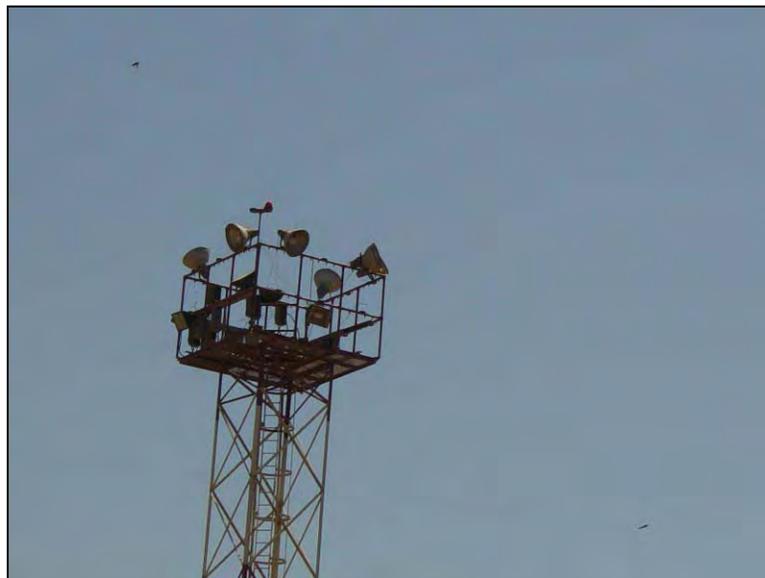
Lighting at the berths consists of tower mounted HPS light fixtures. Branch circuit wiring on the towers is badly deteriorated and requires replacement. The towers are set up for forty light fixtures each. Currently there are only 8-10 light fixtures per tower.

***Photo 4.2.2.1.3-6 Typical Light Tower on Berths 13-19.***

- Do not operate wharf equipment until the 11KV infrastructure, transformers, and low voltage (400v) switchgear are replaced.
- Provide a separate power feed for the light towers on Berths 13-19. Provide hand-off-auto switching with photocell control. Provide 2 separate power feeds at each light tower to allow for security level lighting and operations level lighting. Provide additional circuit breaker at each light tower to allow for separation of security lighting from operational lighting. Clean, re-lamp, and test all light fixtures/ballasts. Provide additional light fixtures as necessary. Estimated cost US\$250,000.

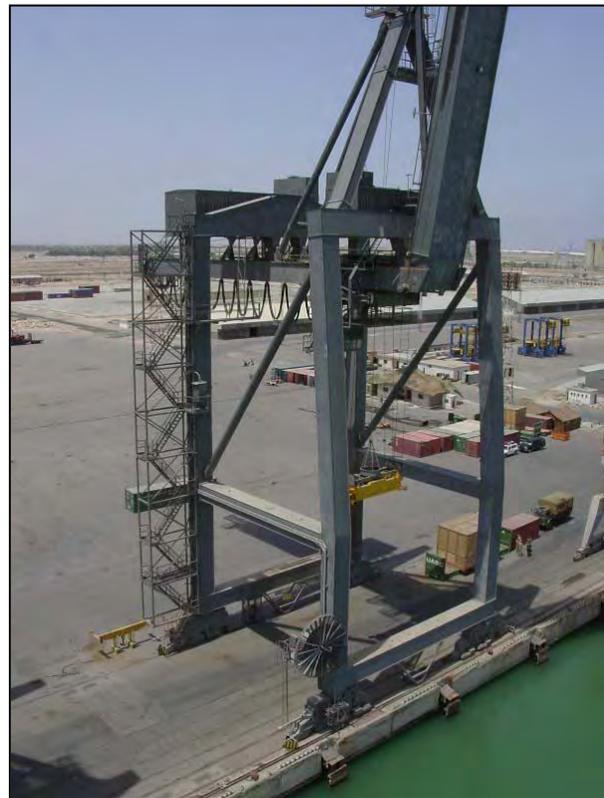
Two Nelcon quay cranes are installed in the “old” port serving Berth 5, see Photo 4.3.1.1-1. These Nelcon cranes are very old and the condition is unknown. One crane suffered damage to its cable reel assembly as the conflict started and it has been stuck in a boomed down position. See Photo 4.3.1.1-2.

*Photo 4.3.1.1-1 Nelcon Quay Crane, “Old” Port, Berth 5.*

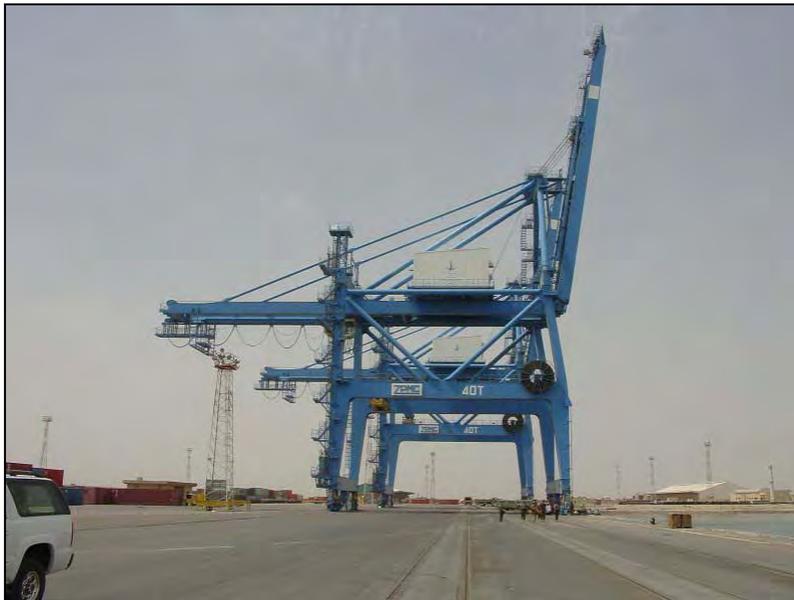
**Photo 4.3.1.1-3 Two ZPMC Container Cranes at Berth 20.**

The boom-locking latches on both cranes are not engaged having been electrically disconnected, leaving the cranes in a compromised safety condition.

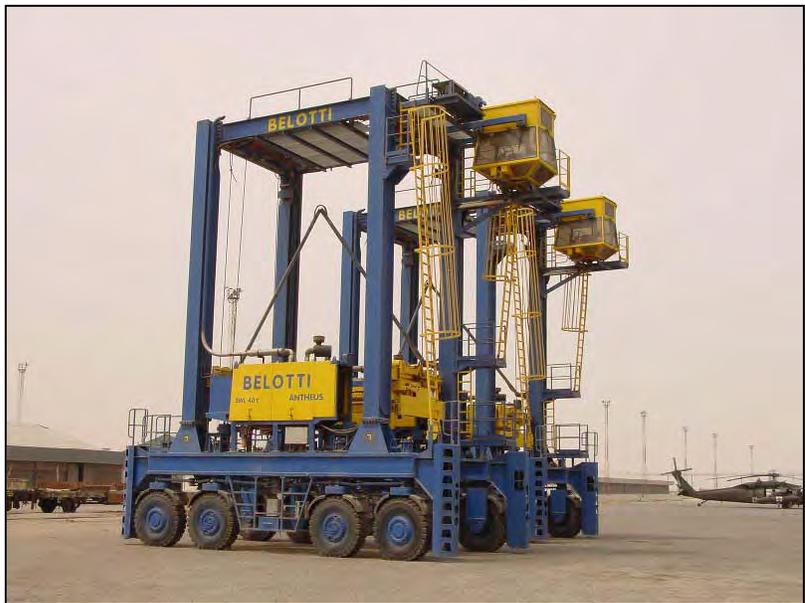
**Photo 4.3.1.1-4 Four Belotti Straddle Carriers.**

despite having been delivered one year earlier. We are aware that Belotti is no longer manufacturing this type of equipment, which was only ever produced in low numbers but that the company CVS Ferrari may have taken over support activities. In full reliable operating condition, these straddle carriers should be quite capable of transporting and stacking ISO freight containers within the configuration and volumes anticipated but since they have never been used, it is considered reasonable to plan for a second option. It should be noted however, that this type of equipment has a history of extremely high maintenance costs.

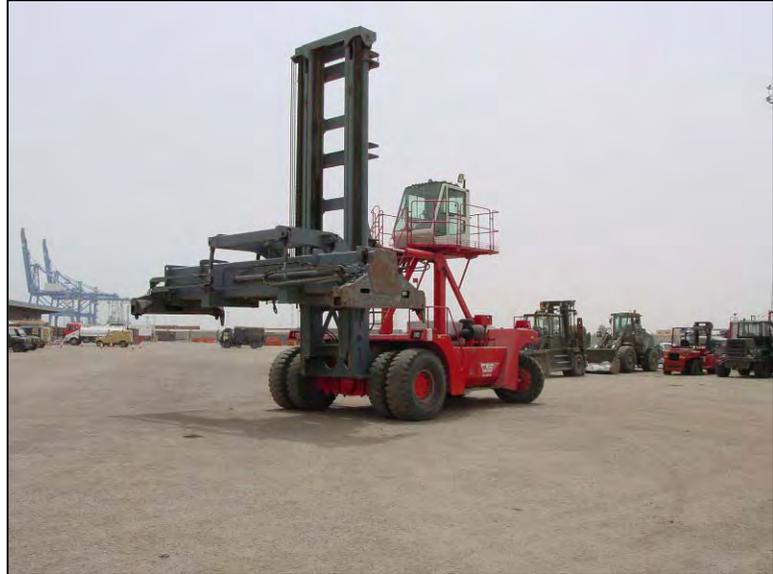
This second option could utilize four CVS Ferrari top picks (see Photo 4.3.1.1-5) that are available in the “new” port but would also need to be supplemented by yard tractors and specialized container chassis to transport containers to and from the stacking area. Only three of the CVS top picks are operational, the fourth was damaged and partially overturned while attached to a heavy 20-foot ISO container. At the time of inspection, the spreader had been disconnected from the machine but remained locked onto the damaged container (see Photo 4.3.1.1-6). The spreader itself appears to have suffered minimal, if any damage, and should be easily returned to operational condition.

**Photo 4.3.1.1-5 CVS Ferrari Top Pick.**

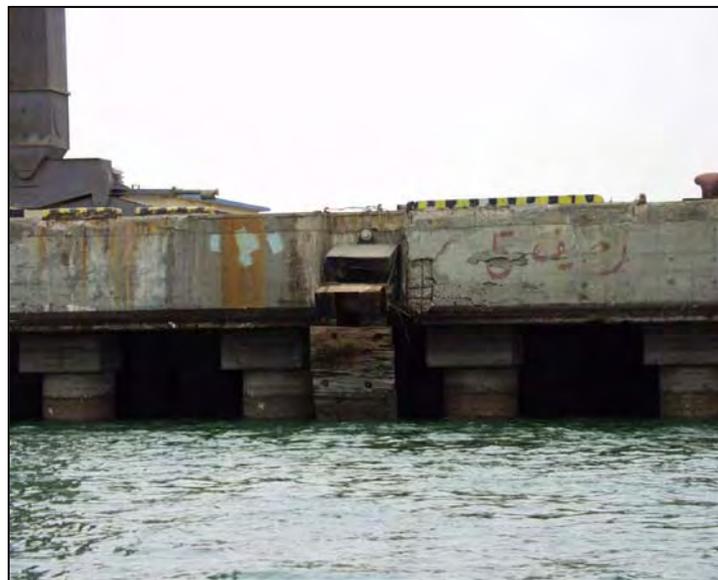
Fendering consists of V rubber elements and two fender piles supporting a panel at 10 meters on center. See Photo 4.3.2.1.1-3. The fendering system varied in condition from fair to poor condition and all rubber elements showed signs of UV induced deterioration.

**Photo 4.3.2.1.1-3 Damaged Fendering System.**

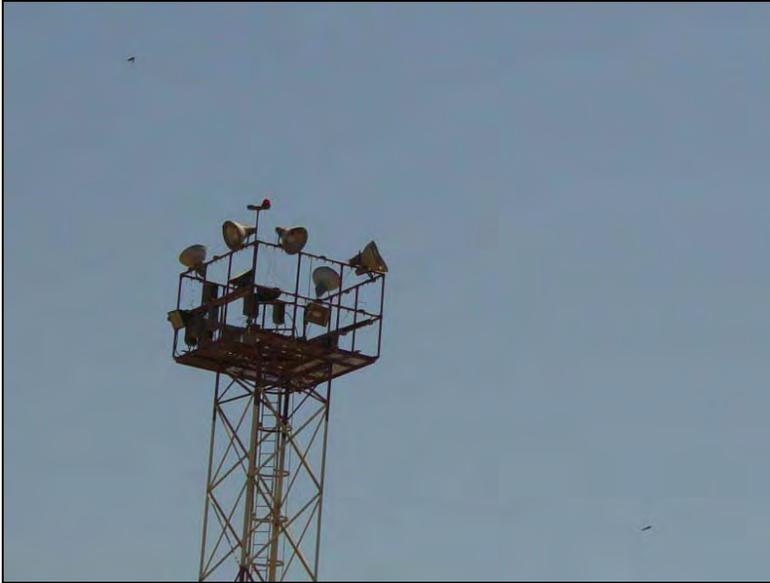
**Photo 4.3.2.1.1-4 Typical Light Tower at Berth 5.**

With the exception of fire water, vessel service utilities and other utilities at Berth 5 are nonexistent. It was not determined if the fire water system was operable because its pump system was not powered. Lighting at the berth consists of tower mounted HPS light fixtures. The branch circuit wiring is badly deteriorated and requires replacement. Each tower is set up to have 40 light fixtures. Currently there are 8-10 light fixtures on each tower. See Photo 4.3.2.1.1-4.

- Do not operate wharf equipment until the 11KV infrastructure, transformers, and low voltage (400v) switchgear are replaced.
- Provide a separate power feed for the light towers at Berth 5 and support area. Provide hand-off-auto switching with photocell control. Provide 2 separate power feeds to each of the light towers to allow for security level lighting and operations level lighting. Provide additional circuit breaker at each light tower to allow for separation of security lighting from operational lighting. Clean, re-lamp, and test all light fixtures/ballasts. Provide additional light fixtures as necessary. Estimated cost US\$200,000.

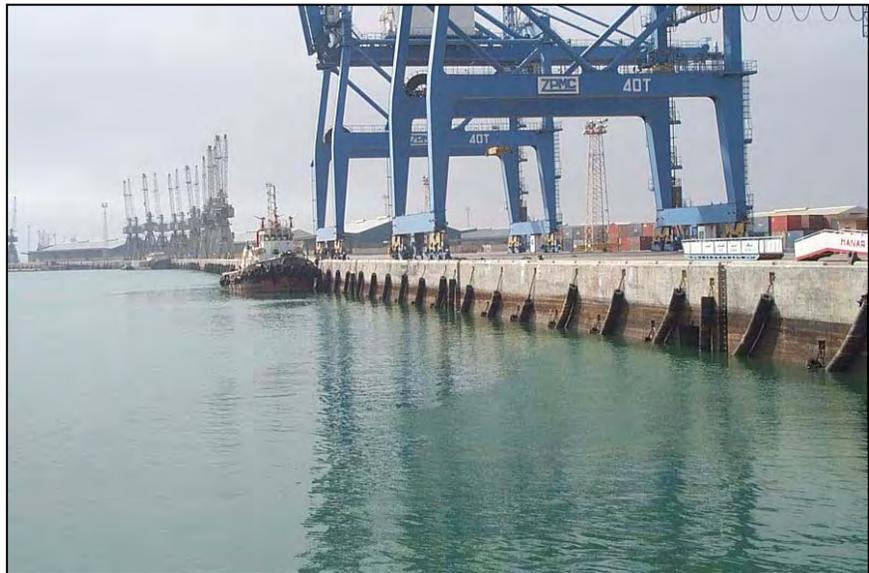
**Photo 4.3.2.1.2-1 Container Cargo Facility at Berth 20.**

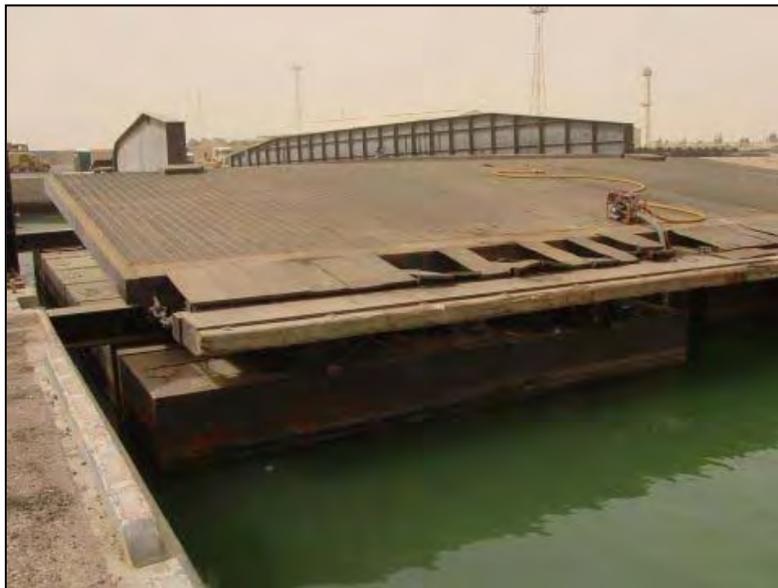
This ramp is well designed and able to support traffic moving to and from a RO/RO vessel. It is 40 meters long and 18 meters wide on the land side end. Minimal repairs will be required to the steel deck plating closest to the water edge of the ramp.

*Photo 4.4.1.1-1 RO/RO Ramp Berth 21.*

The RO/RO facility appears to be in very good condition. The rocker hinges at the head of the ramp are in excellent working order as are the guide beams on either side of the seaward end. There is no discernible deterioration of the ramp beams or deck. The pontoons also looked to be in very good condition.

There are no repairs recommended at this facility.

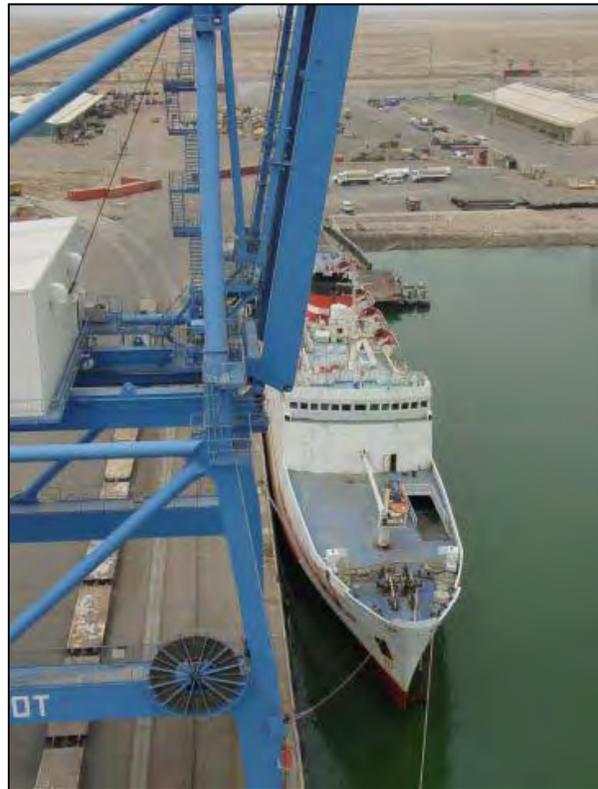
One negative to the RO/RO operation's location is that its berthing or mooring space superimposes a portion of the container berth. This in reality should have minimal impact however, given the length of the container berth. The ship to shore gantry container crane rail track is approximately 550 meters long. The track extends southward through the faces of Berth 19 and B19 warehouse. The actual open berth for container vessels is 300 meters plus.

**Photo 4.4.1.1-3 Vessel on RO/RO Ramp  
Extending into Container Berth.**

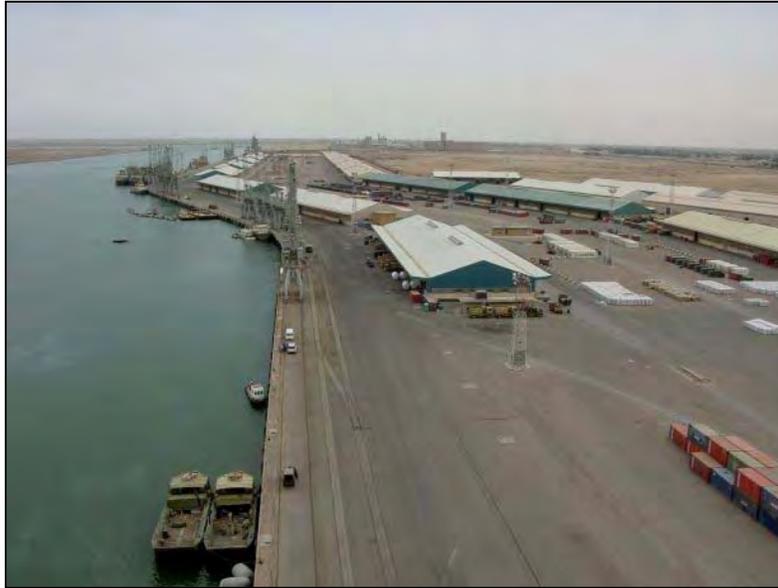
***Photo 4.4.1.1-4 Container Crane Track Extends to South End of Berth 19 Shed.***

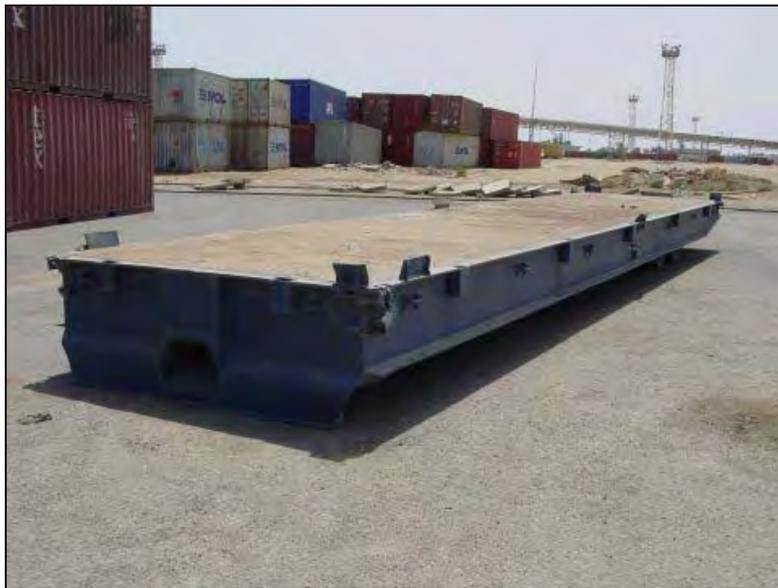
***Photo 4.4.1.1-5 Mafi Trailer Used for Transporting RO/RO Cargo.***

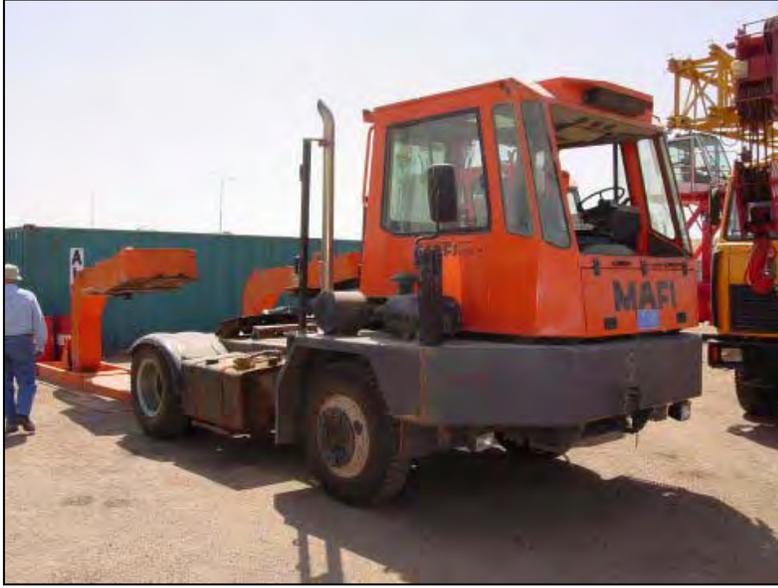
**Photo 4.4.1.1-6 Mafi Tractor, Which has a Special Gooseneck Attachment for Towing Mafi Trailer.**

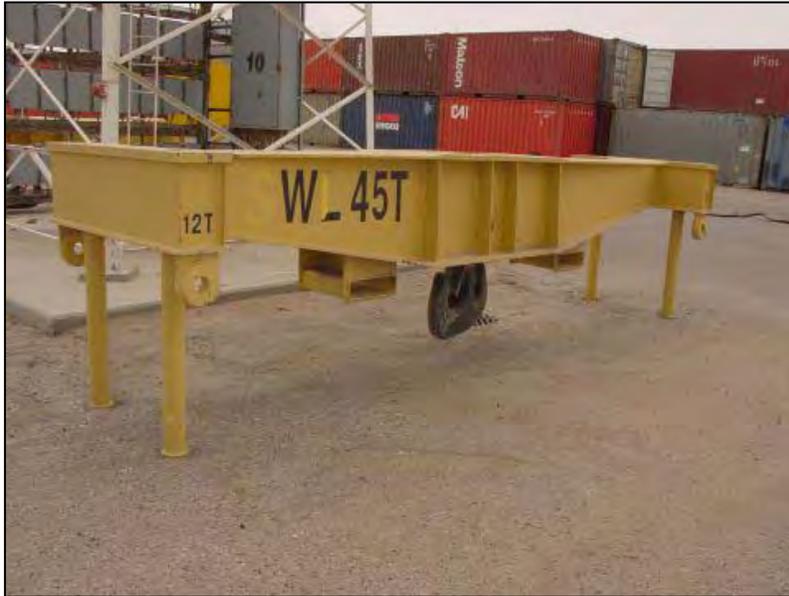
**Photo 4.5-1 45-Ton Heavy Lift Cargo Beam for ZPMC Container Cranes.**

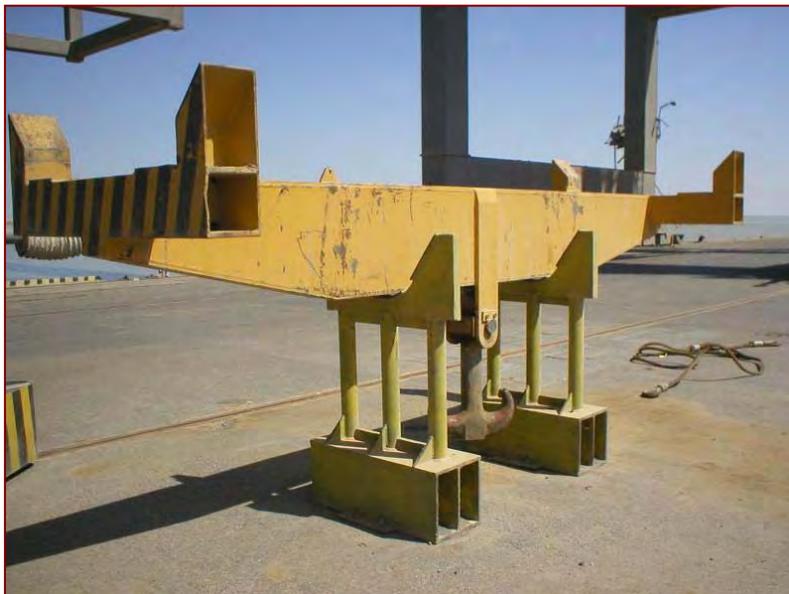
The old port Nelcon container cranes have only one total heavy lift beam. The safe working load of this hook is unknown.

**Photo 4.5-2 47-Ton Heavy Lift Cargo Beam for Nelcon Container Cranes.**

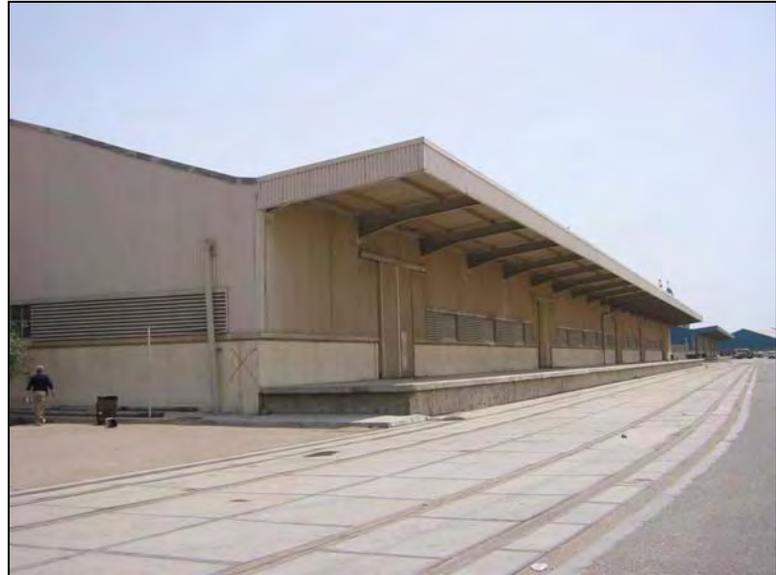
**Photo 5.1.1-1 Typical “New” Port Warehouse Building Showing the Loading Dock along the Side of the Building away from the Berth.**

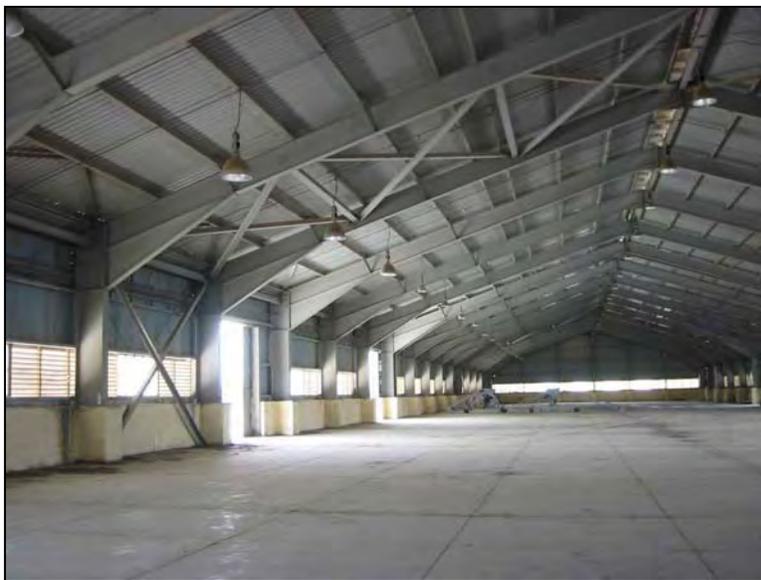
**Photo 5.1.1-2 Typical “New” Port Warehouse Construction.**

The facilities are in relatively good condition (see Photo 5.1.1-2). However, the facilities have seen very little maintenance effort and most of them are in need of at least some maintenance work to ensure weatherproofing and to improve rodent control.

All covered storage warehouses have highbay-type hanging lights (see Photo 5.1.1-2). It is not evident if these are high-pressure sodium (HPS) or metal halide. It is assumed they are 400w HPS.
