# Umm Qasr Port Assessment

USAID TRN-03-009

## Draft Report

April 2003

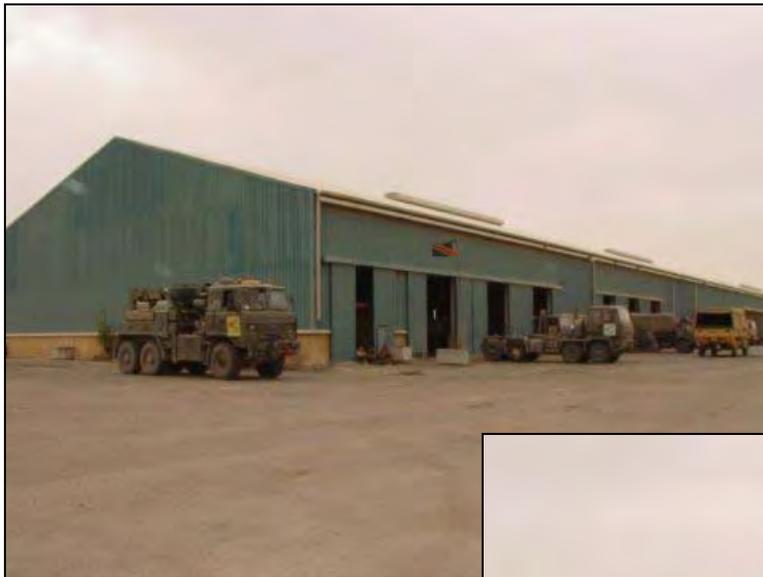
In the “old” port, there is a building containing some spare parts and engineering manuals, and it appears this may have been the area where mechanics were located (see Photos 6.1.1-1 and 6.1.1-2). The condition of the interior was very poor, offices have been ransacked, delicate spare parts have been damaged, but there are some components that could be recovered.

**Photo 6.1.1-1 Proposed Maintenance Shop, Looking North.**

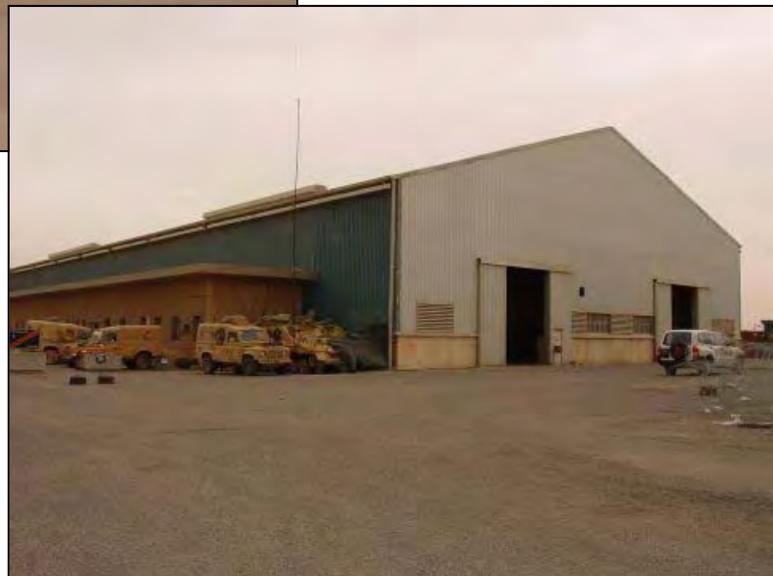
**Photo 6.1.1-2 Proposed Maintenance Shop, Looking South.**

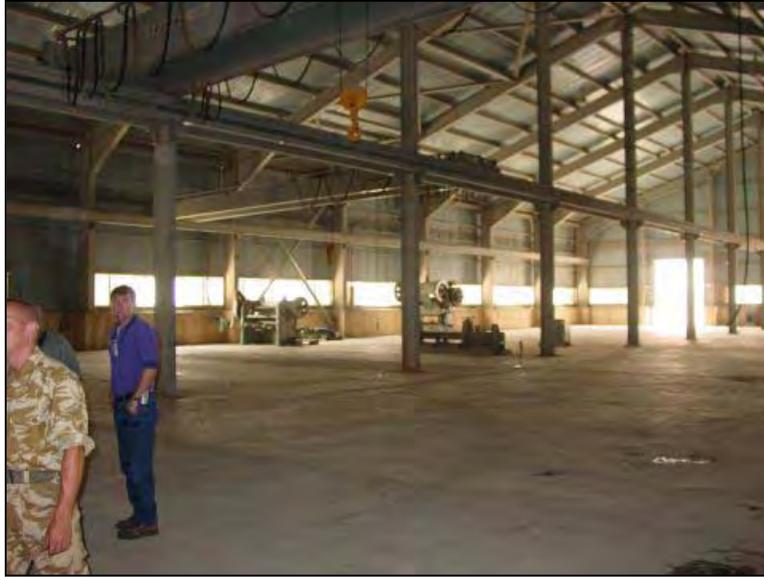
This building is in good condition with 4-meter-wide sliding door access in several locations (see Photo 6.1.1-3). The power supplies and lighting need attention to repair damage, as do the washrooms in which all the sanitary ware has been broken (see Photo 6.1.1-4). There are even some old machine tools, but it’s doubtful any could be brought back into operation.

**Photo 6.1.1-3 Interior View of the Proposed Maintenance Building.**

- Clean offices and repair broken fixtures such as windows and doors
- Clean and replace all sanitary ware, which is broken
- Repair damage to electricity supply panel and safety check all outlets
- Provide additional electrical outlets as required
- Repair all light fittings to provide a facility, which could operate 24 hours per day
- Repair all doors to provide a secure facility
- Repair overhead crane pendant, function test, and recertify
- Provide additional exterior security and working lighting

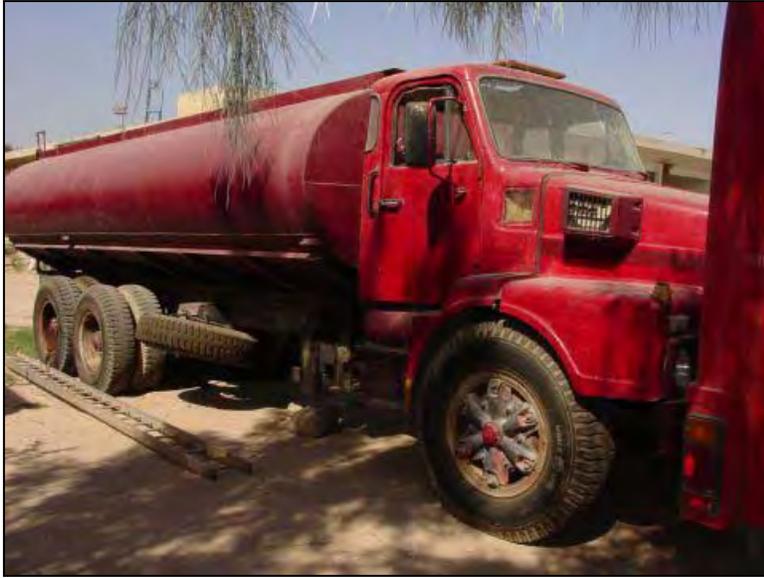
*Photo 6.1.1-5 – Fuel Truck.*

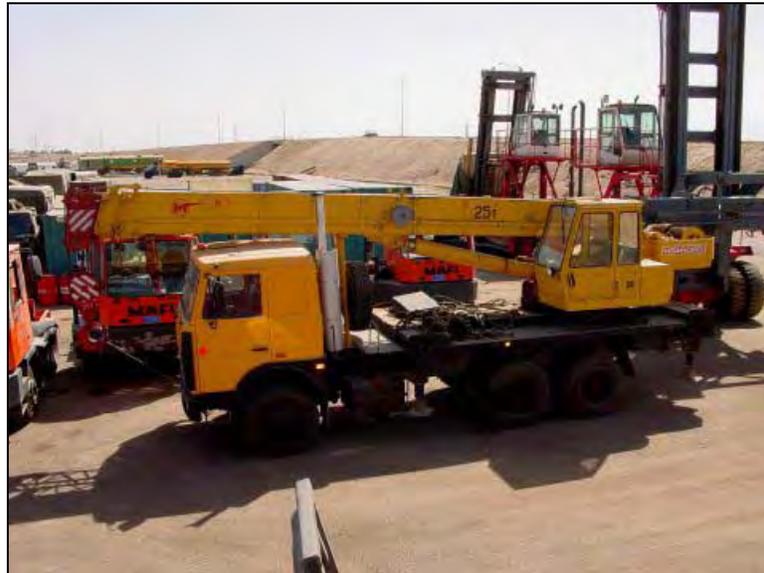
*Photo 6.1.1-6 – Mobile Telescopic Crane.*

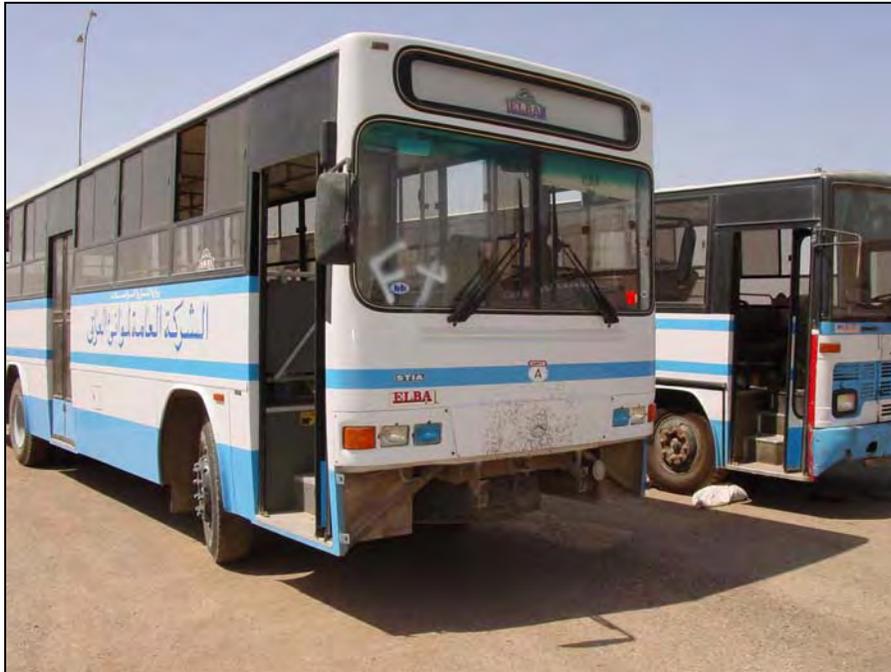
*Photo 6.1.1-7 One of Two Operating Buses.*

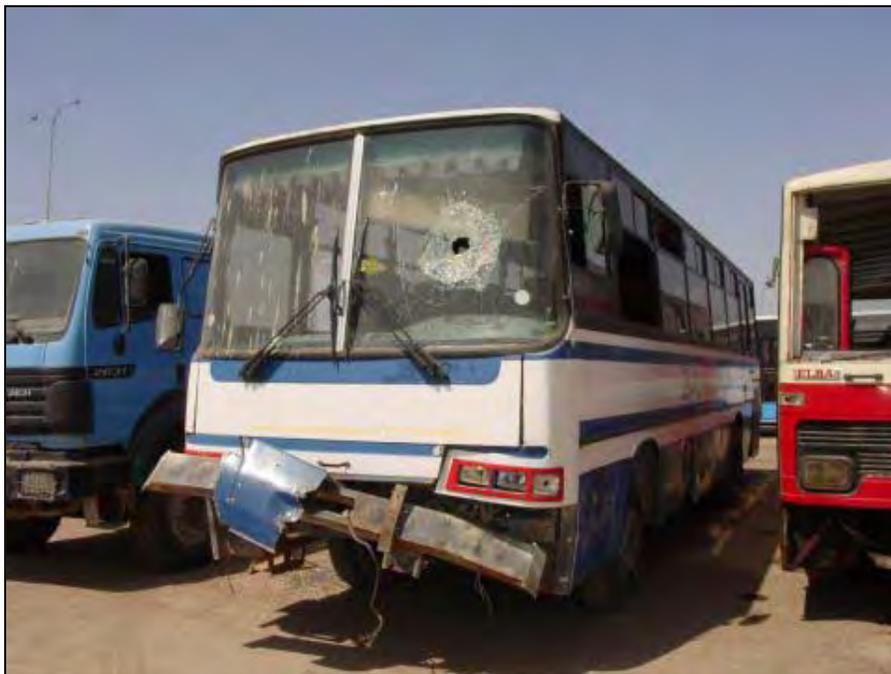
*Photo 6.1.1-8 Other Buses are Not Operational.*

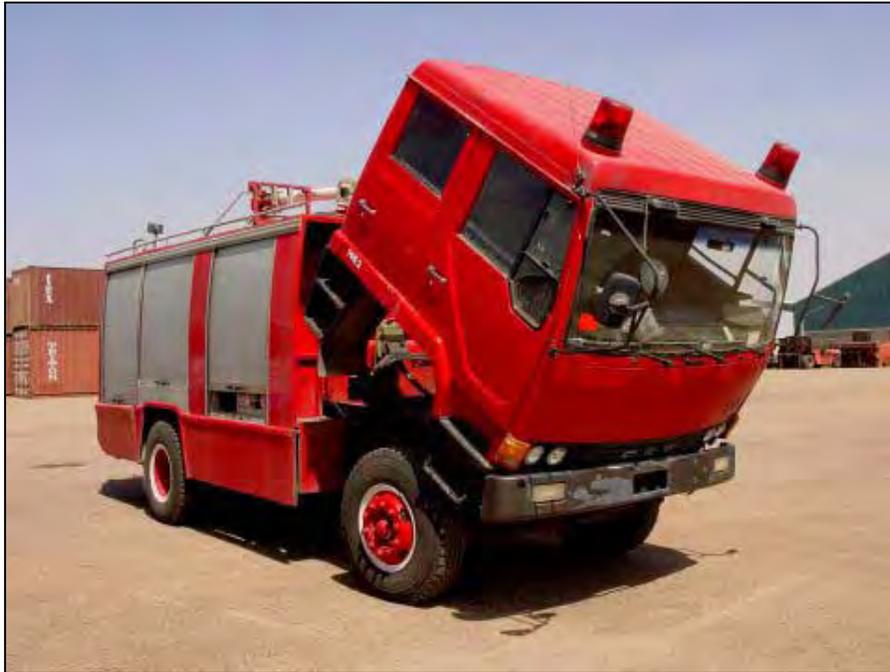
*Photo 6.1.1-9 One of Two Available Fire Trucks.*

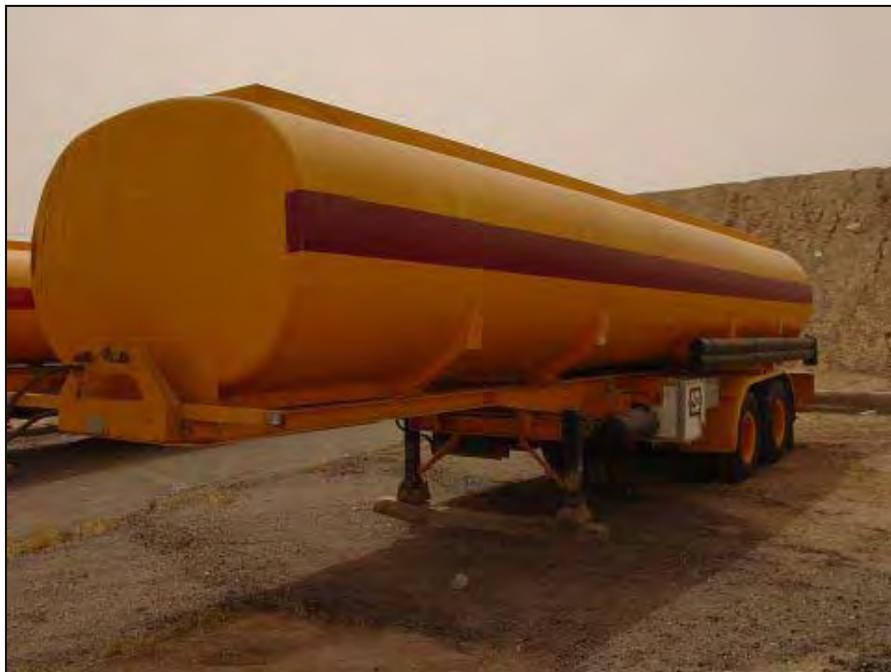
*Photo 6.1.1-10 One of Two Available Fuel Trailers.*

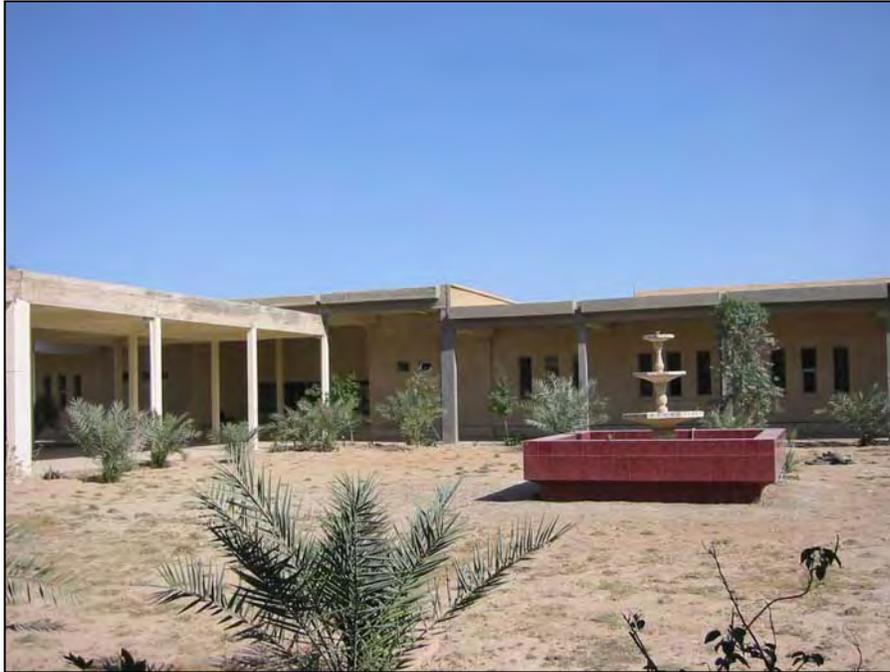
*Photo 6.2.2-1 Administration Building and Courtyard.*

Today, the administration building is home to marine operations and infrastructure reconstruction under taken by the 17th Port and Maritime Regiment RLC. Their presence and location is assumed to remain in place and in current space occupied for the next several months. The building will need some degree of repair and restoration to bring it up to suitable office standards.

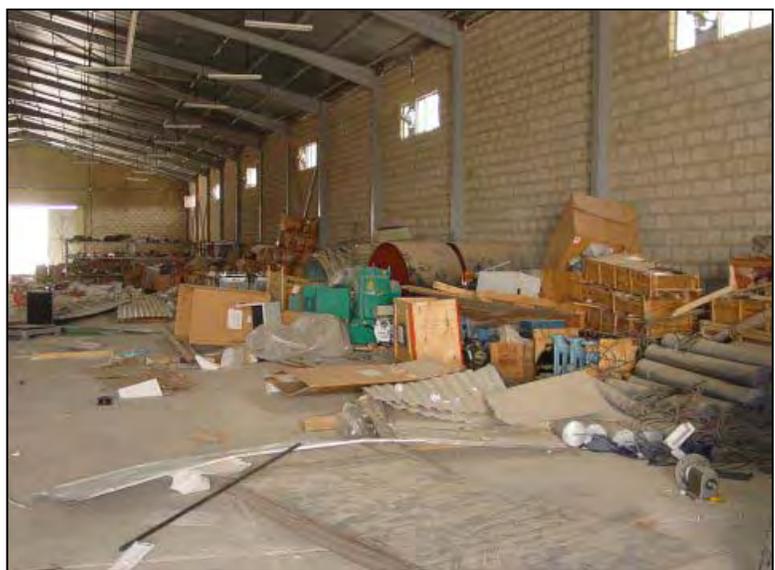
Inspection of each facility suggested that the Port was equipped with spare parts warehouses in many different locations (see Photos 6.4.1-1 through 6.4.1-4). The grain terminal undoubtedly held the most substantial stock holding, having three large warehouses of material. Others, such as the engineering department in "old" and "new" ports, held only minor items of stock that appeared inadequate for the size of the operation. In each case, the stores areas had been ransacked, many parts damaged or completely destroyed

**Photo 6.4.1-1 Grain Elevator Terminal Store.**

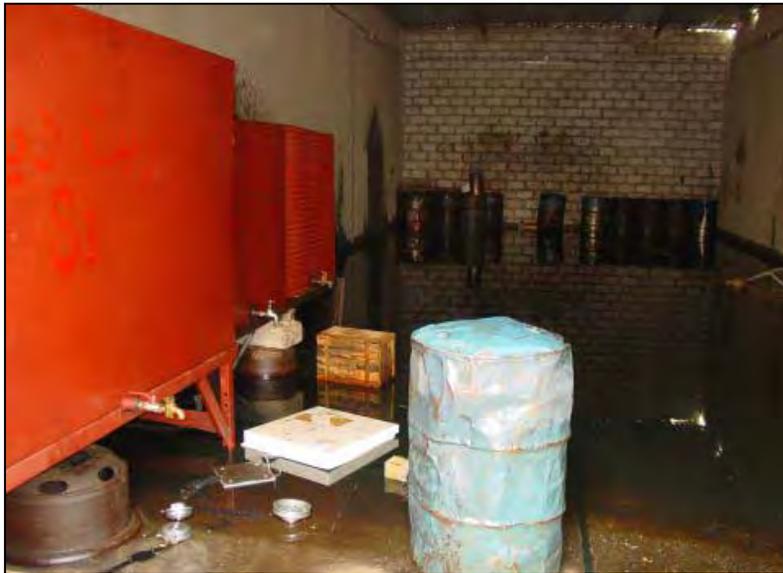
**Photo 6.4.1-2 Lube Store at Grain Elevator Terminal, Flooded with Engine and Transmission Oils.**

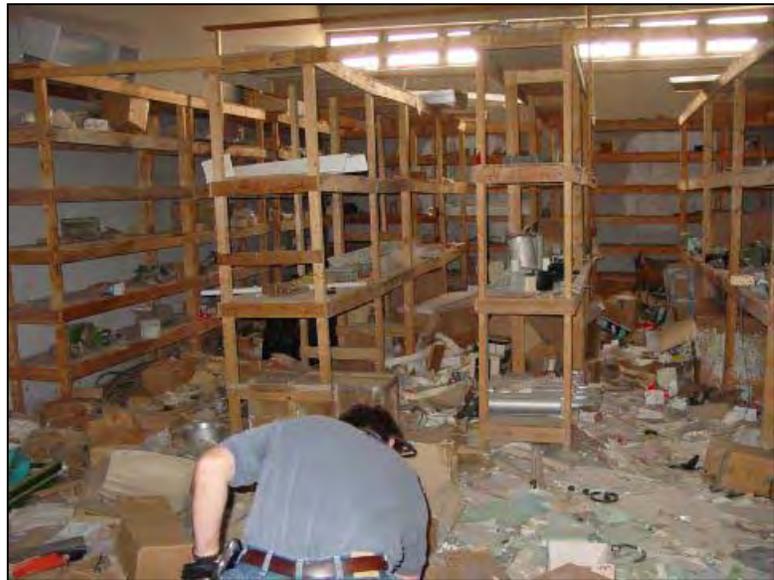
**Photo 6.4.1-3 Spare Parts Store “Old” Port.**

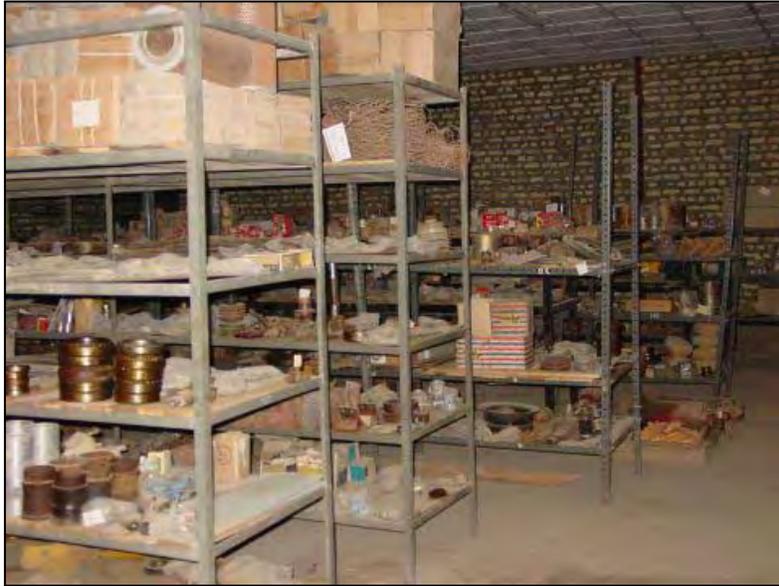
**Photo 6.4.1-4 Spare Parts Store “New” Port.**

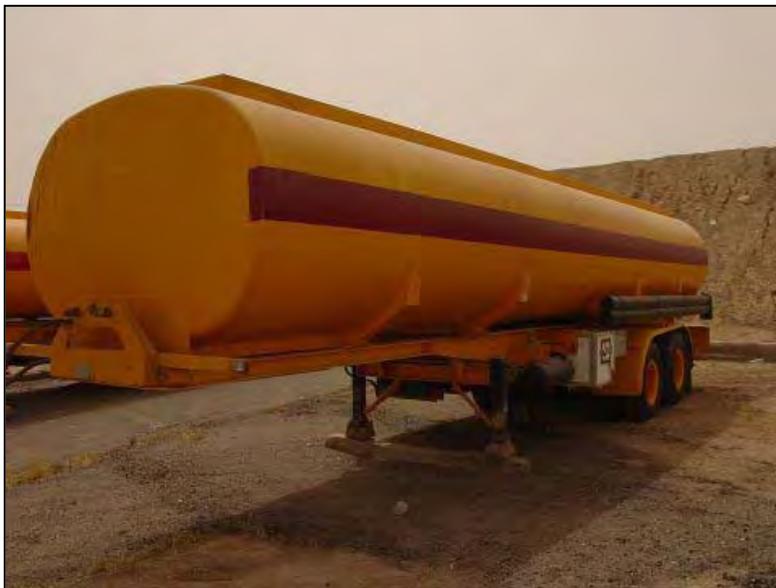
**Photo 6.5.2-1 Two Mobile Tankers, Capacity 5,000 Gallons.**

In the meantime, there are limited facilities to store fuel on site in mobile tankers comprising two trailers and one fuel truck (see Photos 6.5.2-1 and 6.5.2-2). For the future, it is recommended that the provision of a safe, fixed dispensing station where fuel can be stored in tanks having secure access and containment systems. This will provide an additional buffer against shortage of supplies, reduce deliveries, and improve storage safety.

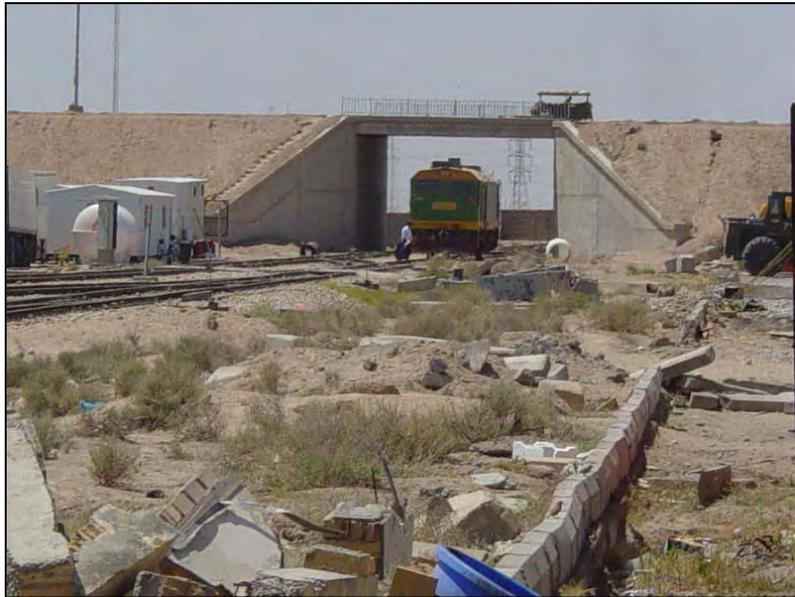
The internal roadway system consists mostly of two-lane, asphalt-paved roads that are in reasonably good condition. Existing concrete bridges that carry an internal circulation road over railroad tracks at the north end of the “new” port also appear to be in satisfactory condition (see Photo 7.1.2.1-1). Vehicular access to berthing areas and storage warehouses is readily available. Exterior circulation roads appear adequate for queuing of trucks awaiting access to the “new” port.

**Photo 7.1.2.1-1 Existing Concrete Bridge Over Railroad Tracks.**

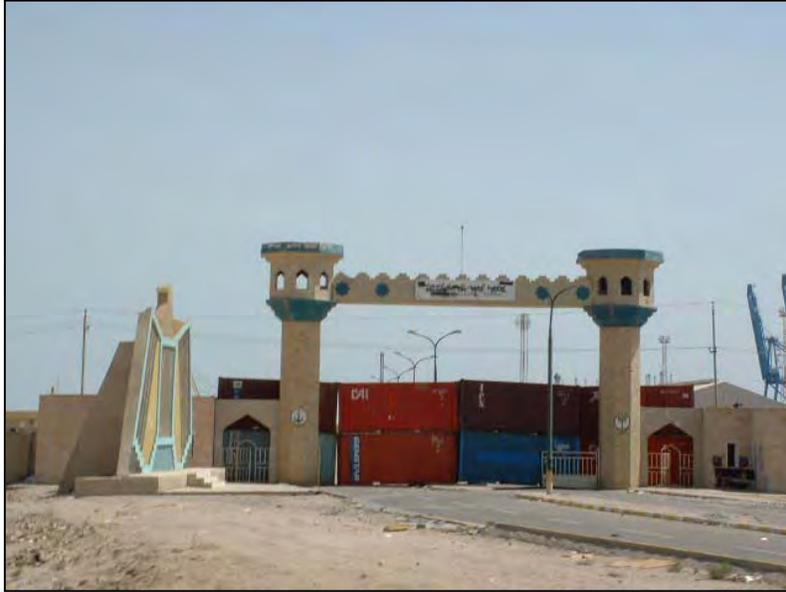
Two entrances provide vehicle ingress and egress to the “new” port, neither of which has gated access control. The north gate has been temporarily blocked with cargo containers by the 17th Port and Maritime Regiment R.L.C. for security purposes (see Photo 7.1.2.1-2). Primary access to the “new” port appears to be through the west gate, which is currently controlled by military security forces. There is a gate house, scale house, two electrical vehicle weighbridges, and inspection platforms located at the west gate (see Photo 7.1.2.1-3).

*Photo 7.1.2.1-2 North Gate at "New" Port.*

Existing cargo containers that block the south gate should be removed and a permanent movable security barrier installed to allow opening or closing the gate as necessary for changing access needs during Port operations. Damaged facilities at the north gate should be repaired as necessary, and a permanent security barrier installed to allow emergency closure of the gate if necessary.

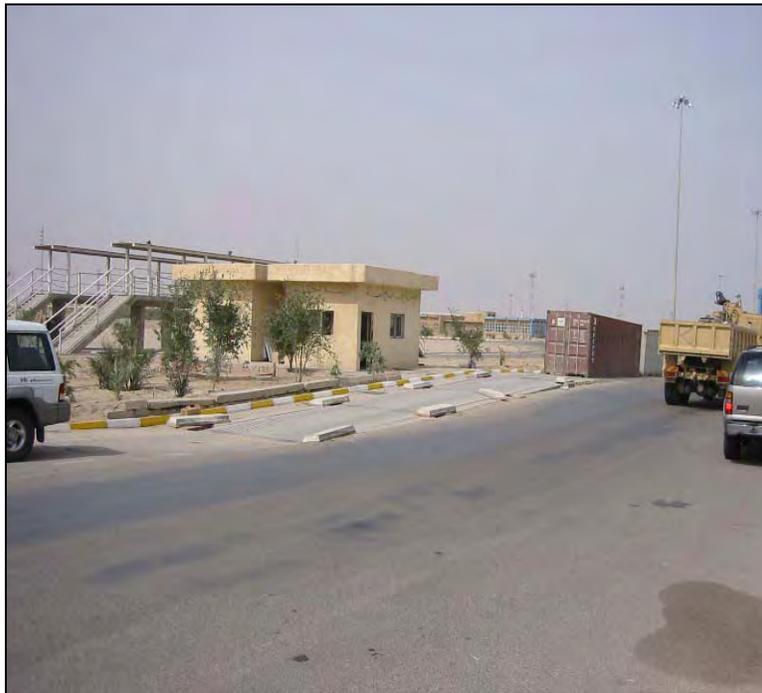
*Photo 7.1.2.1-3 Scale House and Weighbridges at West Gate.*

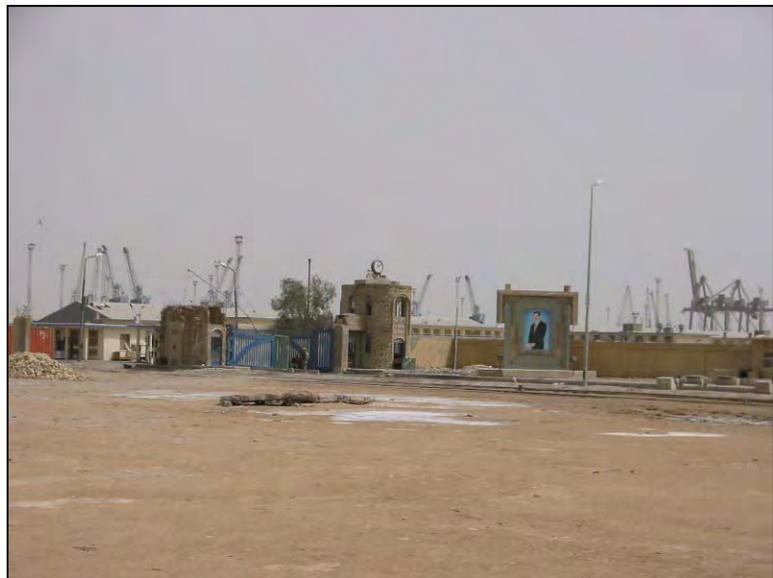
Two entrances provide vehicle ingress and egress to the “old” port from circulation roads outside of the Port. The south gate has been temporarily blocked with cargo containers by the 17th Port and Maritime Regiment R.L.C. for security purposes. Primary access to the “old” port appears to be through the north gate, which is currently controlled by military security forces (see Photo 7.1.3.1-1). There are several structures at the north gate that have been damaged by unknown causes and will require repair. Exterior circulation roads appear adequate for queuing of trucks awaiting access to the “old” port.

*Photo 7.1.3.1-1 North Gate at “Old” Port.*

Costs for repairing damaged facilities at the north gate, and installing permanent movable security barriers at both north and south gates are estimated to be US\$150,000.

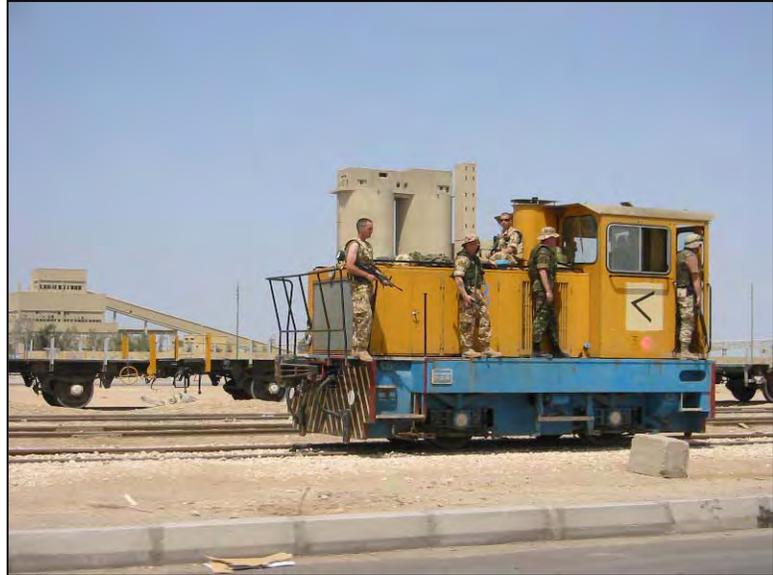
The existing rail system provides rail access to all ship berthing/unloading areas and storage warehouses within the port (see Photo 7.2.2.1-1). Although the track appears to be in reasonable condition, it has been poorly maintained and will require some repair of rail, operating switches, and vehicle crossings.

**Photo 7.2.2.1-1 Rail Spur at “New” Port.**

All onsite railroad tracks should be tested for soundness and repaired or replaced as necessary. Maintenance and repair of operating switches, other moving parts of the rail system, and electronic controls should be completed, and any damaged vehicle crossings repaired.

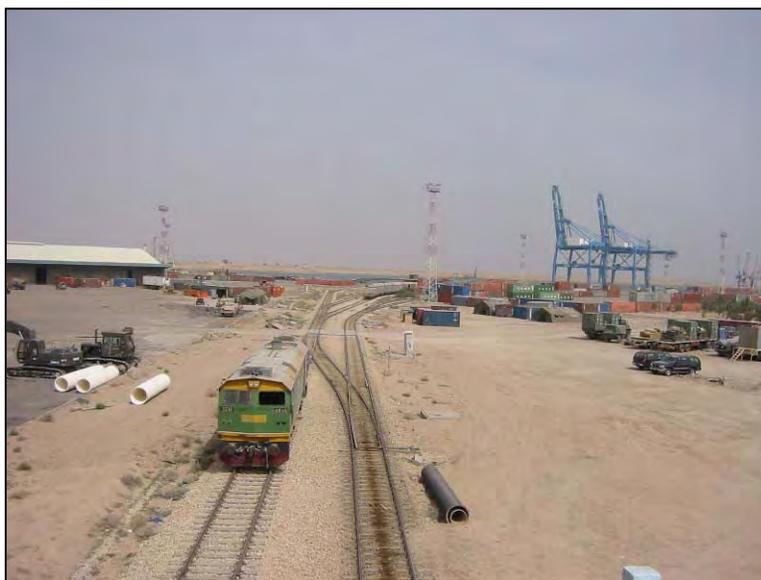
Two shunting locomotives that are located in the “new” port have been made operational by the military (see Photo 7.2.2.1-2). One Chinese-made main line locomotive was also towed into the “new” port, but currently is not operational. Examination of the main line engine by the military indicates that it is in good condition, but factory refurbishment may be necessary to make it fully operational. Approximately 18 flat cars and 5 hopper cars have also been stored within the “new” port for security. The military indicated that a large supply of rolling stock has been stored at a rail yard located west of Al Basrah and may become available for use after rail service is fully restored.

**Photo 7.2.2.1-2 Shunting Locomotive.**

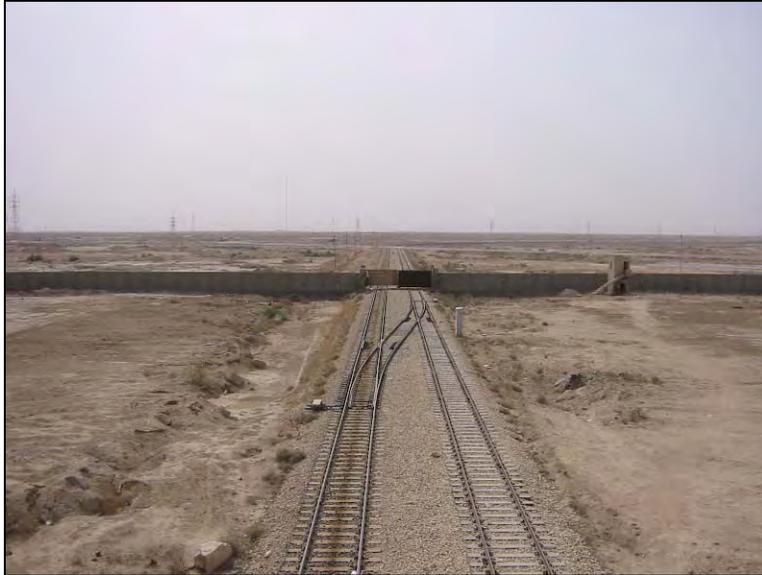
One railroad entrance with gated access control is located on the north side of the “new” port (see Photo 7.2.2.1-3).

**Photo 7.2.2.1-3 Rail Entry at “New” Port.**

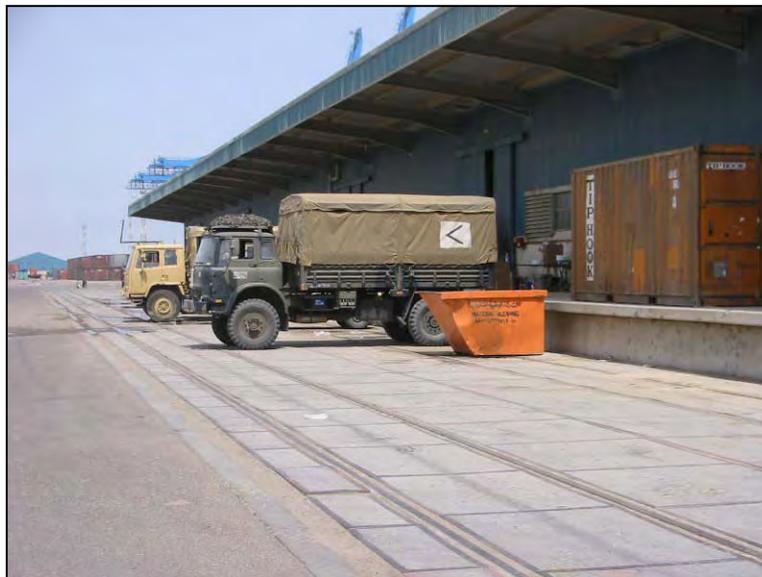
**Photo 7.2.2.1-4 Warehouse Loading Ramp at “New” Port.**

Rail car loading ramps are located at each storage warehouse and at several locations within the container storage yard (see Photo 7.2.2.1-4). All appear to be in good condition and usable.

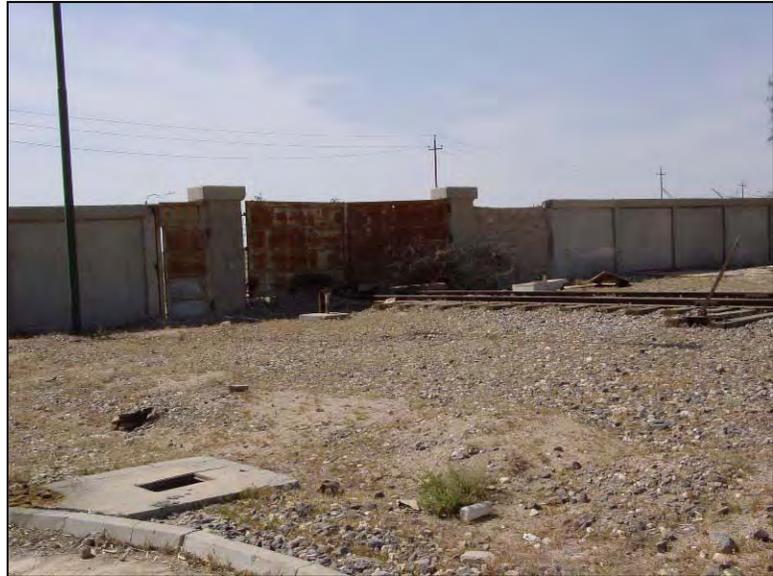
Rail access to ship berths, grain unloading areas, and storage warehouses is adequate at the “old” port. At least five rail spurs extend through the perimeter security barrier around the “old” port, several of which have been blocked with cargo containers by the military for security purposes (see Photo 7.2.3.1-1). Most of the railroad track within the “old” port appears to be usable, but is in a state of neglect and disrepair. Some portions of the rail system serving Berths 1 and 2 are missing and will require replacement.

*Photo 7.2.3.1-1 Rail Entry at “Old” Port.*

Existing cargo containers that are currently blocking the rail entrances should be removed and permanent movable security barriers installed at entrances without existing security gates to allow opening or closing of the rail spur as necessary for security purposes during port operations.

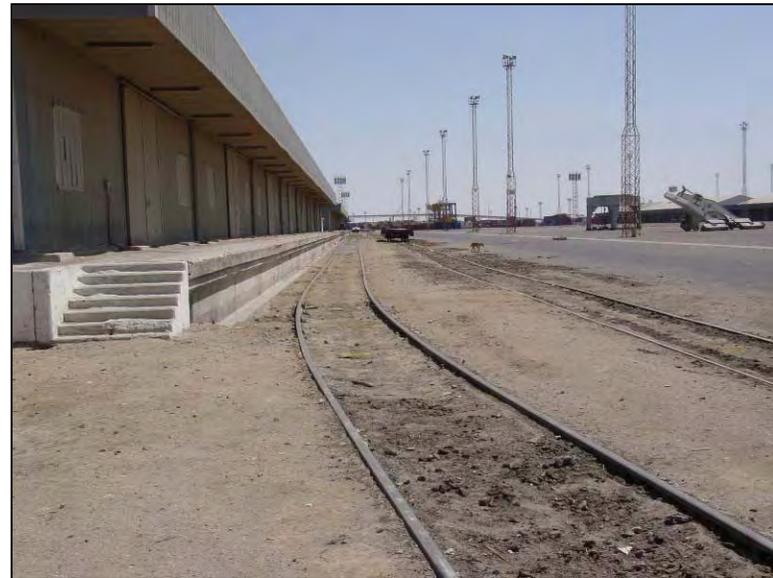
Rail car loading ramps are located at storage warehouses (see Photo 7.2.3.1-2). All appear to be in fair condition and usable.

*Photo 7.2.3.1-2 Warehouse Loading Ramps at “Old” Port.*

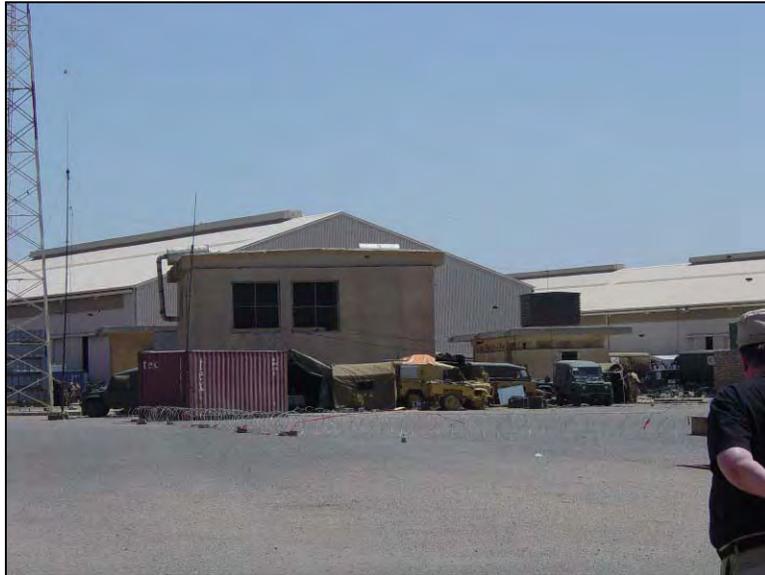
The original design for backup power was a single building that has space for two generator sets. These generators have been removed.

***Photo 8.1.2.1.2-1 Generator Building.***

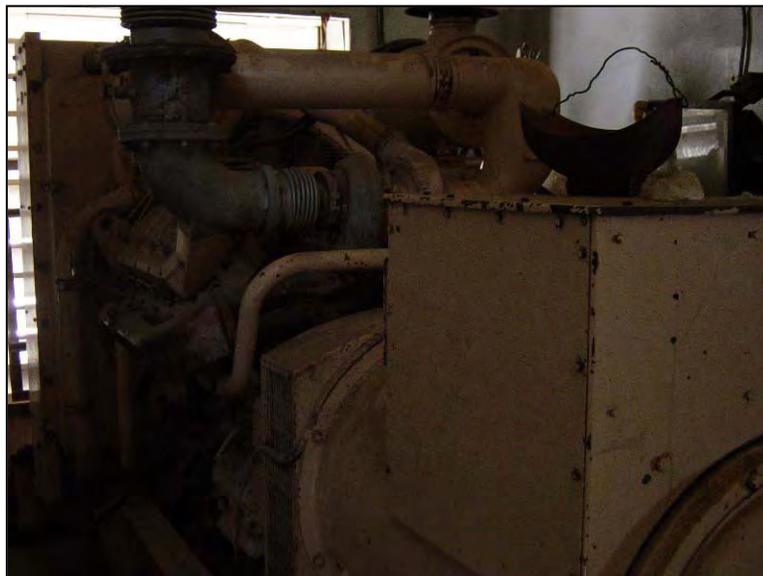
The Customs building located near the RO/RO berth and the Water System(s) building are the exceptions to the new port area backup power system. The electrical service for these buildings consists of stand alone generators. These generators have damage and need replacement.

***Photo 8.1.2.1.2-2 Generator.***

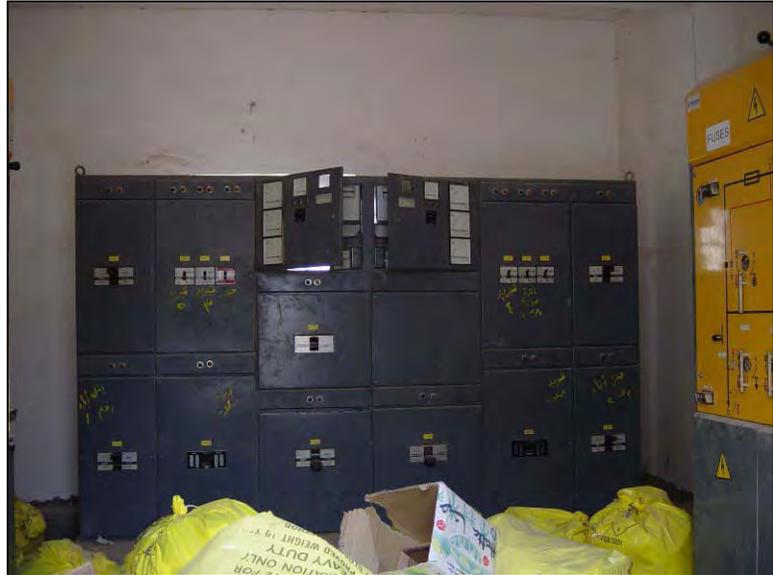
The 11KV Cable/Switchgear/Transformers are all over 20 years old. Switchgear and 11KV cable has been damaged. Transformers are low on oil and some show signs of leakage.

**Photo 8.1.2.1.2-3 Switch Gear.**

All 11KV cable, switchgear, and transformers are past their useful life and need to be replaced to safely operate the new port area on a permanent basis.

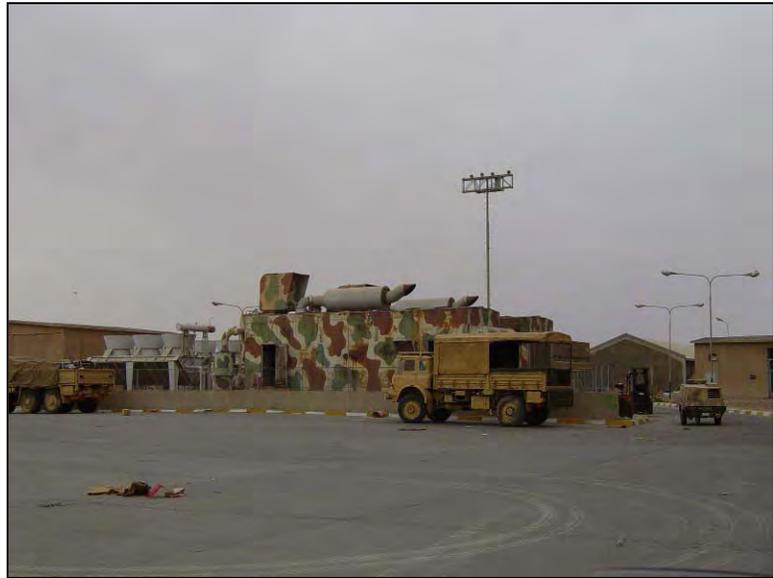
**Photo 8.1.3.1.2-1 Generator Building.**

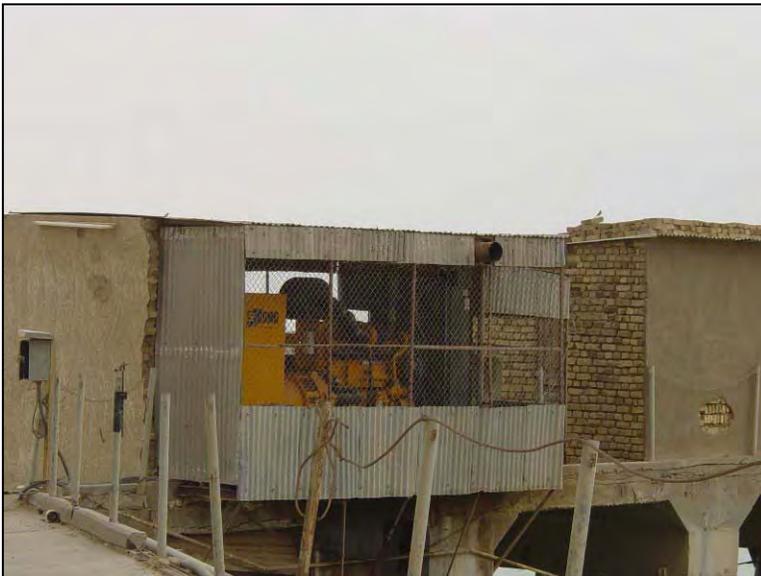
Backup power for the grain elevator and evacuator dock is currently supplied from two, 2.5MW, 3.3KV, parralled generators. These generators are 20-plus years old. The British have been unable to get generator No. 1 started and were in the process of performing a major overhaul on

generator No. 2 to make it operational. They have since abandoned the attempt to refurbish either of the generators and are in the process of getting a new 2.5MW, 3.3KV generator.

**Photo 8.1.3.1.2-2 Generator.**

Replace the two existing 2.5MW, 3.3KV generators, switchgear, and one 400KW, 400v generator set to

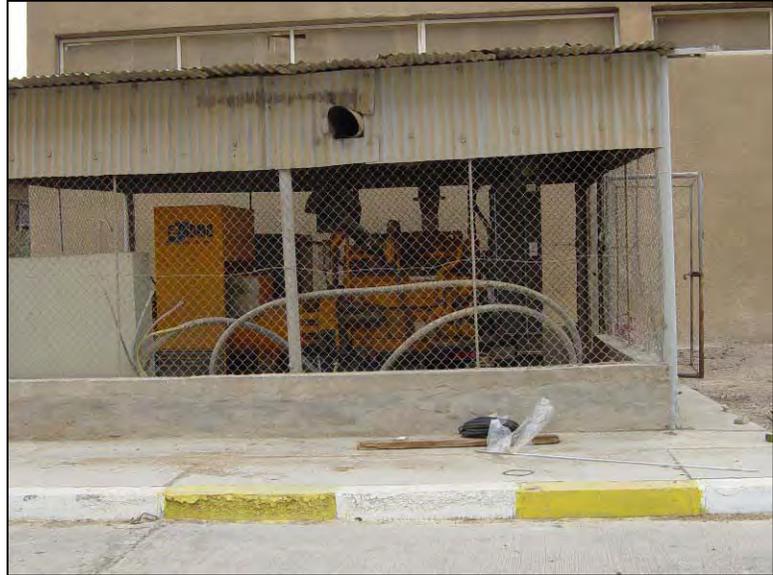
The support buildings at the grain terminal receive backup power from a 400KW (500KVA), 400v, (722 amps) Cummins generator. This generator has been stripped of batteries and other parts. This is a fairly new piece of equipment and can probably be operational with new parts and maintenance. Currently, the British have provided a separate portable generator at this location to operate and test systems.

**Photo 8.1.3.1.2-3 Generator.**

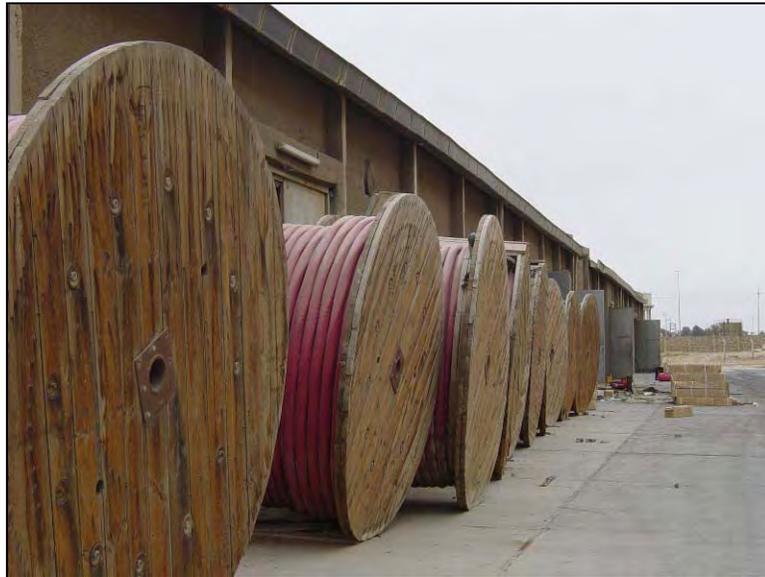
The 33 KV System has been disconnected. There are several reels of 33 KV cable stored onsite. Status of these cables is unknown. There is visual damage to the outer jacket of the cable on one of the reels and the jacket color has been bleached out from exposure to the sun. It is not clear or evident if the existing 33 KV cable has failed in the past but it is probably original (over 20 years old) and near the end of rated life.

**Photo 8.1.3.1.3-1 33KV Cable Reels.**

The existing 33KV, 3.3 KV cables, switchgear, and transformers are over 20 years old and are recommended for replacement to safely operate the grain facility on a long term and permanent basis.

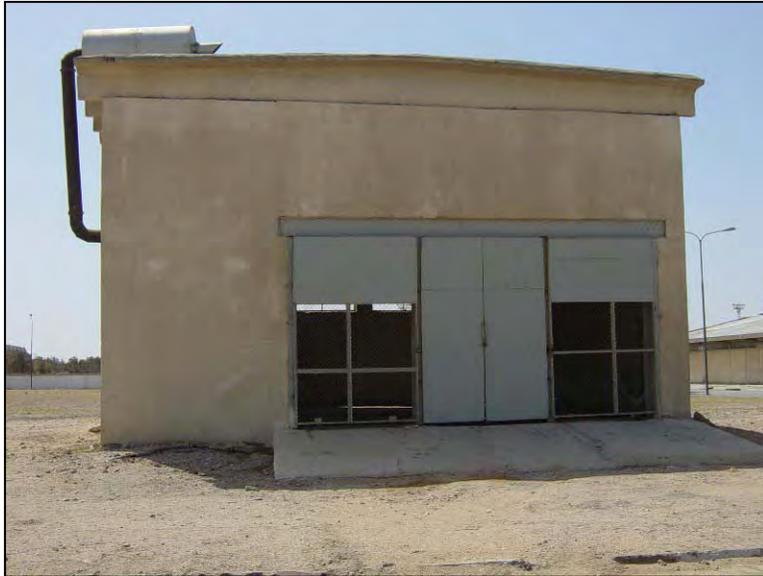
*Photo 8.1.4.1.1-1 Generator Building.*

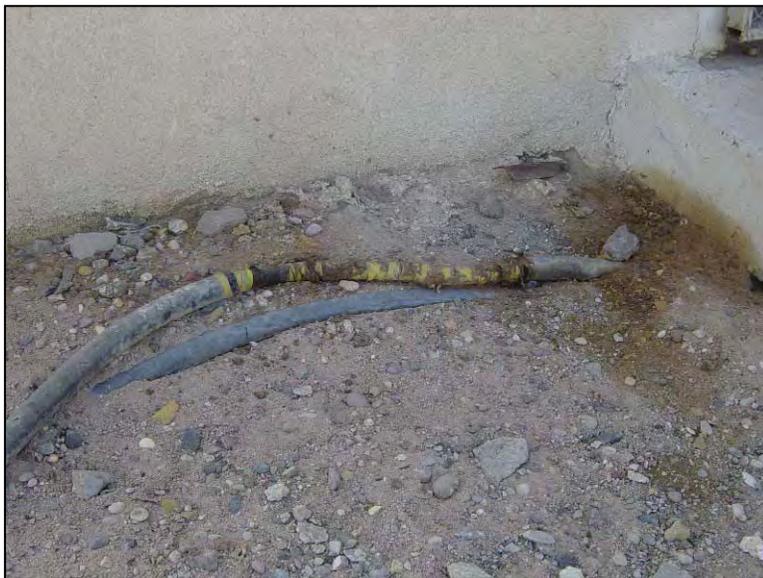
The 11KV cable system is damaged at several locations.

*Photo 8.1.4.1.3-1 11KV Cable.*

All 11KV cable, switchgear, and transformers need replacement for safe operation of the old port area electrical system on a permanent basis.

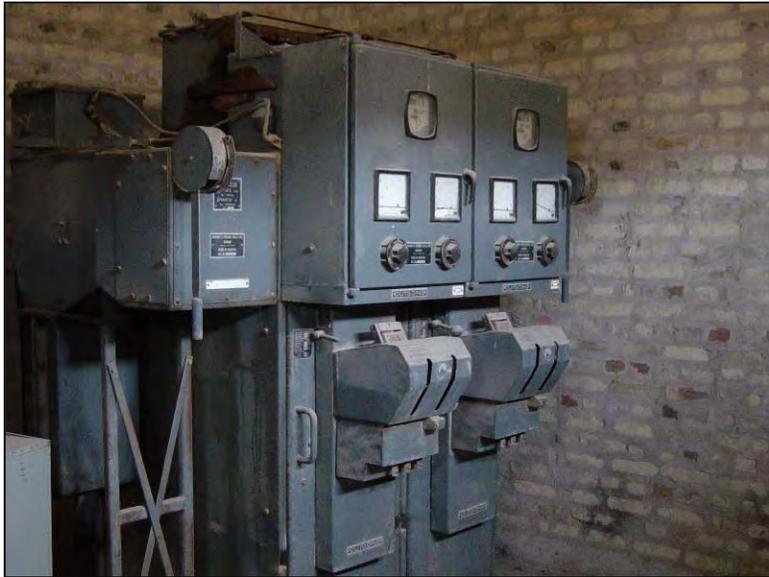
All switchgear and transformers are over 40 years old and past their useful life.

*Photo 8.1.4.1.3-2 11KV Switch Gear.*

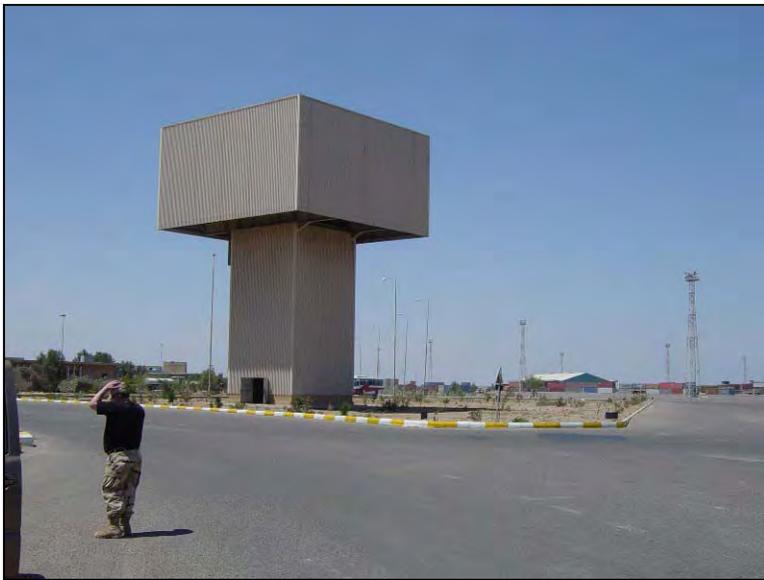
The potable water system at the new port is supplied by the municipal water system in Umm Qasr and includes a separate water tower reservoir and pump station (see Photo 8.2.2.1-1). The system serves the Administration and other support buildings, several restroom facilities located throughout the grounds, and shipping berths within the new port. The water system is currently inactive due to lack of electric power in the region.

*Photo 8.2.2.1-1 Water Tower at New Port.*

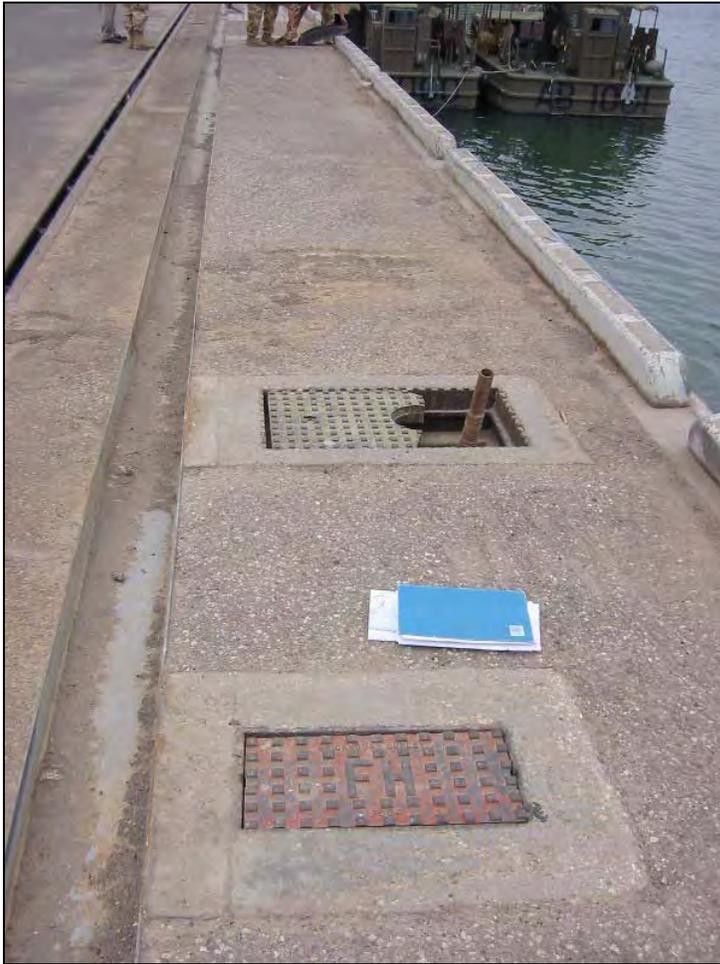
Water lines for supplying potable water to ships berthed at the new port are located in a dockside utilidor incorporated into the existing wharf structure. Metered ship service connections are located along the wharf, spaced approximately 100 meters apart (see Photo 8.2.2.1-2). Information obtained from discussions with local port workers during SSA's field investigation suggests that cargo ships berthed at the Port routinely refused to connect to the water supply due to contamination of the potable water system.

**Photo 8.2.2.1-2 Water and Fire Connections along Pier Face.**

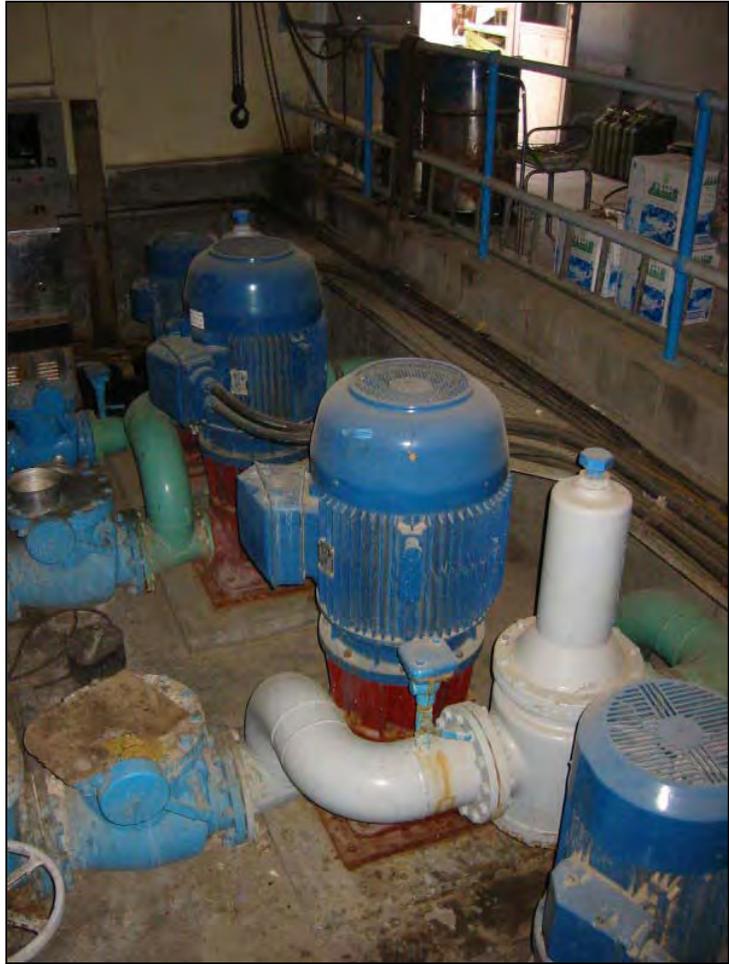
The existing pump station is located immediately north of Shed 18, Berth 18 and contains separate pumping equipment for the potable water, fire suppression, and air conditioning systems. Hydraulic pumps, valves, electric motors, and controls were manufactured in England, and were apparently designed and installed by a British firm. Primary power to the pump station is provided by the Port's electrical system, with emergency backup power supplied by a diesel generator located at the pump station. Exposed pumps, electric motors, valves, and piping seem to be in good condition (see Photo 8.2.2.1-3), but could not be tested. Electronic controls for operation of the pump station appear to be in poor condition and will probably require repair or replacement.

*Photo 8.2.2.1-3 Pump Station at the “New” Port.*

Upon restoration of power to the new port, all water pumping equipment and electronic controls at the pump station should be tested and repaired as necessary. The

Costs for testing, cleaning, and repair of the existing potable water distribution system, including repair of the pump station at the "new: port is estimated to be US\$350,000.

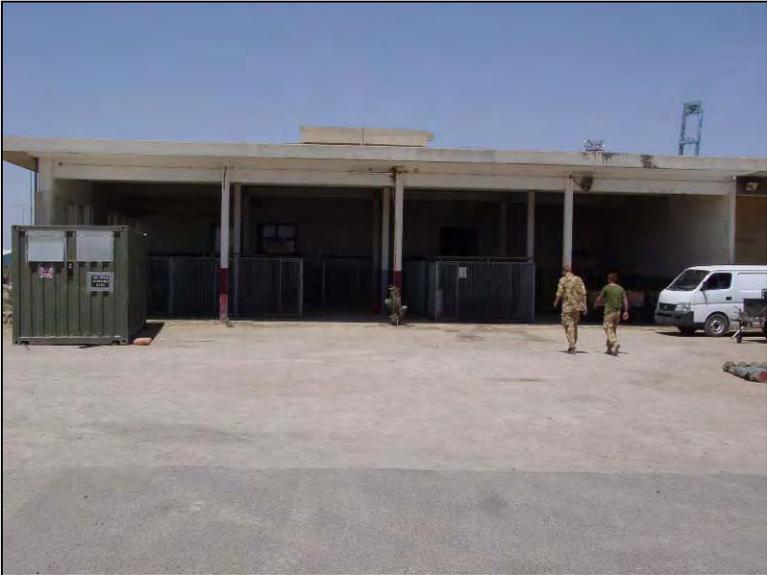
No fire hydrants were found within the new port compound, and storage warehouses were not equipped with fire suppression systems. However, one of the support buildings on the grounds is a fire station (see Photo 8.2.2.3-1). Existing fire fighting equipment found at the site appears to be in operating condition, and includes a relatively new fire truck (see Photo 8.2.2.3-2) and a water tanker truck (see Photo 8.2.2.3-3).

*Photo 8.2.2.3-1 Fire Station at New Port.*
