# Umm Qasr Port Assessment

USAID TRN-03-009

## Draft Report

April 2003

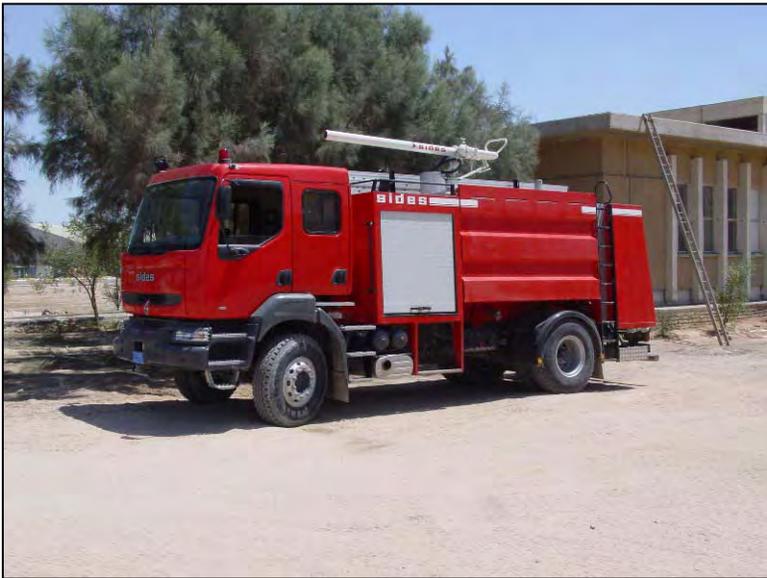
*Photo 8.2.2.3-2 Fire Truck.*

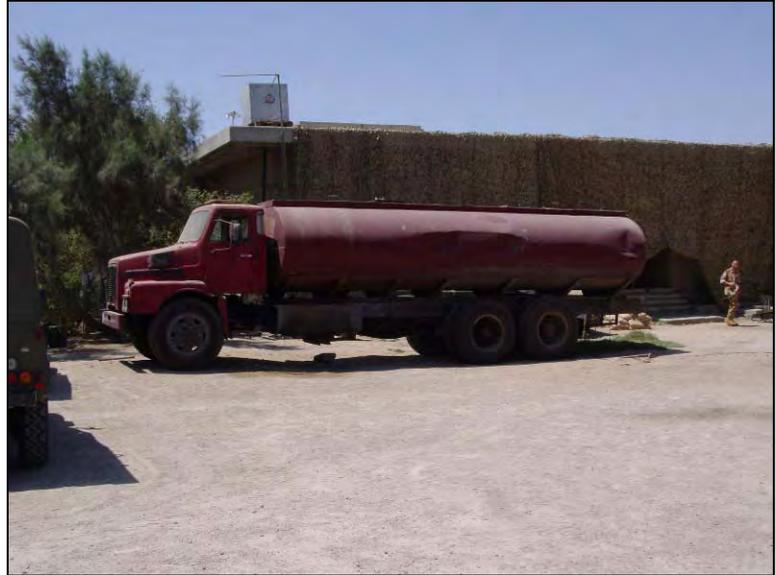
**Photo 8.2.2.3-3 Water Tanker Truck.**

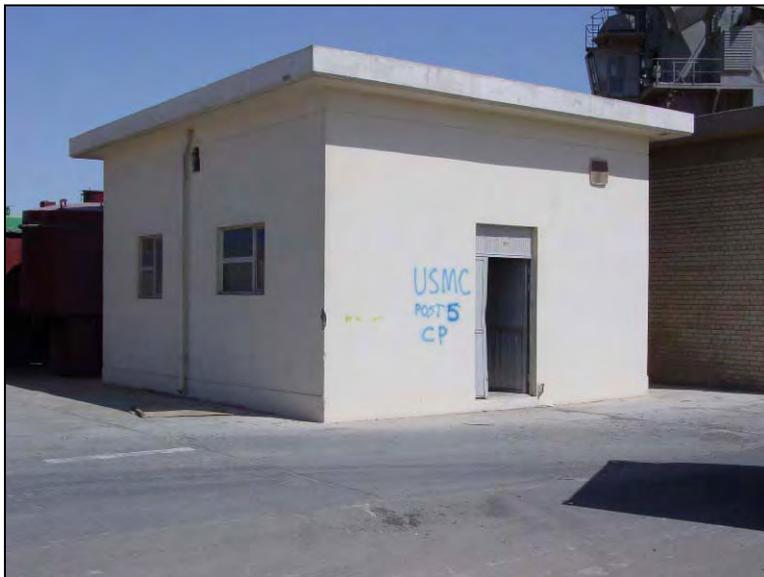
**Photo 8.2.3.1-1 Pump Station at Old Port.**

Two existing pump stations is located immediately north of Berth 2 contain pumping equipment for separate potable water and fire suppression systems (see Photo 8.2.3.1-1). Hydraulic pumps, pump motors, and valves appear to be old and in poor condition.

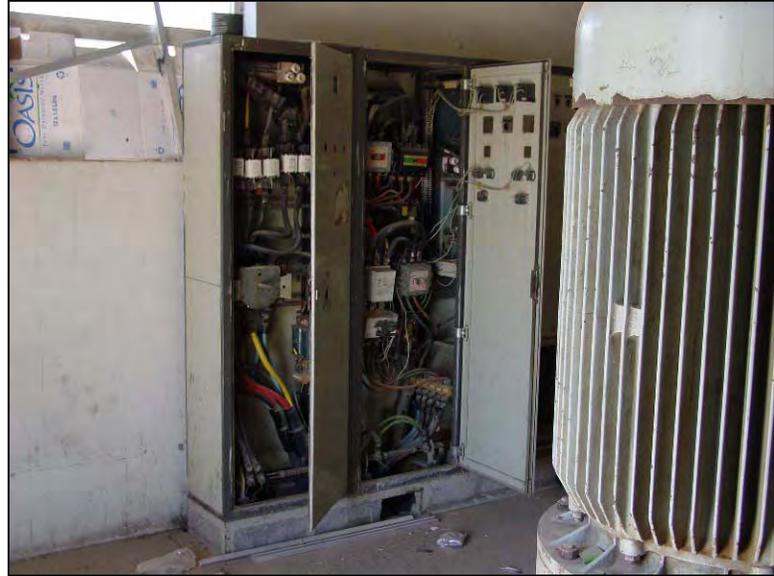
*Photo 8.2.3.1-2 Pump Station Controls.*

Primary power to each pump station is provided by the Port's electrical system. One of the fire system pumps is driven by a diesel motor, apparently to serve as an emergency backup. Exposed pumps, electric motors, valves, and piping could not be tested. Electronic controls for operation of the pump station appear to be missing or in very poor condition, and will require repair or replacement (see Photo 8.2.3.1-2).

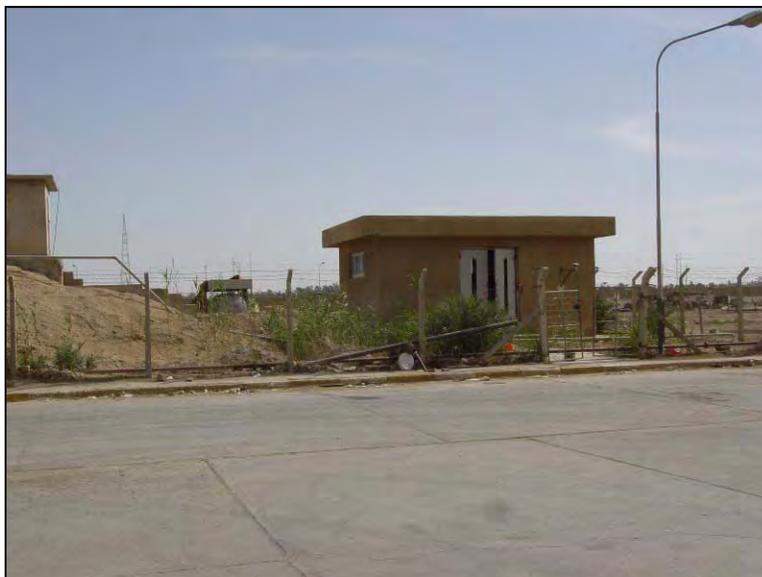
The potable water system at the grain elevator is supplied by the municipal water system in Umm Qasr and includes a dedicated pump station (see Photo 8.2.4.1-1) and underground storage tank (see Photo 8.2.4.1-2). The system serves the onsite support buildings and restroom facilities located at the grain elevator site. The system is currently inactive due to lack of power in the region.

The existing pump station contains separate pumping equipment for the potable water and fire suppression systems. Hydraulic pumps, pump motors, and valves are old and in poor condition. Primary power to the pump station is provided by the Port's electrical system with backup power provided by an onsite generator farm. Exposed pumps, electric motors, valves, and piping could not be tested. Electronic controls for operation of the pump station appear to be missing or in poor condition, and will require repair or replacement.

**Photo 8.2.4.1-1 Pump Station at Grain Elevator.**

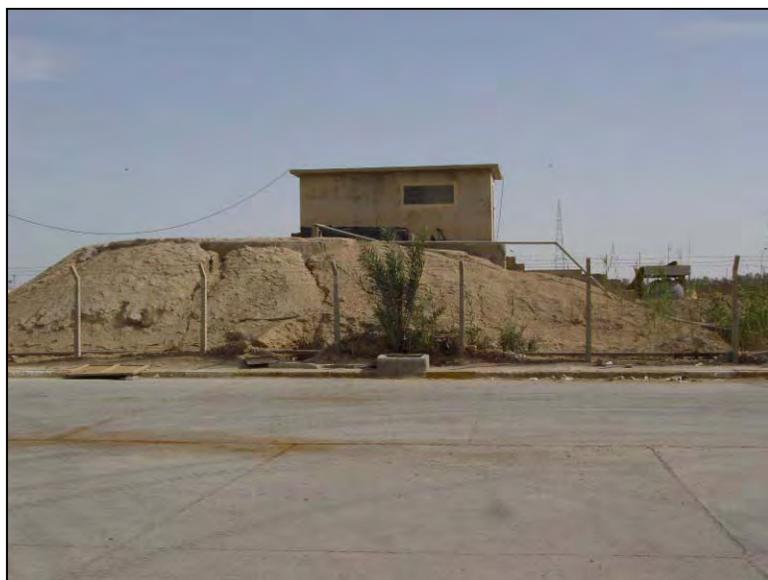
**Photo 8.2.4.1-2 Water Reservoir at Grain Elevator.**

#### **8.2.4.2 Potable Water System Recommendations**

Upon restoration of power to the grain elevator, all water pumping equipment and electronic controls at the pump station should be tested and repaired as necessary. Potable water distribution pipelines within the Port should be cleaned, pressure tested, repaired as necessary, disinfected and made operational to serve any non-potable water needs of the restrooms and support buildings. If operation of the existing water system becomes necessary prior to power restoration, a portable generator may be required to supply power to the pump station.

Costs for testing, cleaning, and repair of the existing potable water system, including repair of the pump station at the grain elevator is estimated to be US\$50,000.

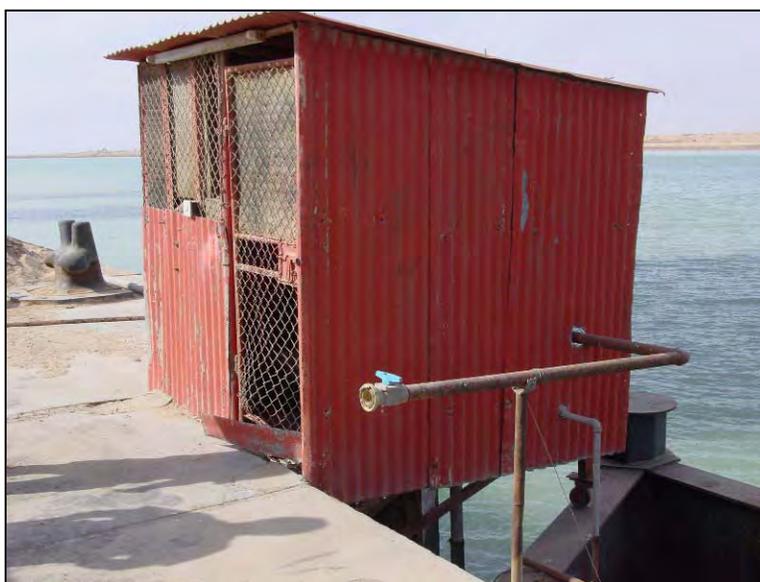
The fire suppression system at the grain elevator draws water from the onsite potable water storage tank and is separate from the fire suppression system on the grain loading pier, which utilizes sea water from the adjacent waterway. The grain elevator has several dry-pipe risers throughout the building that are pressurized by onsite electric pumps. Fire water lines serving the grain loading pier are pressurized by a small pump station located on the pier (see Photo 8.2.4.3-1). In addition to the fire suppression facilities serving the loading pier, at least one of the Port's operational tugs has onboard fire fighting equipment.

*Photo 8.2.4.3-1 Grain Pier Fire System Pump House.*

Several fire hydrants were found within the grain elevator compound. However, support buildings were not equipped with fire suppression systems.

Upon restoration of power to the grain elevator, all fire water pumping equipment and electronic controls at the pump station and reservoir storage tank should be tested and repaired as necessary. Fire water distribution pipelines should be cleaned, pressure tested, repaired as necessary, and made operational. If operation of the existing water system becomes necessary prior to power restoration, a portable generator may be required to supply power to the pump station.

Costs for testing, cleaning, and repair of the existing fire suppression system, including repair of the pump station at the grain elevator is estimated to be US\$150,000.

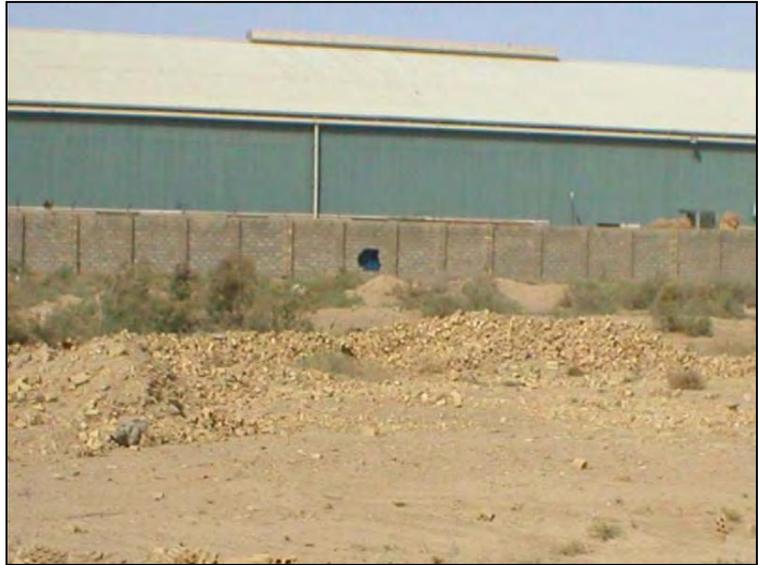
Both the “new” port and “old” port have a masonry wall of some variety (averaging 2.4 meters high) defining the perimeter. These perimeter walls are adequate to “define” the Zone of Concern (the area of cargo operations) but need to be more closely inspected to determine their integrity of construction. Some walls were visibly breached (with man-sized holes or gaps) and most all of the walls either lacked the standard (30.48 centimeters or 1 foot) outrigger top with barbed or concertina wire or the wire was parted, corroded, and unserviceable. During the past several days, members of the team have witnessed young boys scaling these walls until chased away by elements of the coalition force. Figure 9.1 shows the Port’s current Physical Boundary. Figure 9.2 shows the proposed enhancements to the Port’s Physical Boundary.

***Photo 9.4.3.1-1 View of Perimeter Wall with Hole.***

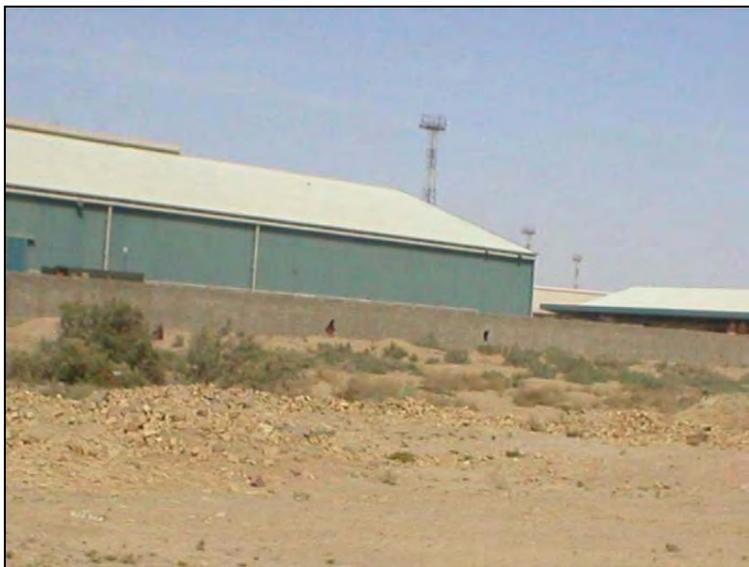
***Photo 9.4.3.1-2 View of Perimeter Wall with Holes.***

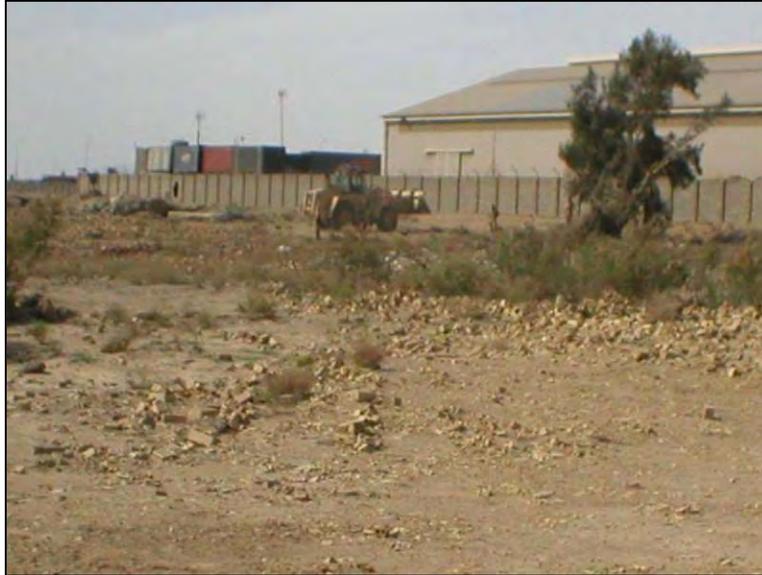
*Photo 9.4.3.1-3 View of Perimeter Wall with Hole.*

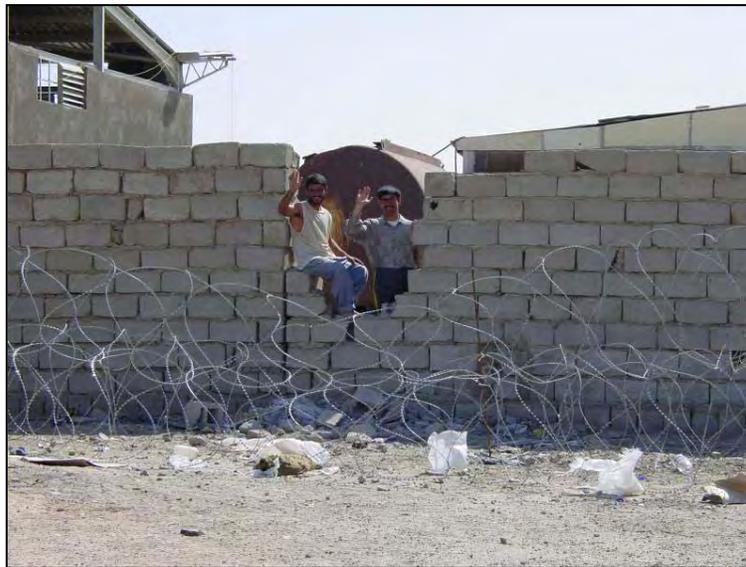
*Photo 9.4.3.1-4 View of Perimeter Wall with Local Children (Typical Security Breach).*

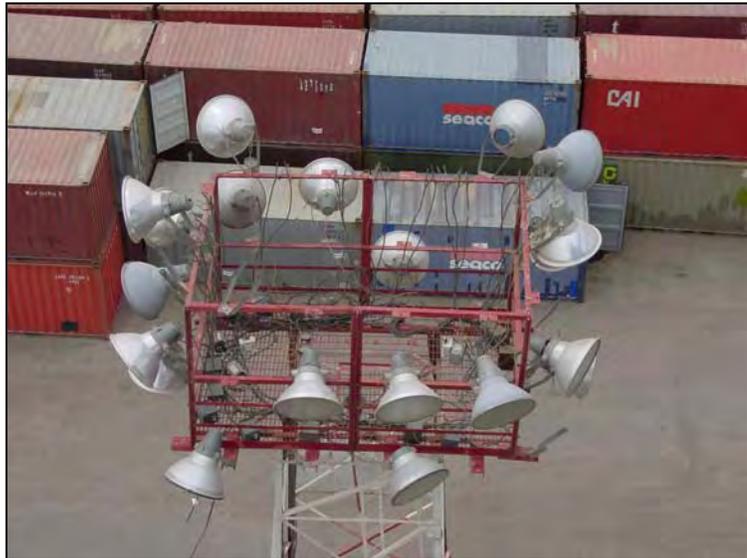
There seems to be an adequate arrangement (positioning) of stadium or high-mast lights (in multiple clusters) around the Port. There also appeared to be adequate lighting fixtures attached to the warehouses along the wharfs and quays. The master power grid has not been connected yet at the port so it could not be determined if any of these lights work. In addition, the team could not conduct a lighting survey at night. SSA anticipates that portable light carts will be required, at least initially, dedicated to conducting cargo operations at night (as applicable) and to the protection of personnel and high value property.

*Photo 9.4.3.6-1 View of High-Mast Lighting.*
