ANNUAL REPORT

“Conservation of the Mosque of Aslam al-Silahdar in Darb al Ahmar, Cairo”

Aga Khan Cultural Services
(Christophe Boleau)

**QUARTERLY PROGRESS REPORT
DECEMBER 2006-FEBRUARY 2007**

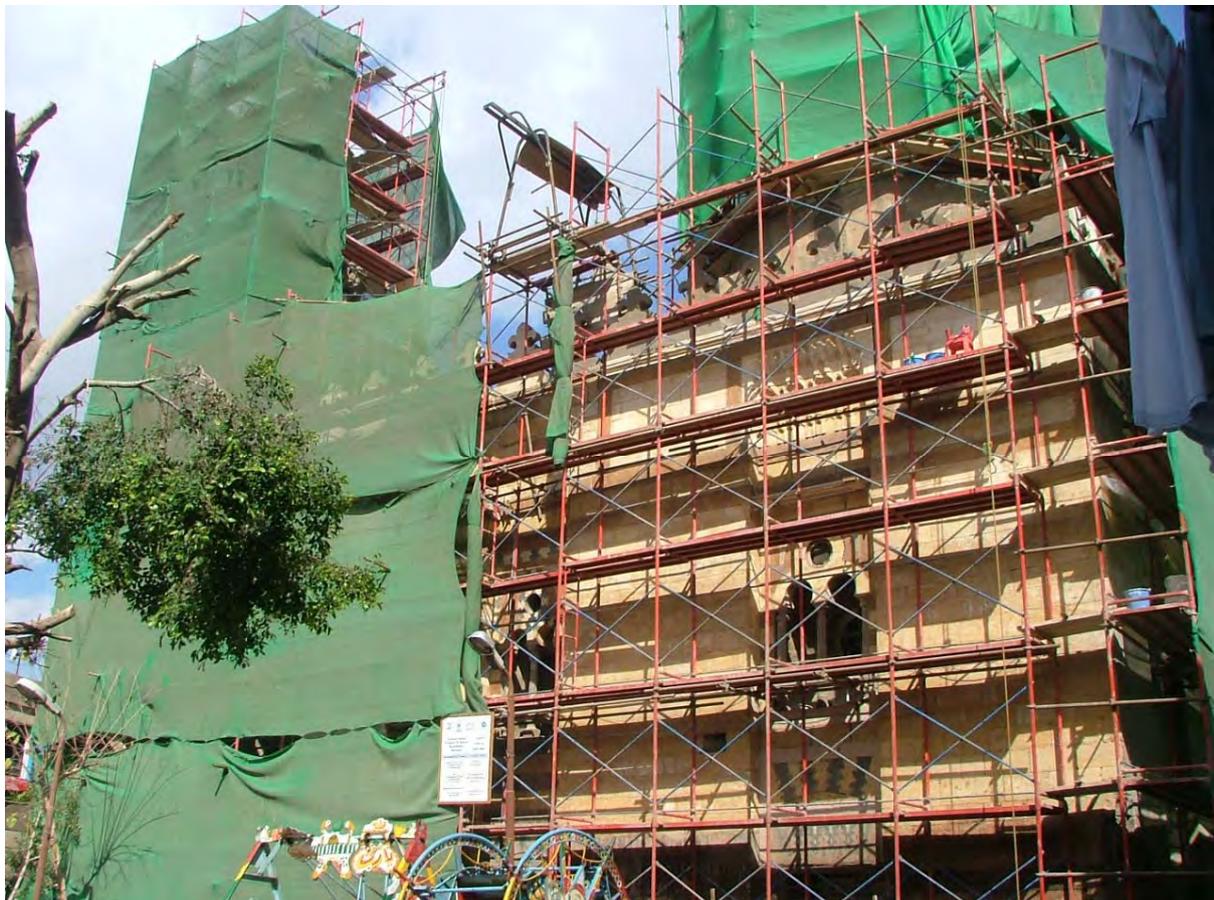
View of the southern elevation of the Aslam al-Silahdar Mosque during conservation

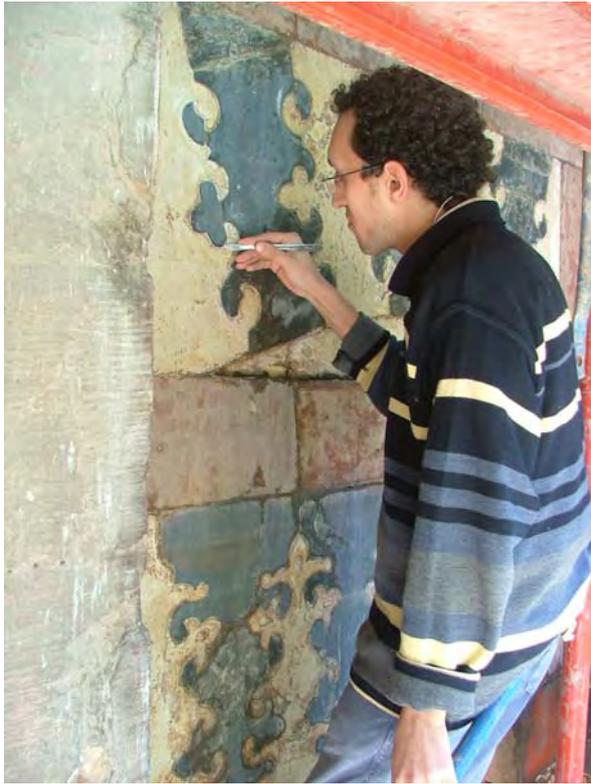
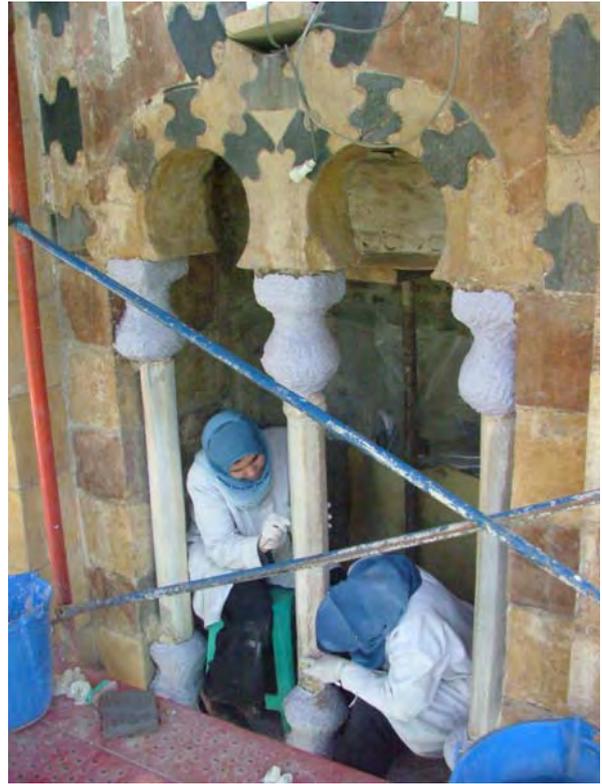
The southern and eastern elevations have been entirely cleaned using humid poultice made of bentonite and paper pulp with a low concentration (3-5%) of Ammonium Bicarbonate. This has revealed the original polychromy of the lime stone made of alternated white and orange horizontal stone courses and has made it possible to identify several stages of construction and restoration.

Cleaning of the southern façade by poultices and mechanical techniques

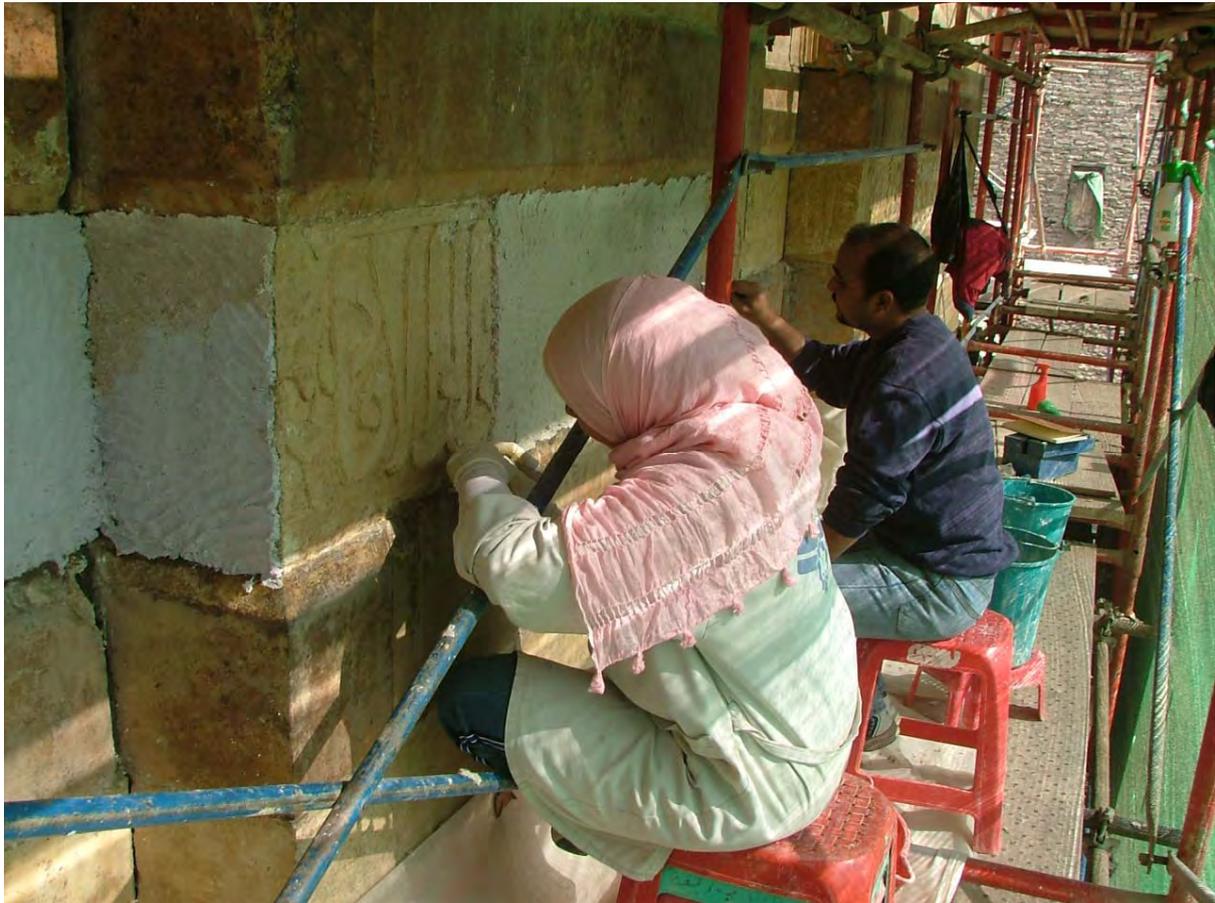
Cleaning of the inscription band on the Eastern façade by poulticing

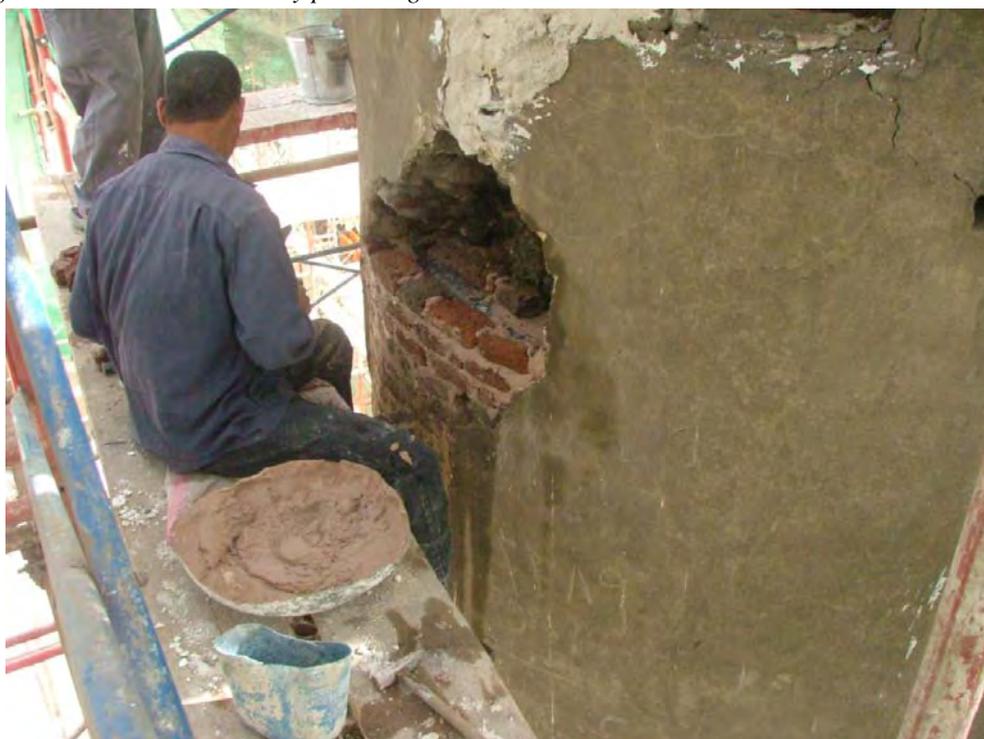
The exterior surfaces of the minaret made of gypsum and lime stucco are under cleaning by micro sand blasters and injection of lime grouts. The deteriorated status of the stucco makes it vulnerable to harsh weather conditions. The upper segment was reconstructed probably during the 19th century (the earliest photographs taken in the 1880's show it similar as today). The pencil shape of the top and the upper part of the brick drum are in a poor condition: the lead roofing is totally ruined, the timber carpentry is almost under collapse and the upper part of the brick drum is affected by serious cracking. A comprehensive restoration is planned in order to re-establish the last documented condition of the minaret as of the 1880's, without attempting to return back to a pre-Ottoman undocumented condition.

Brick restoration activities taking place on the upper part of the minaret

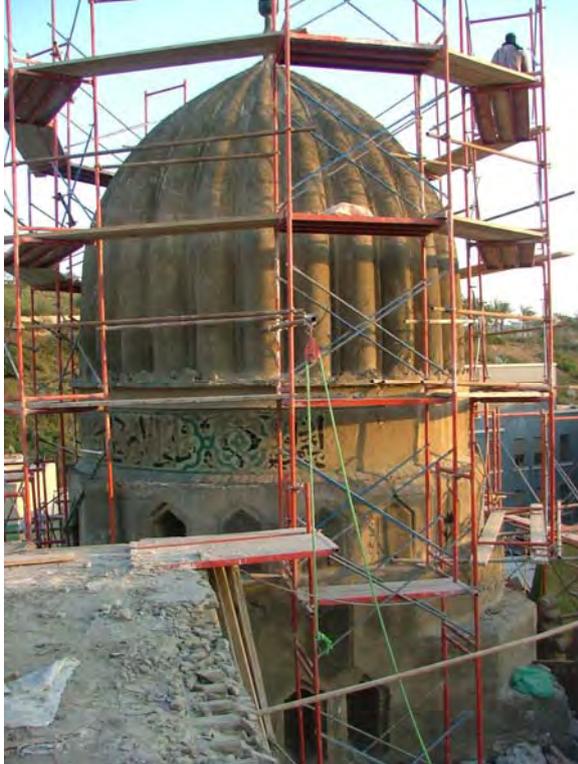
Following the erection of exterior steel scaffolding around the dome, cleaning was initiated by micro-sand blasting and temporary stabilization of the unstable parts was done. The cleaning revealed that the cupola is built with bricks covered by a thick (10-14cm) crust of plaster. Some remains of lime wash are still visible in the recessed angles. Although the cupola is not affected by structural problems, its surfaces and remains of polychrome tiling decoration are in moderately damaged condition.

Dome exterior after scaffolding erection

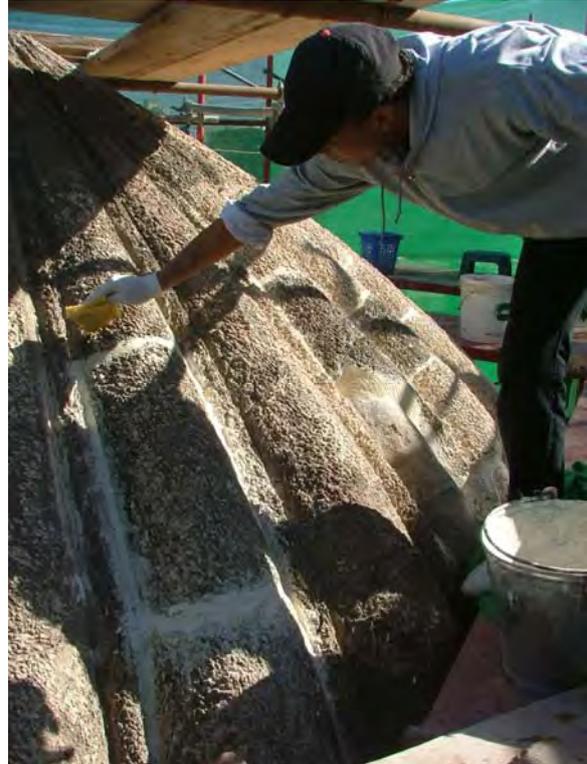
Stabilization of unstable plaster crusts

The cleaning by micro-sand blasting will be continued and completed. Local injections will re-attach the loose parts of plaster crust. The conservation is currently under testing in order to determine the feasibility of filling the cavities of the upper part of the dome's plaster.

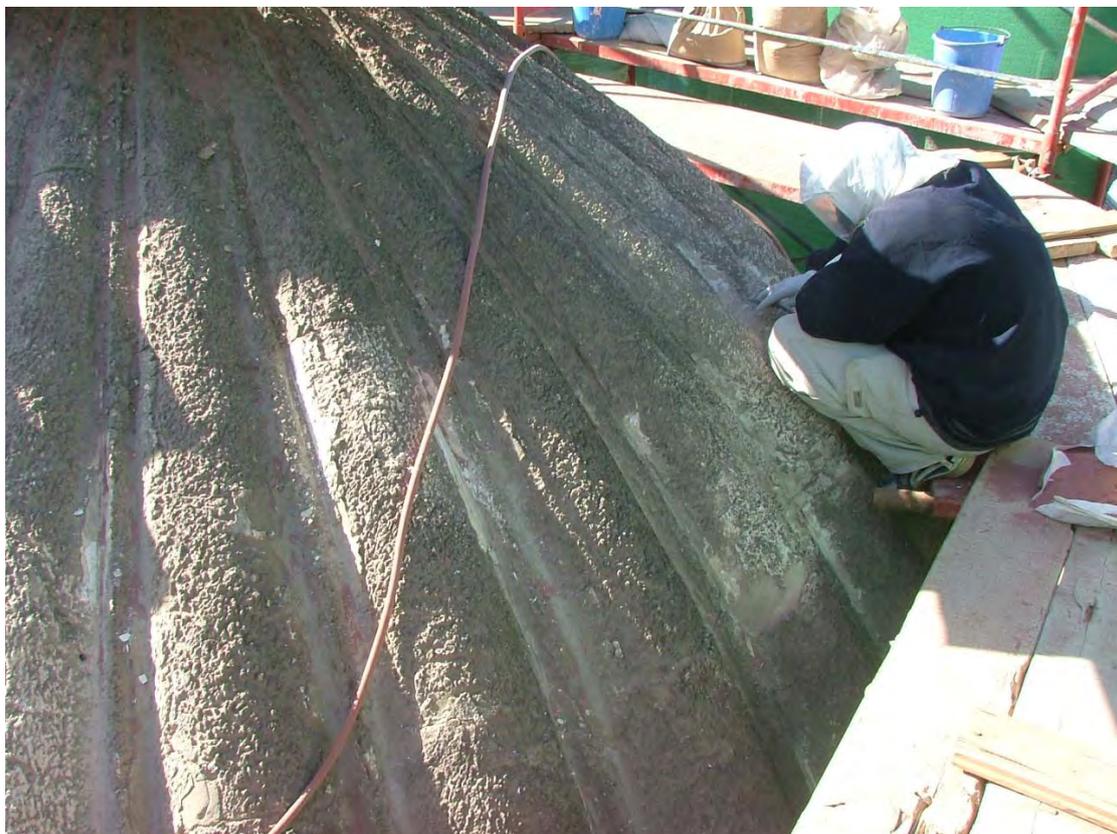
Cleaning of the Cupola by micro-sand blasting

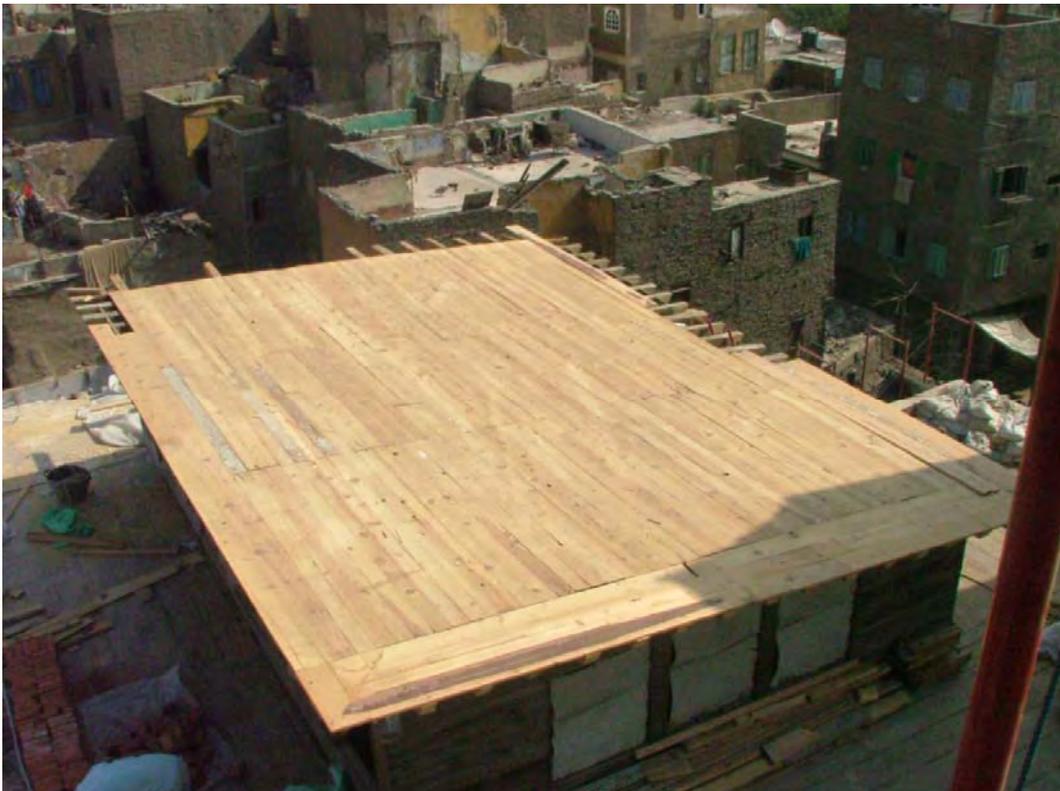
The replacement of broken and damaged beams was done and more than half the surface of the entire roof was already insulated using a bitumen sheet covered with mortar screed. The carpentry of the central shokhsheikha was restored and the construction made by the Comité in 1908 was maintained. It is planned to be covered with lead sheets in order to minimize the dead load.

Ceiling after restoration

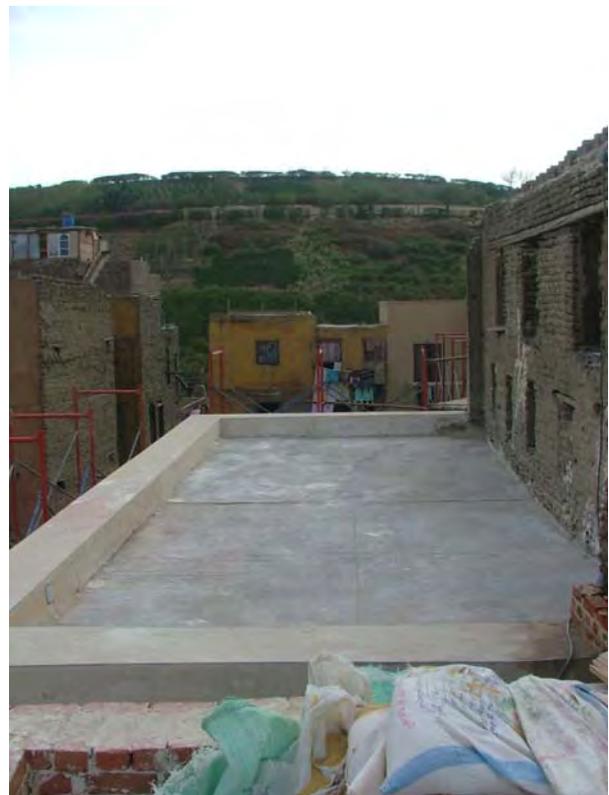
View of roof after insulation

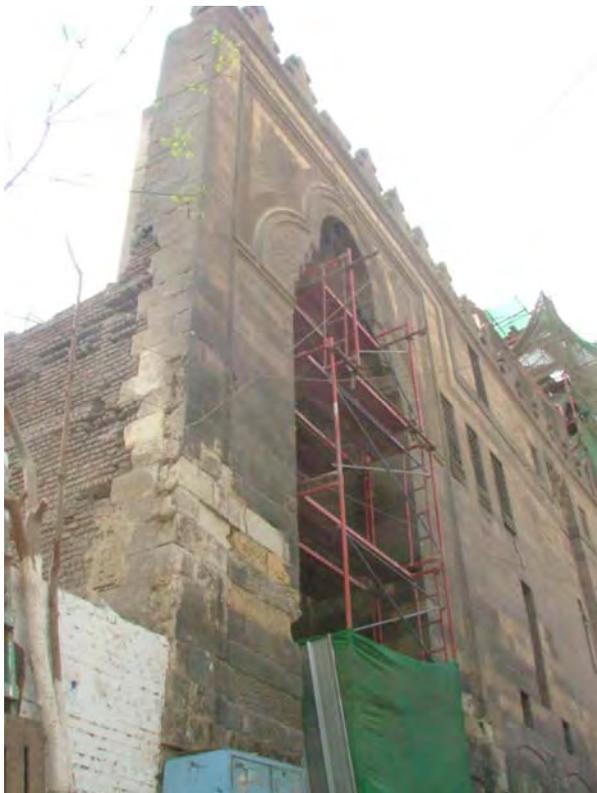
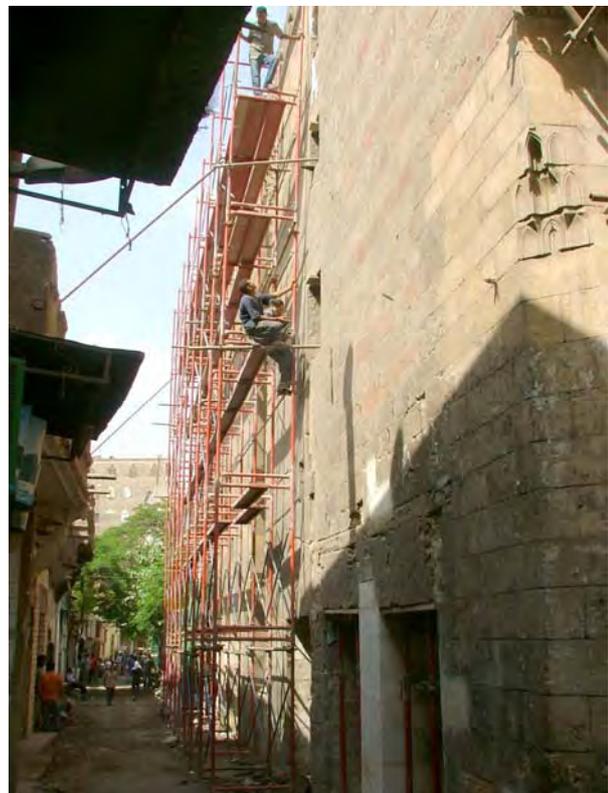
View of the eastern façade during scaffolding erection

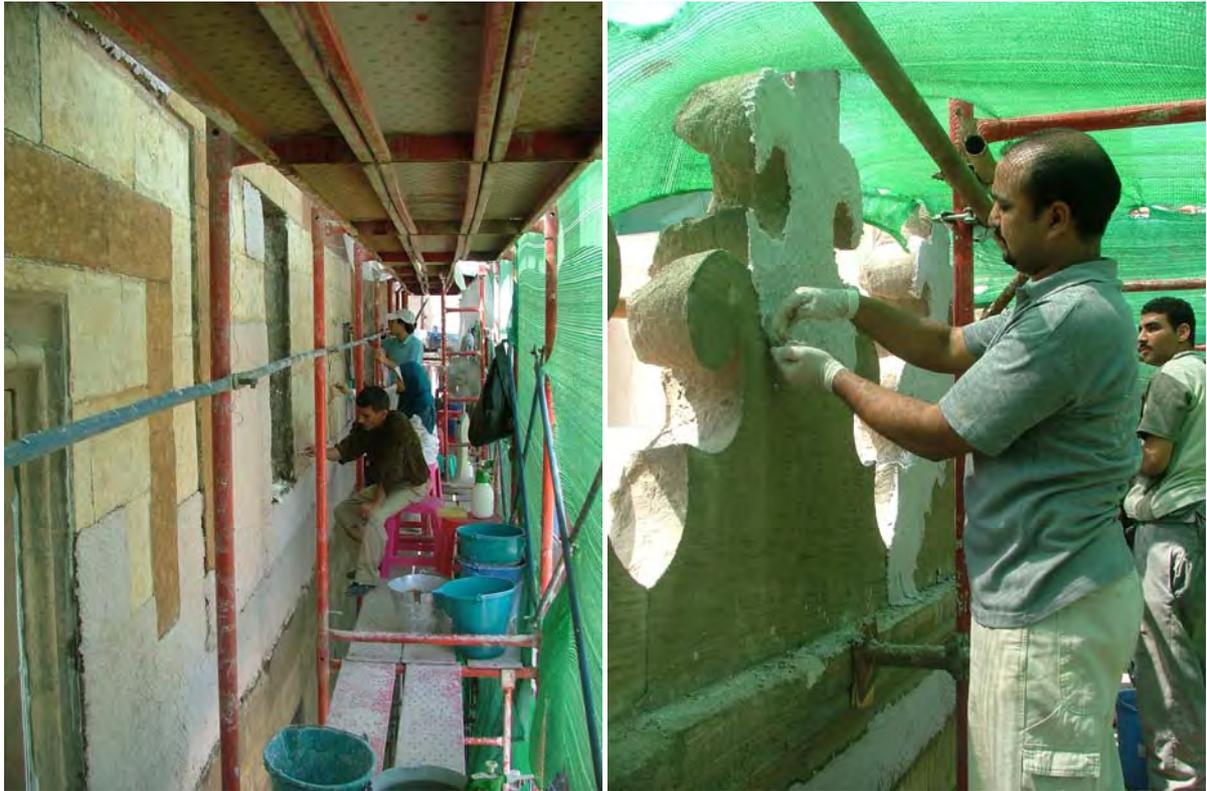
Mechanical cleaning test were started on the western façade in order to determine the state of the lime stones. Following, the fine restoration activities were initiated using poultice made of bentonite and paper pulp with a low concentration (3-5%) of Ammonium Bicarbonate. The same polychromy pattern of the lime stone found on both the southern and eastern façade was revealed.

Stone cleaning activities through mechanical and poulticing techniques.

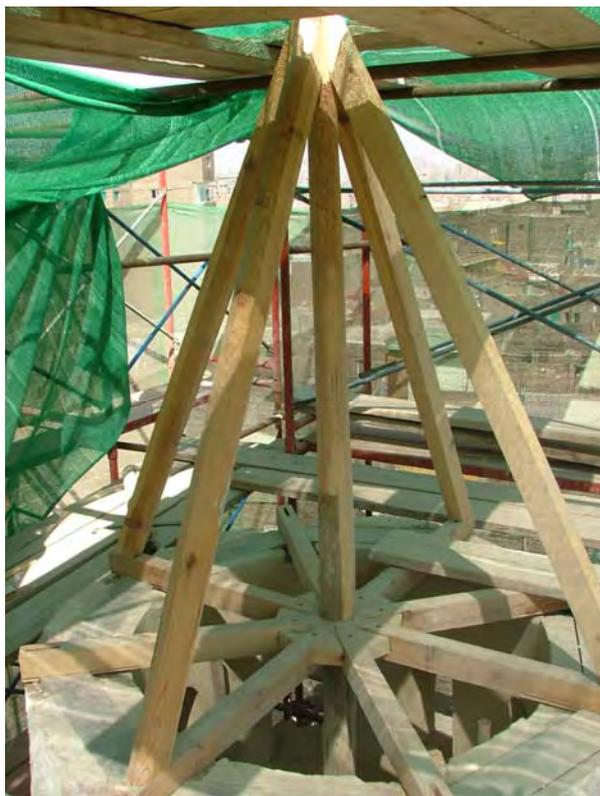
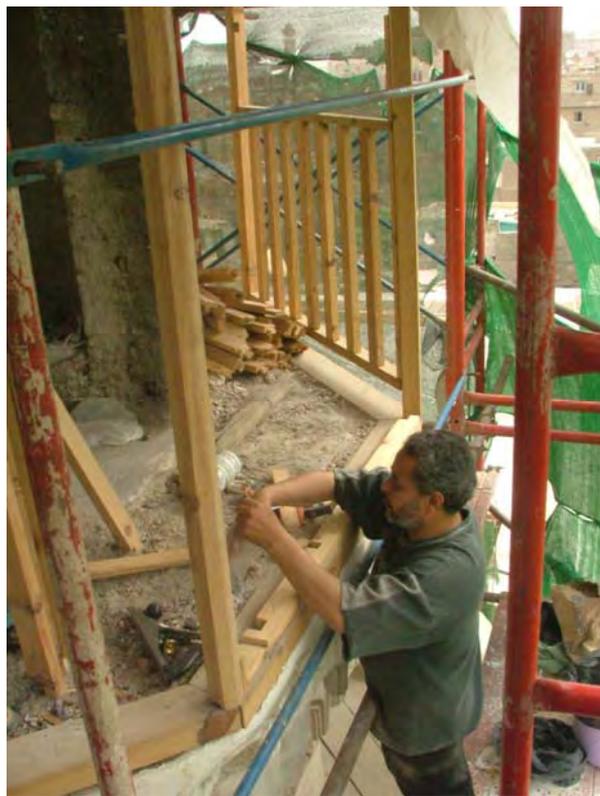
A detailed survey of the upper part of the minaret and tiling in the balcony was completed and a design proposal was prepared for the replacement of the missing tiles and handrail. The timber handrail of the middle platform was restored based on the design of the few conserved fragments. The upper wooden structure will be insulated by lead sheets during the next period.

Wood manufacturing of the upper part and the surrounding handrail of the minaret balcony

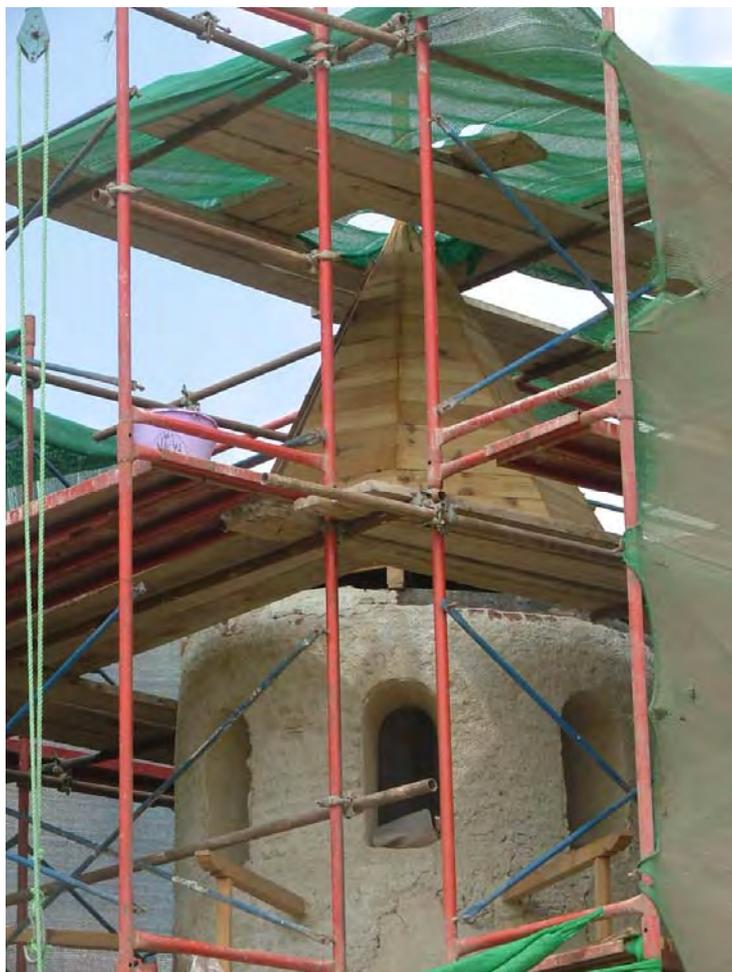
The conservation work included brick repairs on the upper part, the construction of a pencil shaped carpentry top and the cleaning of the interior walls and steps using the sand blasting technique.

View of the minaret after the completion of the upper pencil part and during plastering activities

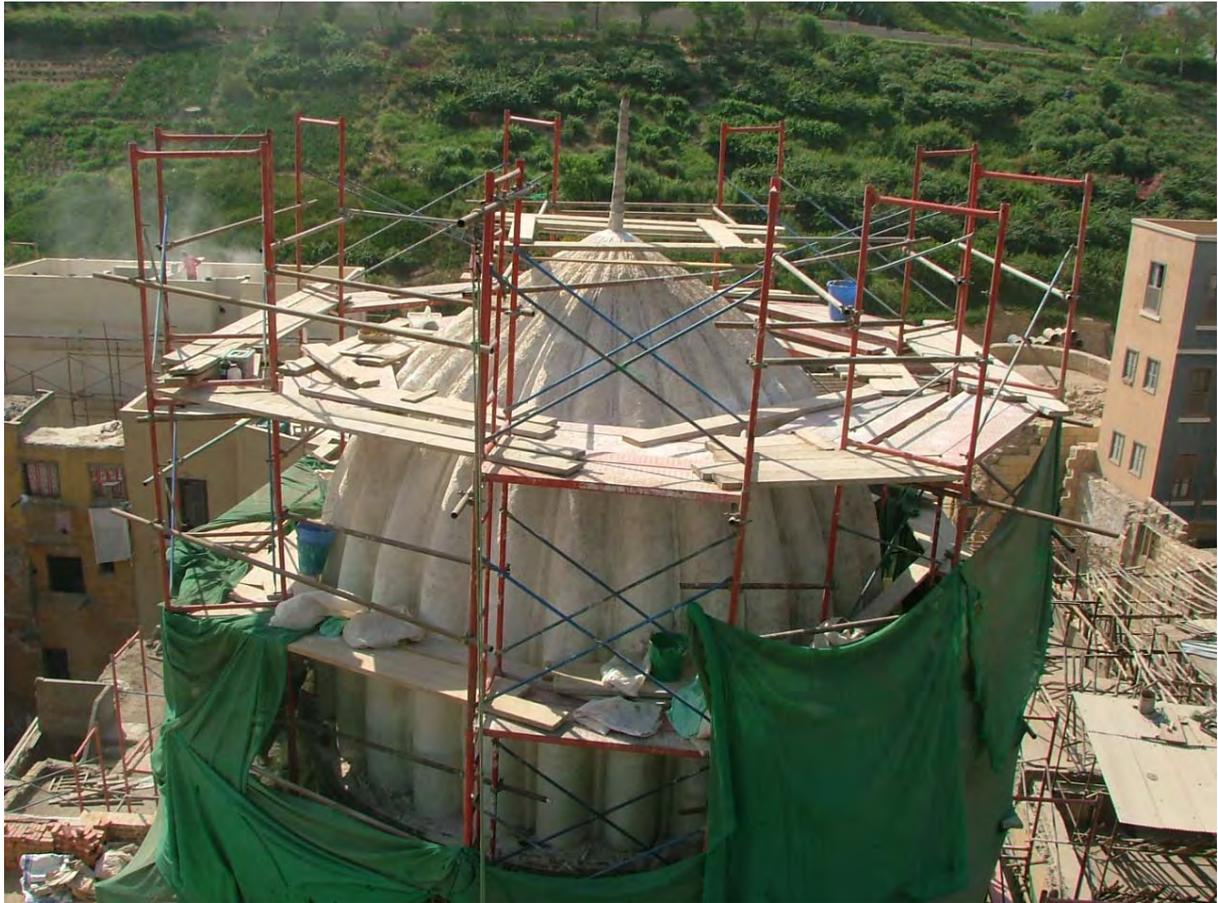
View of the dome exterior after the cleaning and installation of the copper crescent

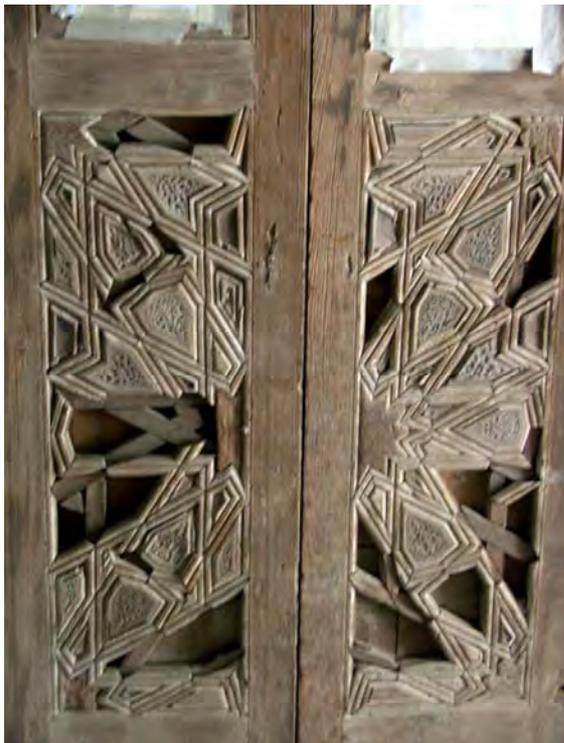
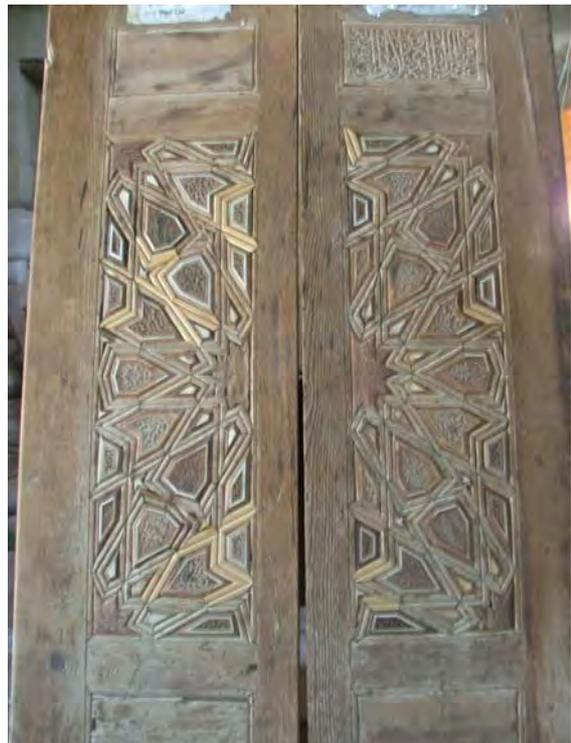
Woodwork restoration of doors, windows and shutters is currently in progress. Following the state of the items, carpentry restoration takes place followed by fine cleaning and conservation of the wooden elements.

View of the Eastern façade shutters before and after restoration

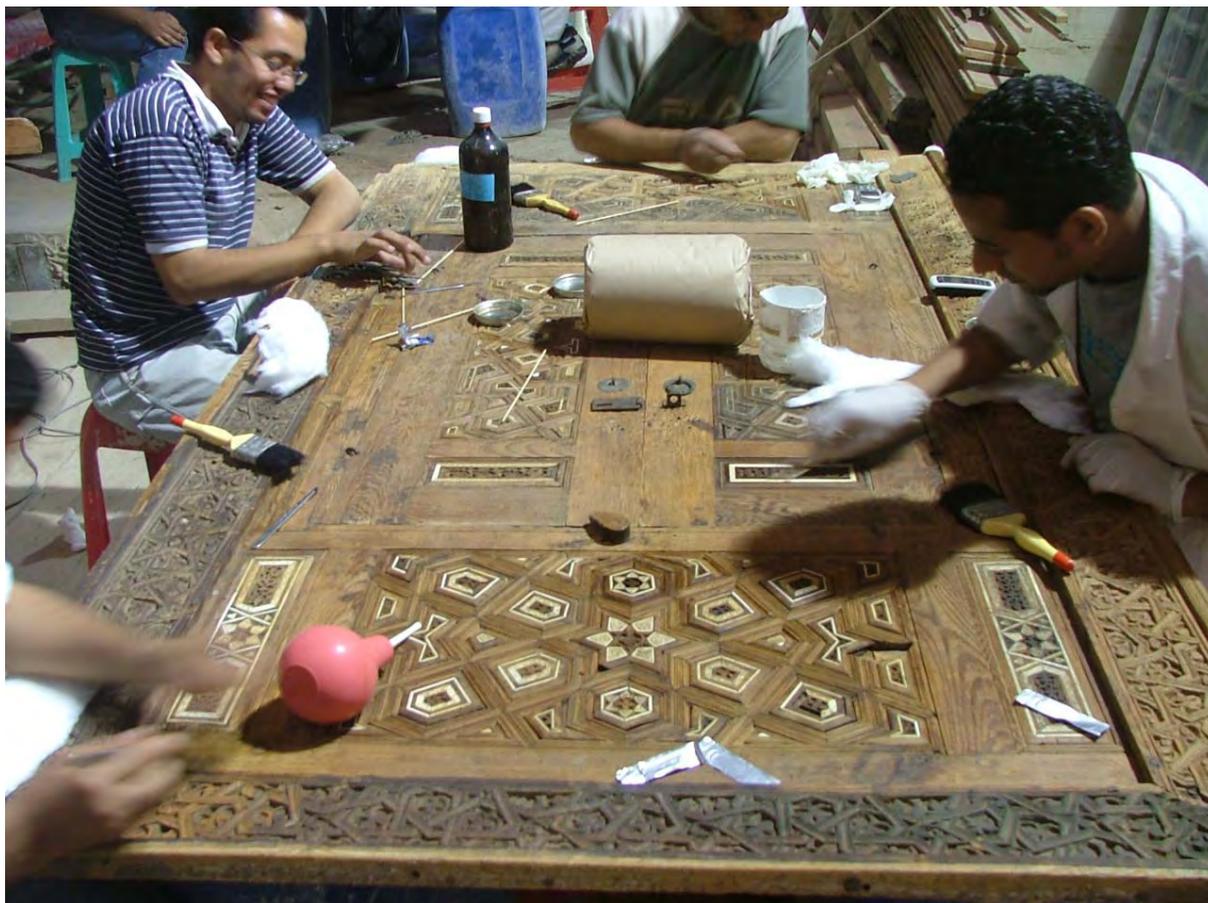
Inlay wooden cupboard during cleaning and consolidation

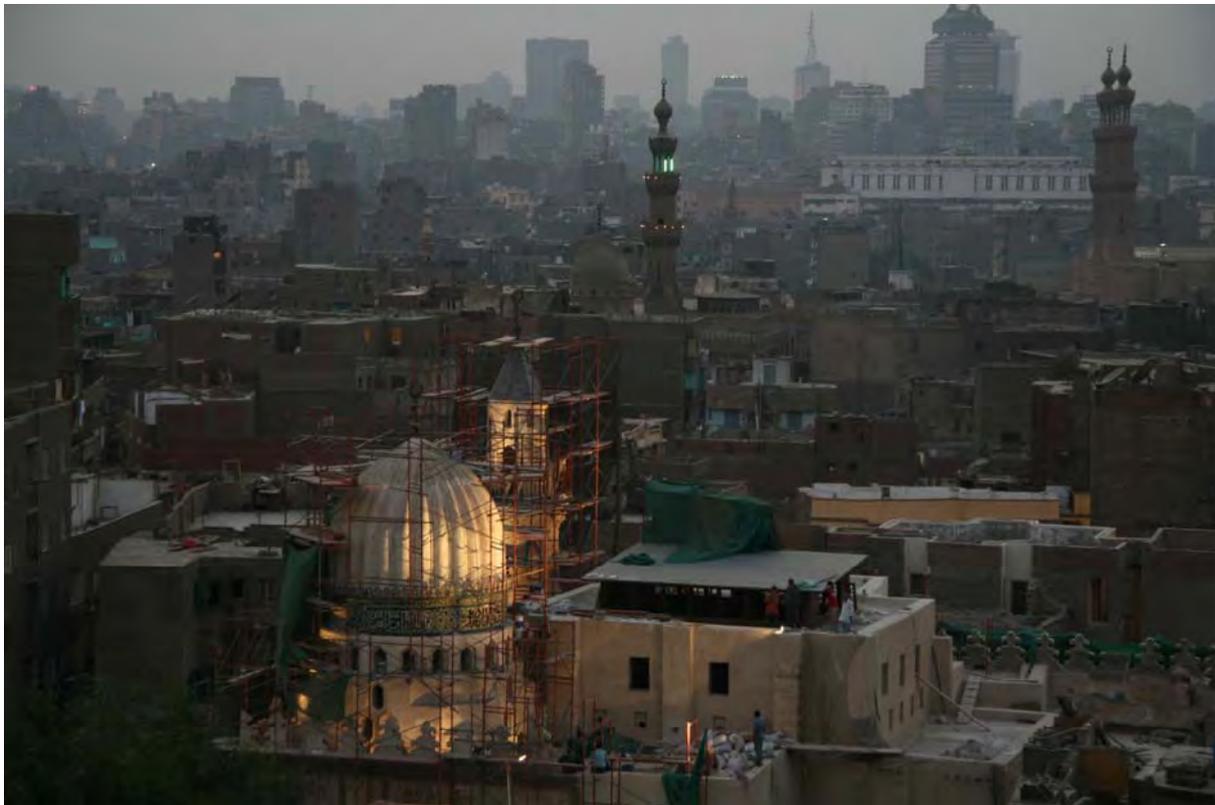
View of the exterior of the mosque during the lighting test. The photo also shows the completed activities of the exterior of the dome and minaret, as well as the shobkshaykha's insulation.

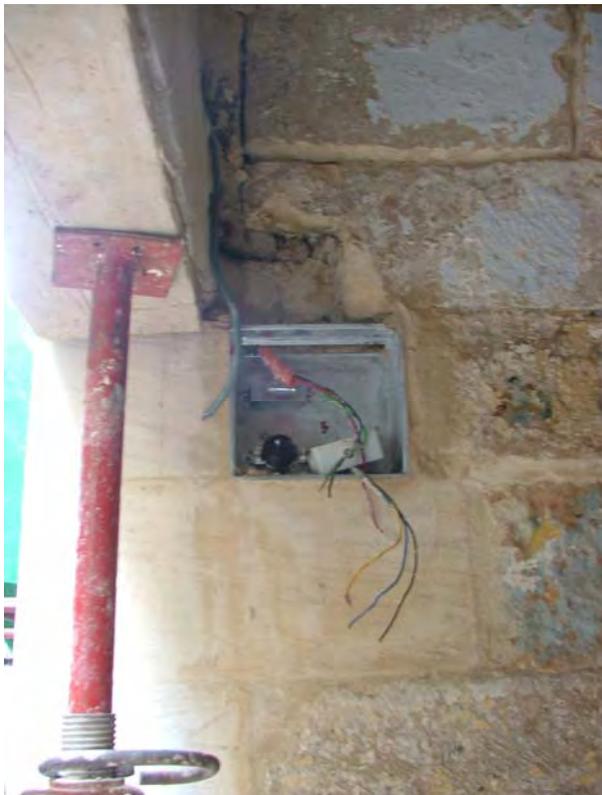
Electrical boxes for the shops

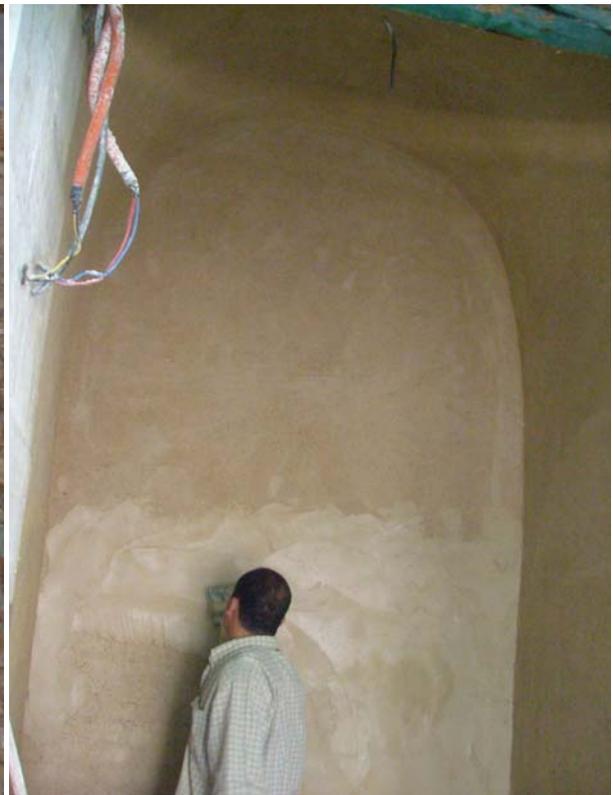
Plastering the brick walls of the shops

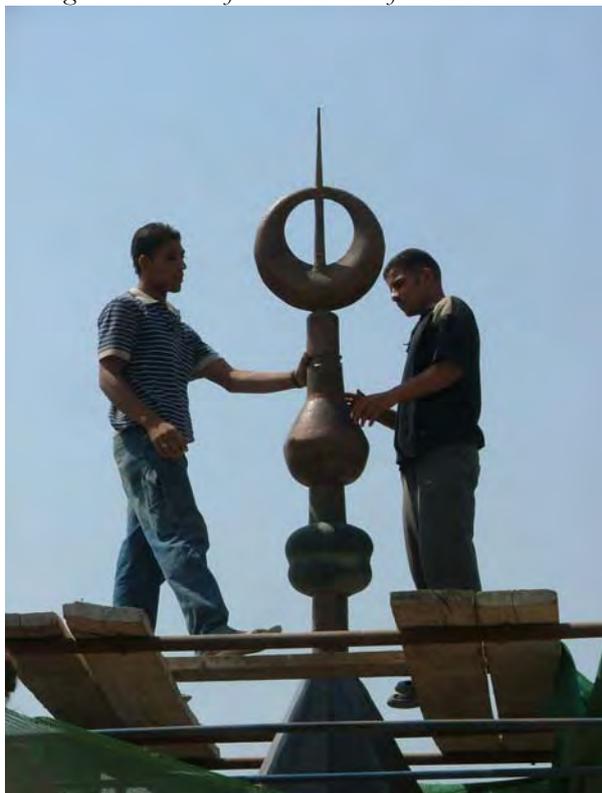
View of the crescent of the minaret

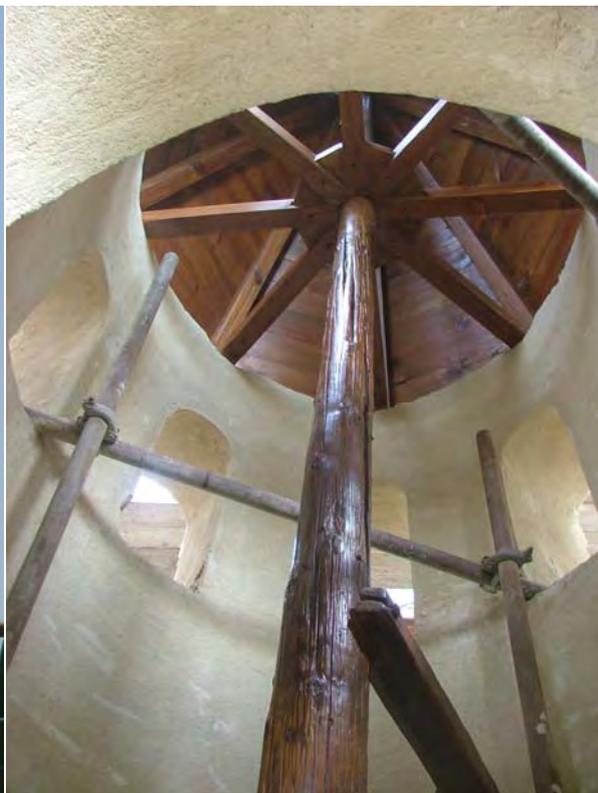
View of the interior of the minaret

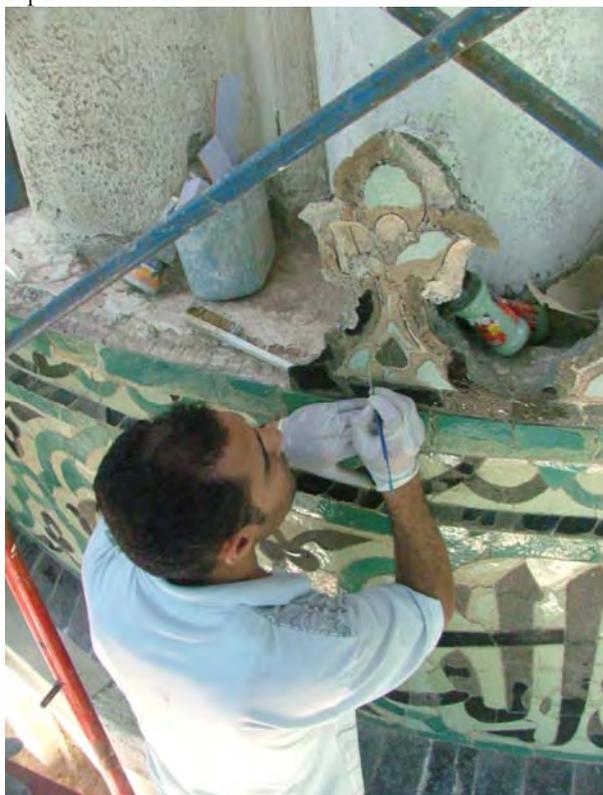
View of the complete existing crescent

The cleaning of the lower part of the dome was finalized; the damaged or missing mortar parts were replastered. The crescent was restored and re-erected on top of the dome.

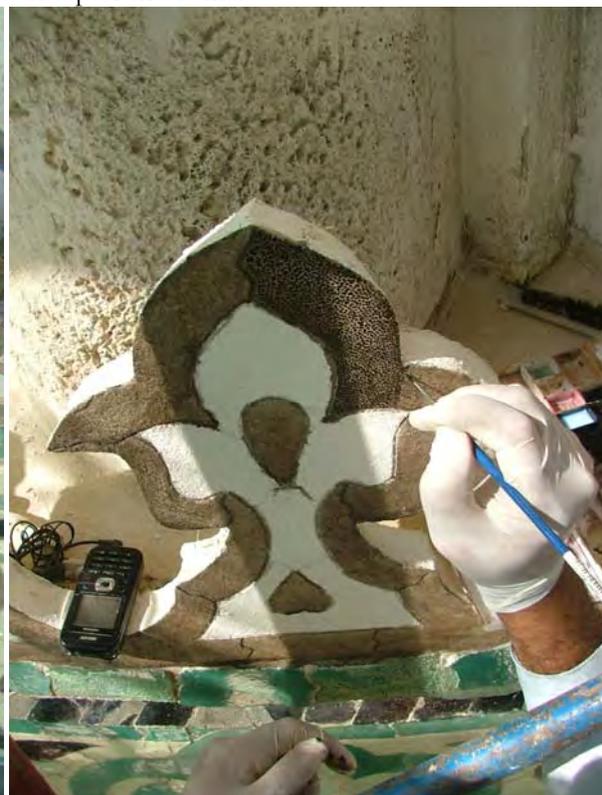
Detail of the sample of the crescent during retouching

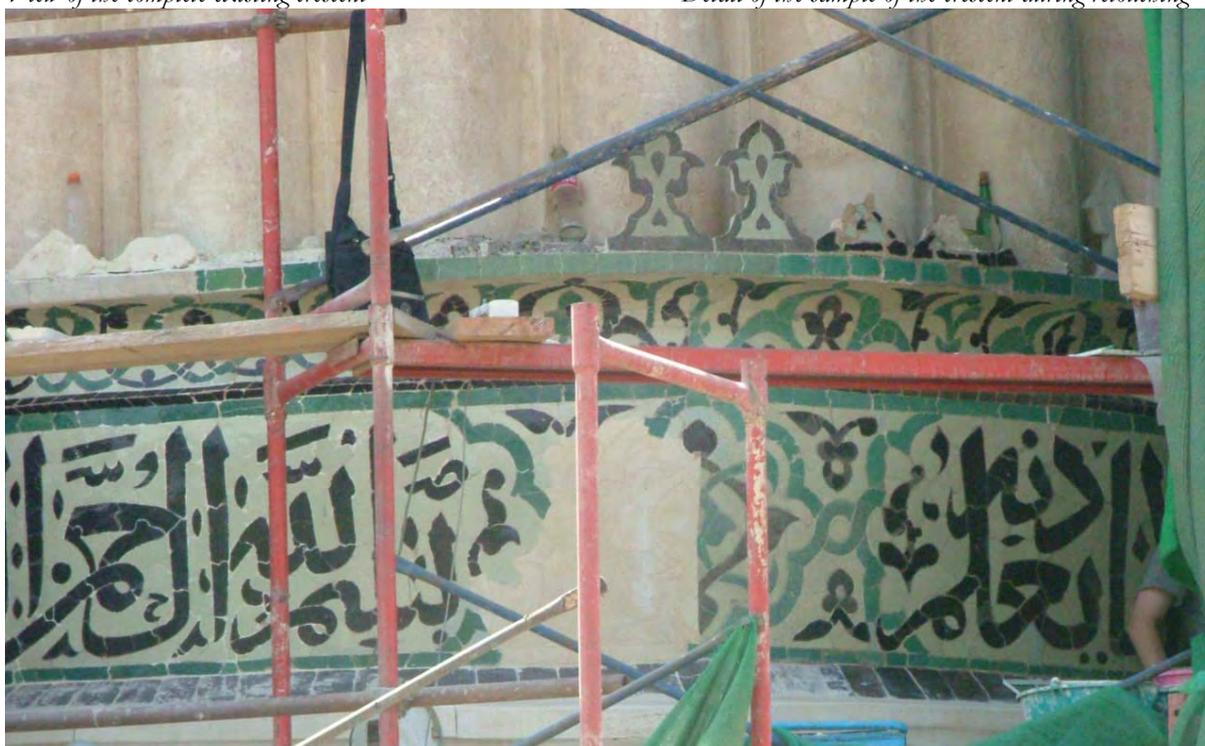
View of the crescents and the retouching tests of the floral pattern

The retouching of the inscription band and its floral decoration proceeded well and is almost complete. Samples for the upper crenellations crowning the dome were made of plaster. A complete crenellation was used for the samples. It was opted to carve the crenellations and retouch them in the same way like the inscription band. The intervention drawing is currently being completed to clearly show the retouched and carved parts and differentiate them from the original existing ceramics.

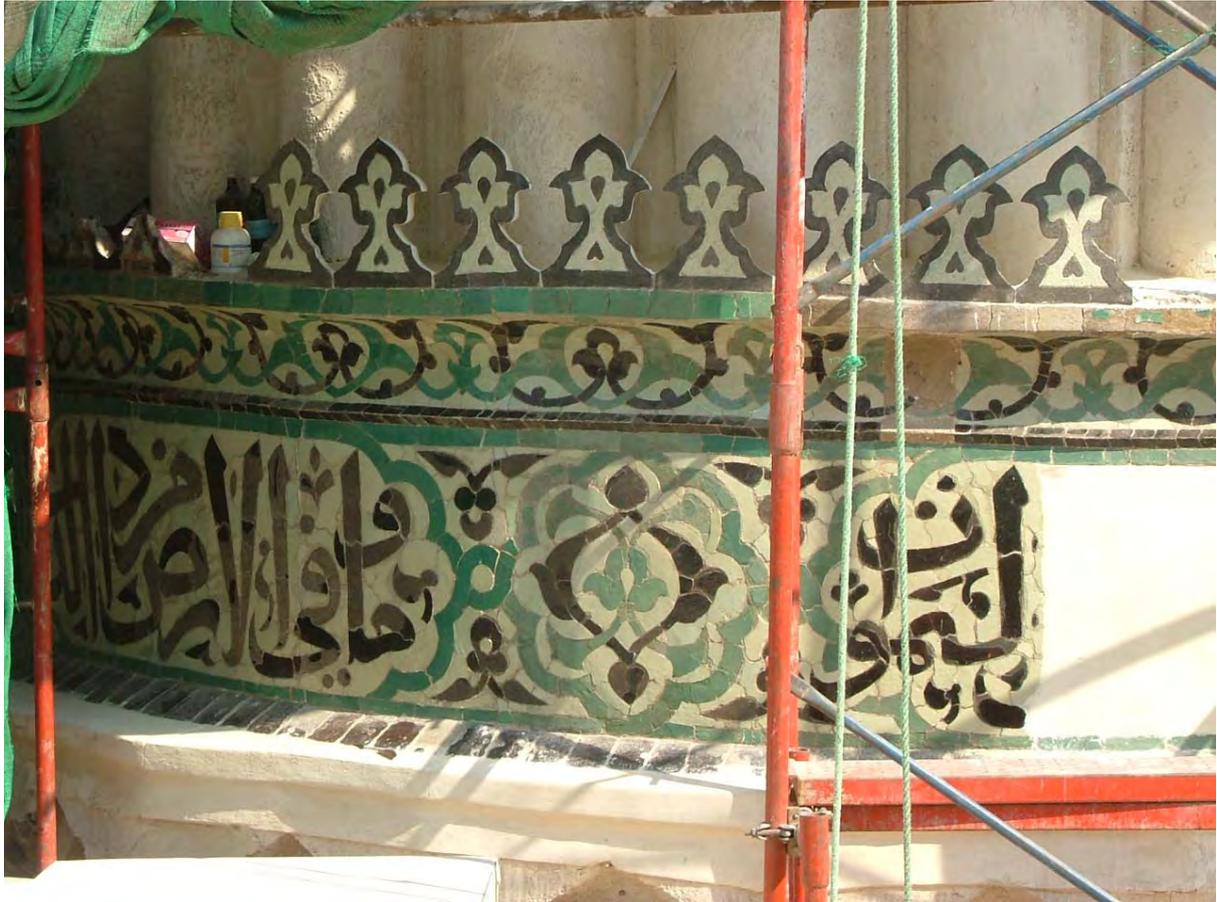
View showing the exterior of the mausoleum with the new crenellations

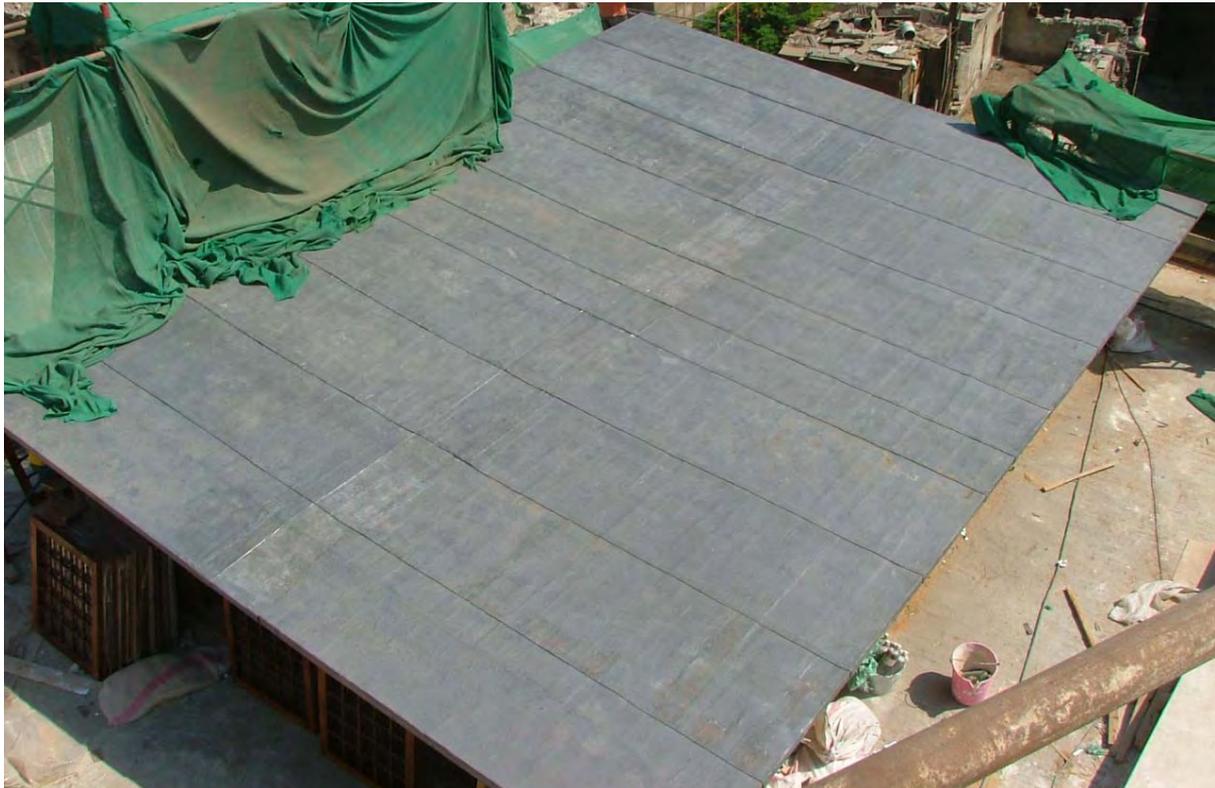
Central shokhshaykha after completing the insulation with lead

The lead was placed on the central shokhshaykha and all its structure was painted. The manufacture of the wooden screens was completed and they are currently being painted. A mesh of steel, similar to the one of the *Comité* will be installed to prevent birds from entering the mosque. It was designed with wider dimensions in order to bring more light into the space.

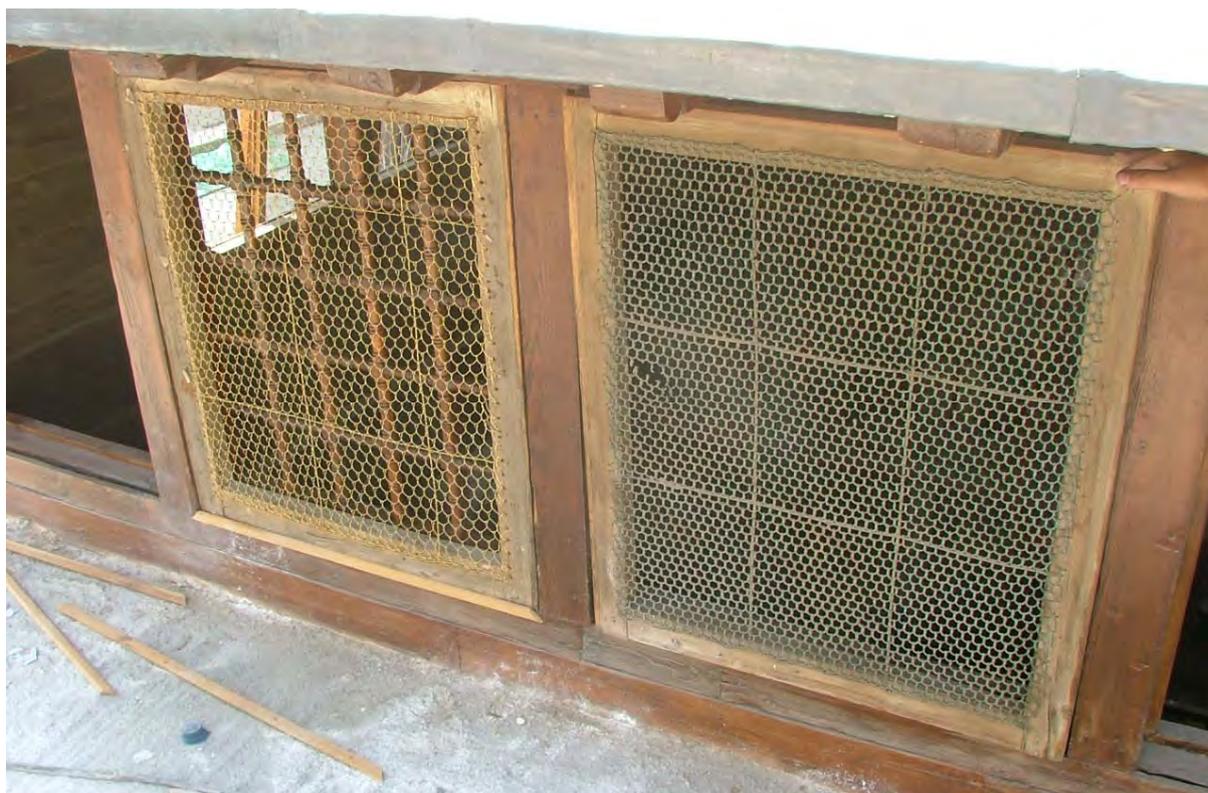
View of the samples of the steel mesh (on the left) and the one of the Comité (on the right)
