ANNUAL REPORT

“Conservation of the Mosque of Aslam al-Silahdar in Darb al Ahmar, Cairo”

Aga Khan Cultural Services
(Christophe Boleau)

**QUARTERLY PROGRESS REPORT
DECEMBER 2006-FEBRUARY 2007**

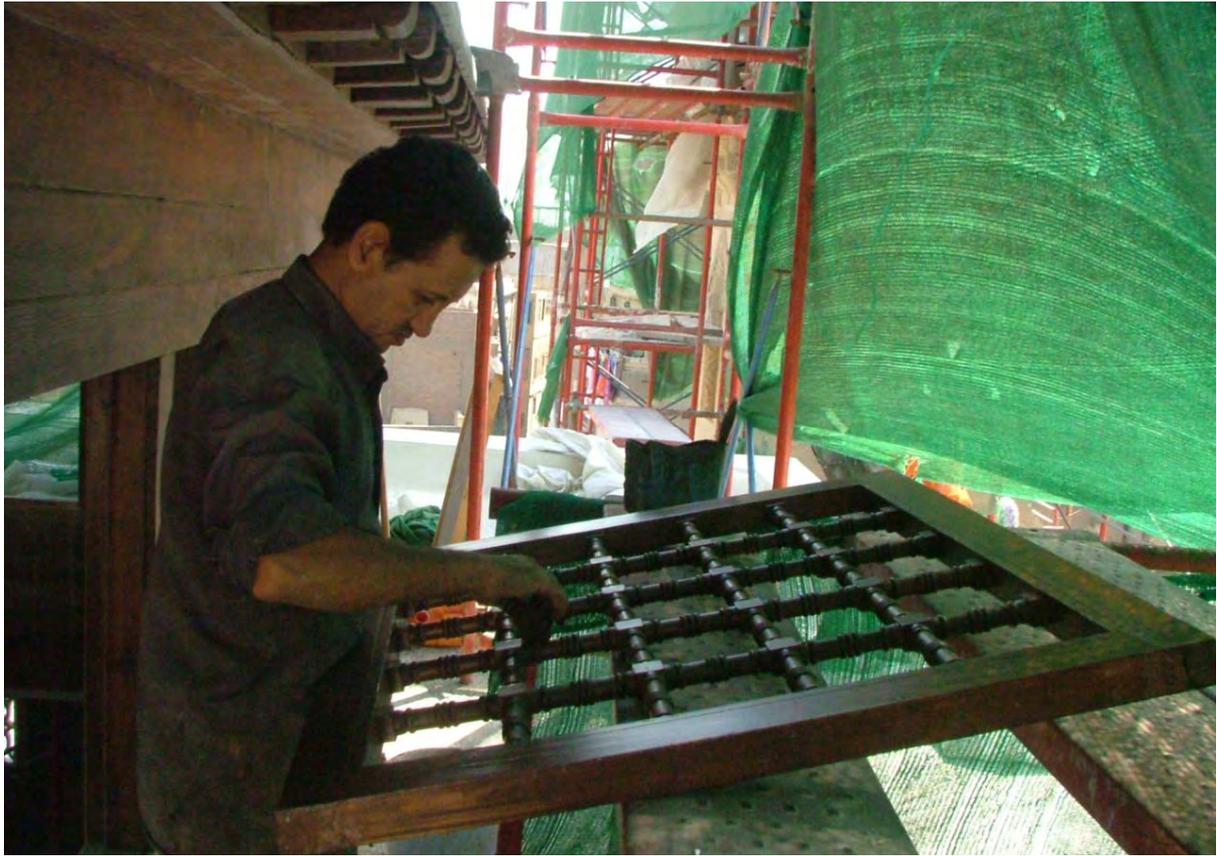
Work of painting the shokhsbaykhaand its wooden screens

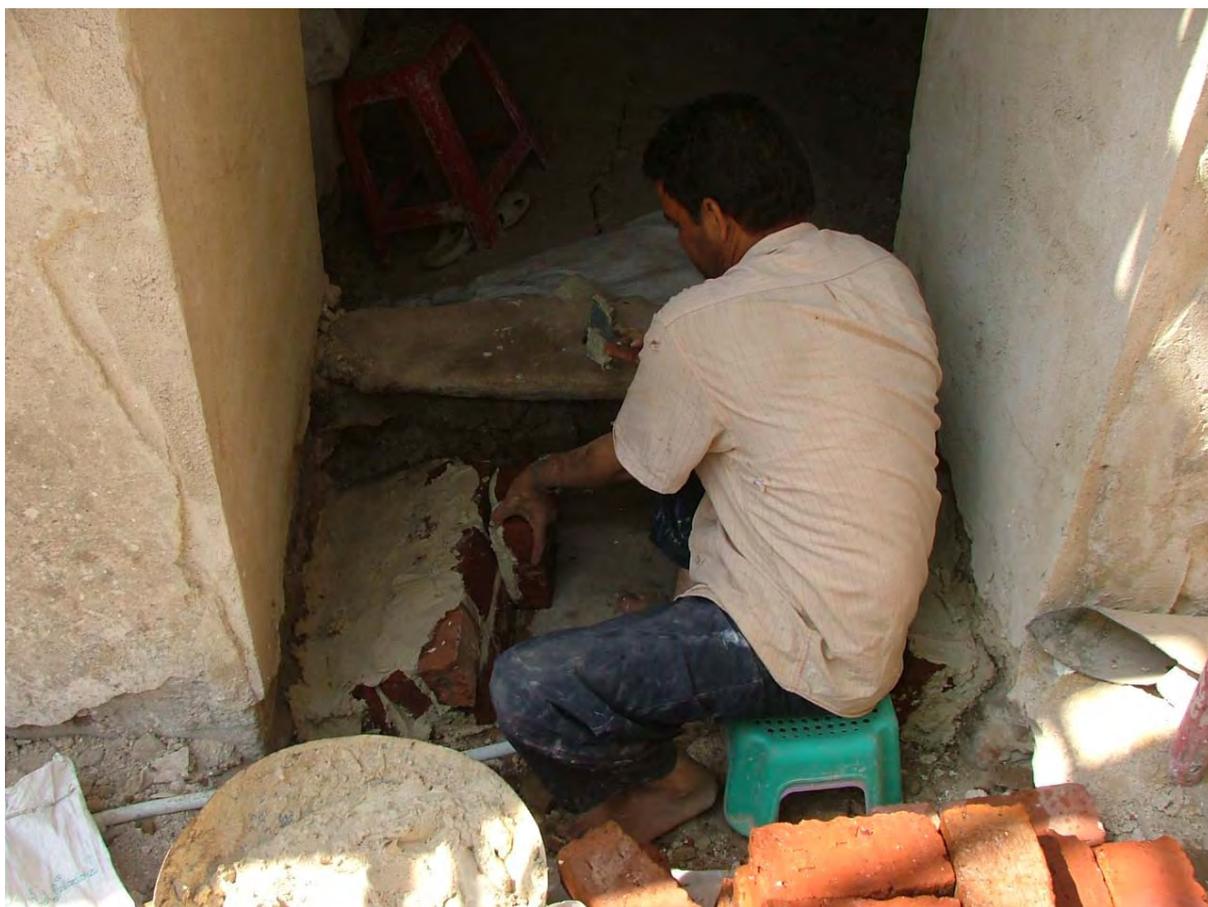
Plastering of room M1

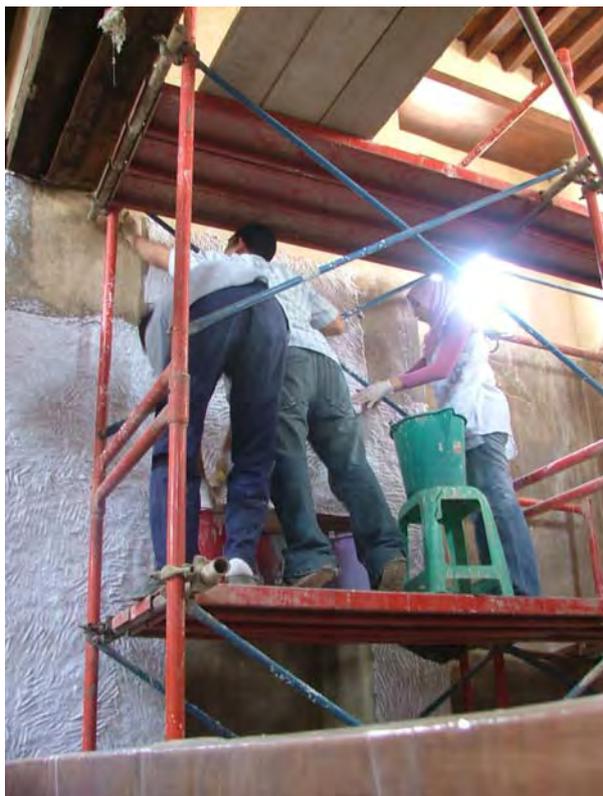
Fixing the vault of the corridor G6 through the upper room 1.3

Brick repair activities started in the corridor leading to the ablution area. The vault was seriously cracked and was repaired through the upper room (1.3).

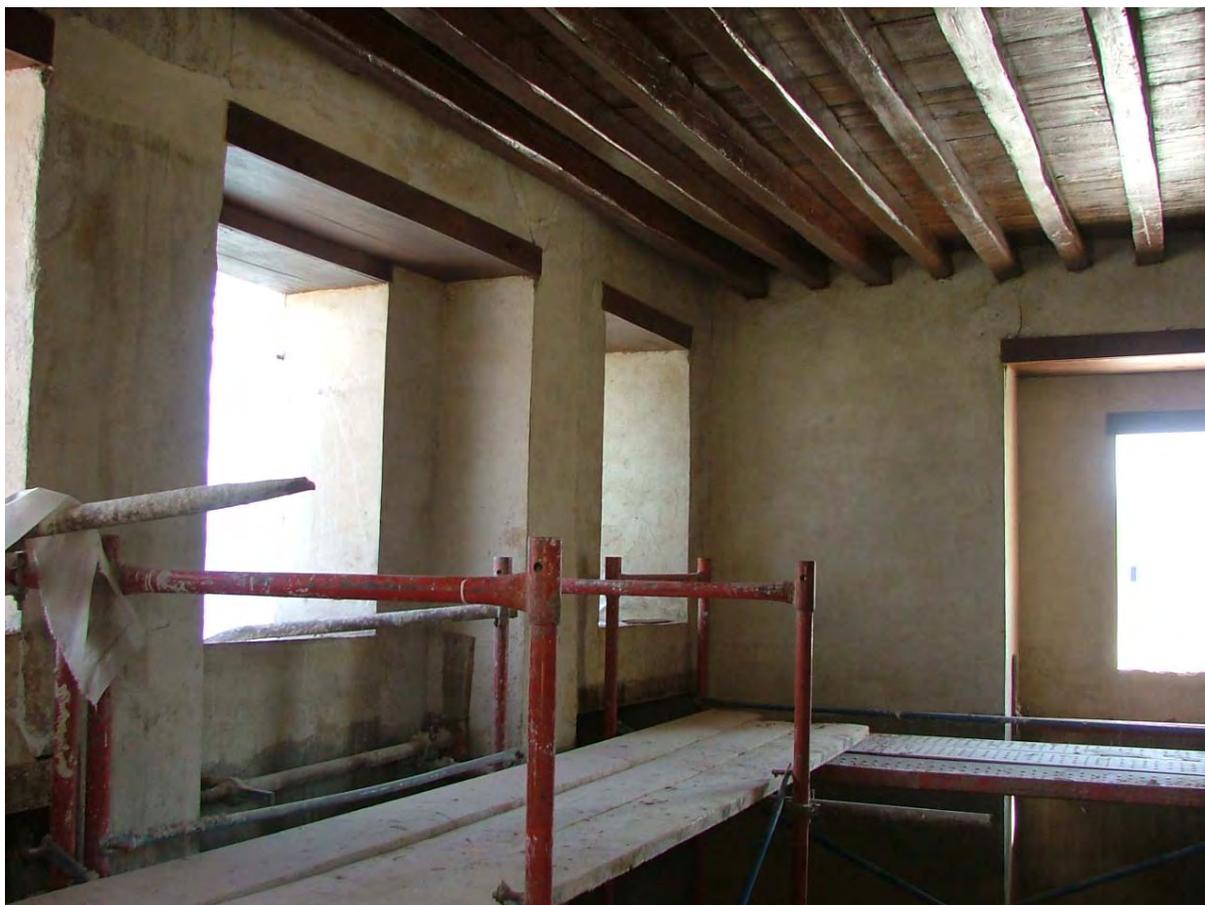
Preparation for painting the ceiling of room 2.2

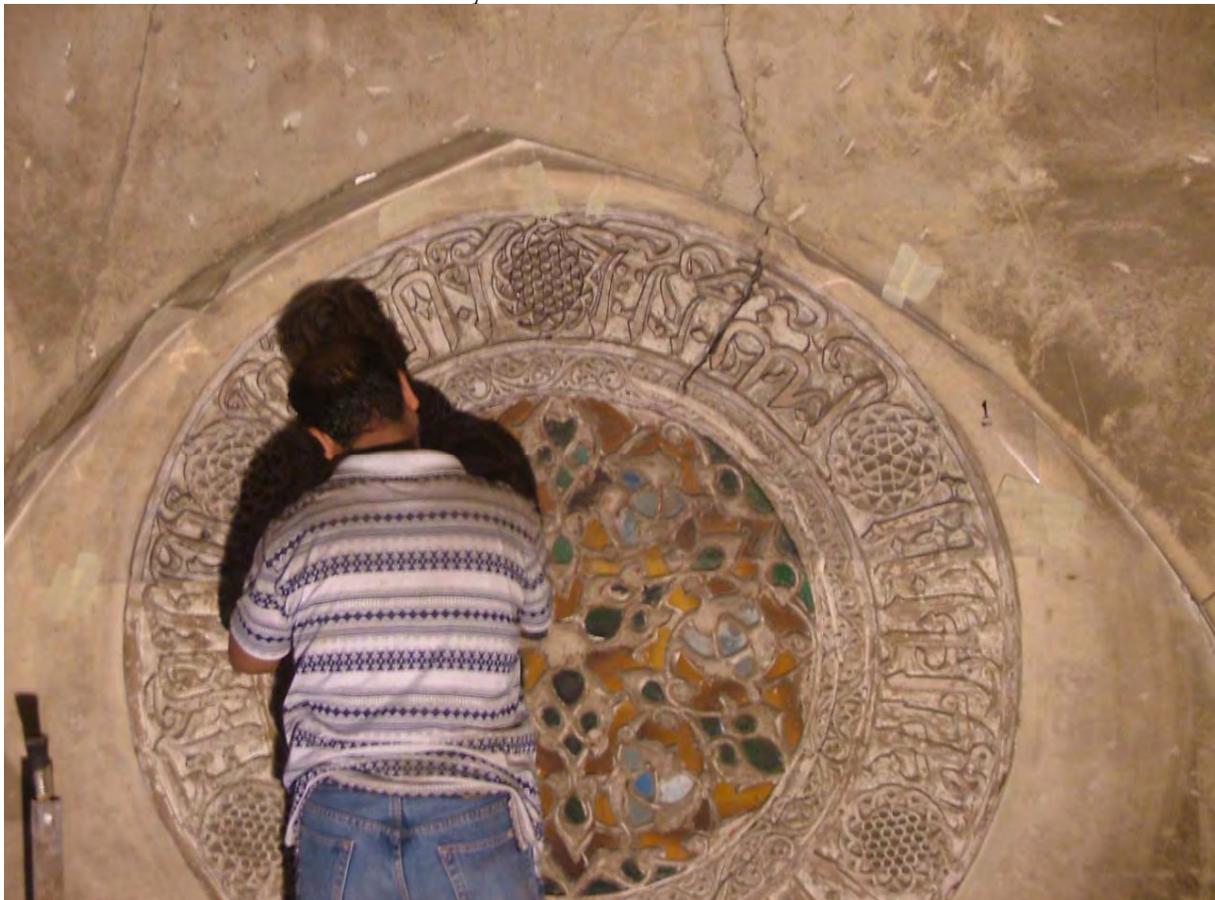
Documenting the stucco roundel in the west iwan

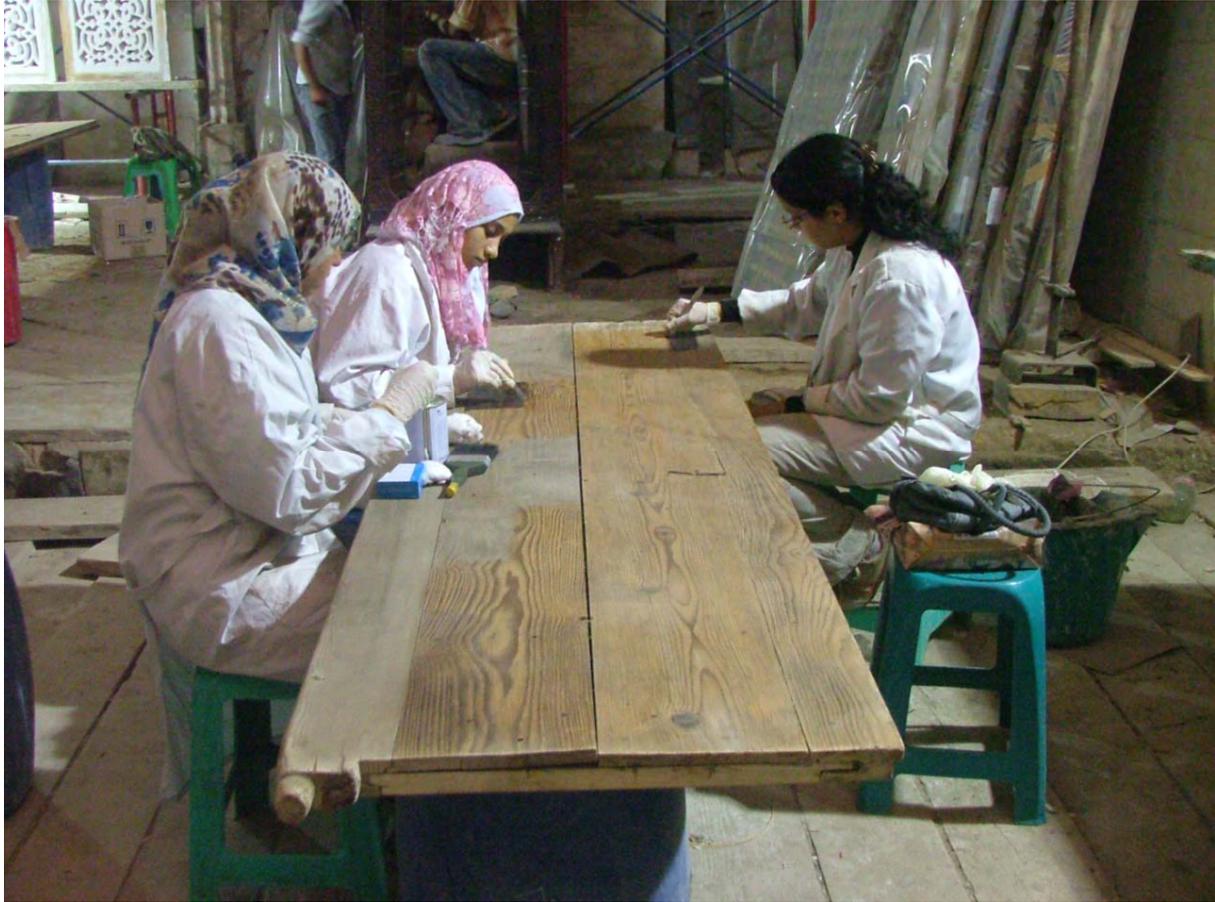
Activities of cleaning the wooden doors

Woodwork restoration of doors, windows and shutters is currently in progress and will be proceeding during the following months. In general, depending on the state of conservation of the item, carpentry restoration takes place followed by fine cleaning and conservation of the wooden elements.

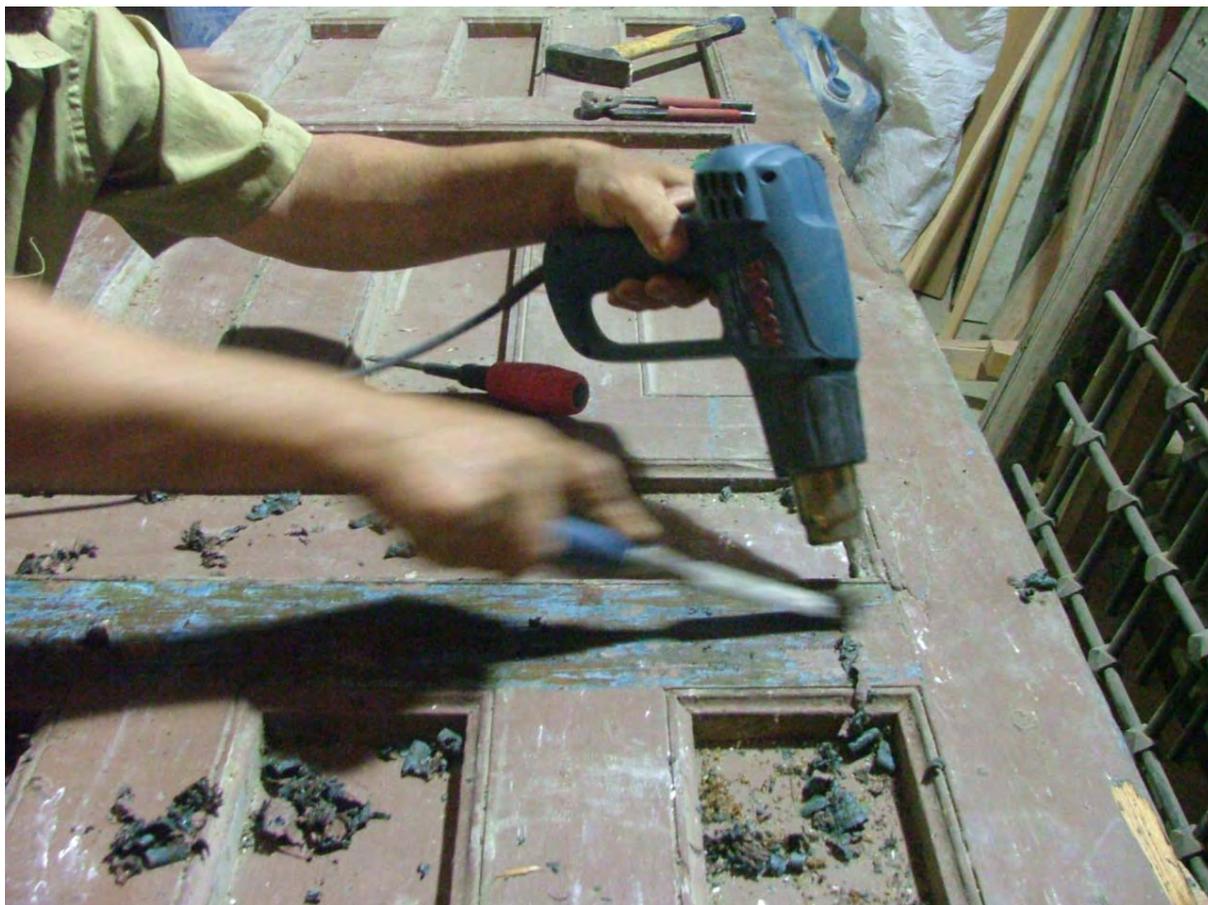
Removal of modern paint using the hot air gun

The wooden doors of the shops were repaired; their modern paint layer was cleaned using the paint remover and in other cases the hot air gun. The wood of the last shop's door was in a very bad condition and a new door was accordingly manufactured.

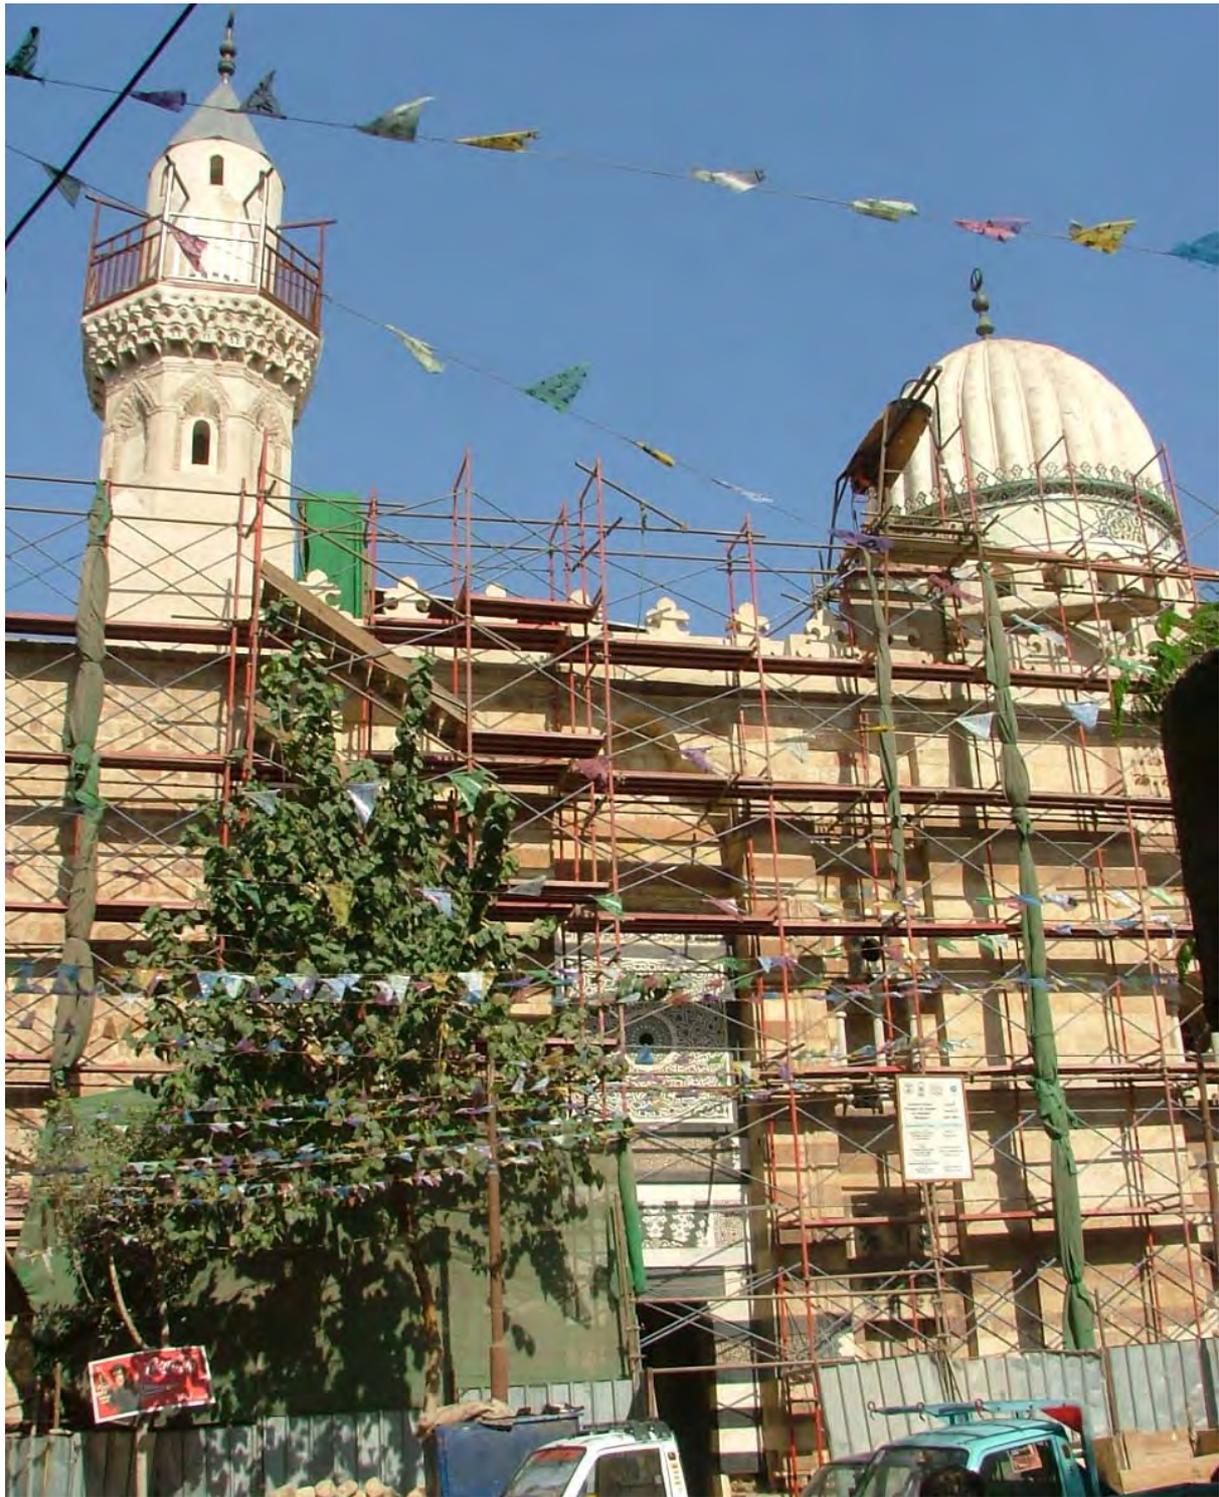
General view of the South façade

The missing crenellations on the south (main) façade were carved, brought up to the roof and installed in place. The missing crenellations on the right side of the west façade were also carved and erected.

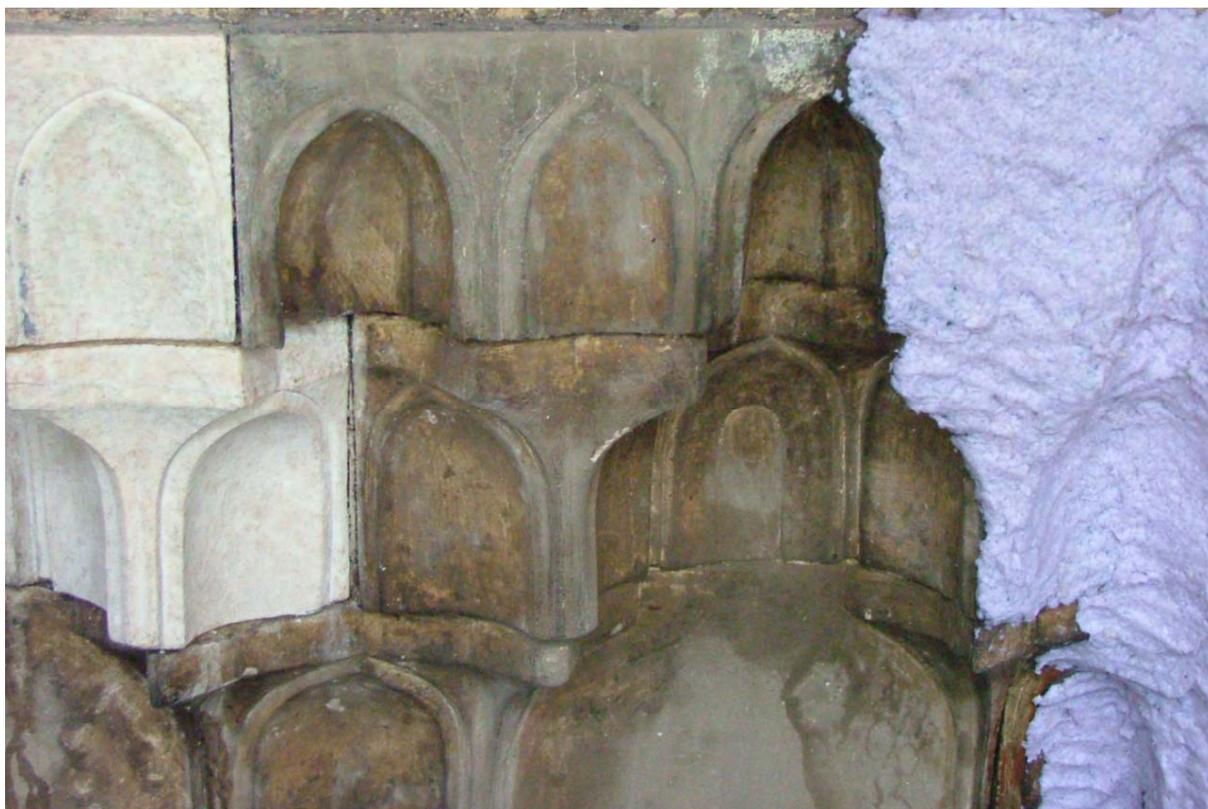
Detail showing the muqarnas on the side entrance portal

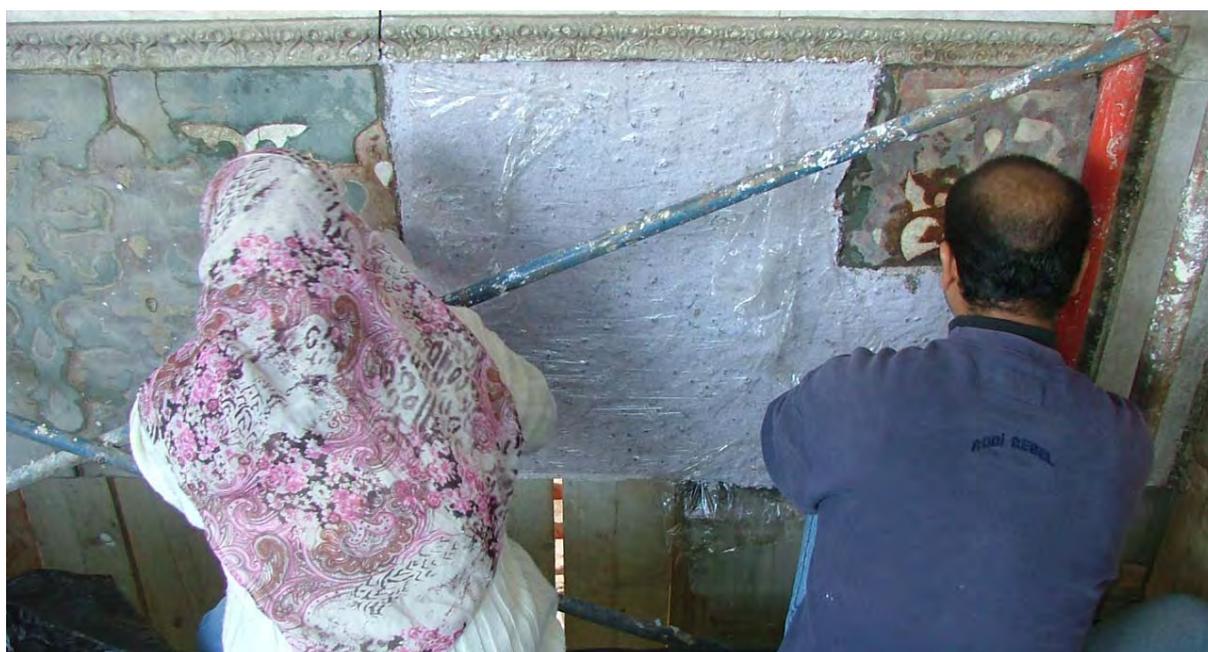
Activities of marble cleaning on the west façade

The fine restoration and cleaning activities were completed on the limestone part of the façade. As for the entrance portal adorned with *muqarnas* and decorated with carved limestone and carved marble, the work is proceeding very well showing nice details and colors of the stones. The cleaning was carried out using different techniques (such as the micro-sand-blaster or poulticing with ammonium carbonate) depending on the type of the stone and the crust on it. The lower part of the entrance portal was in quite a bad condition with a very thick layer of crust; it was cleaned with sand-blasting technique. The remaining activities on the portal will be finalized by mid of January 2008. The wooden elements, repaired and painted, were placed and the scaffolding on the right side of the façade was removed.

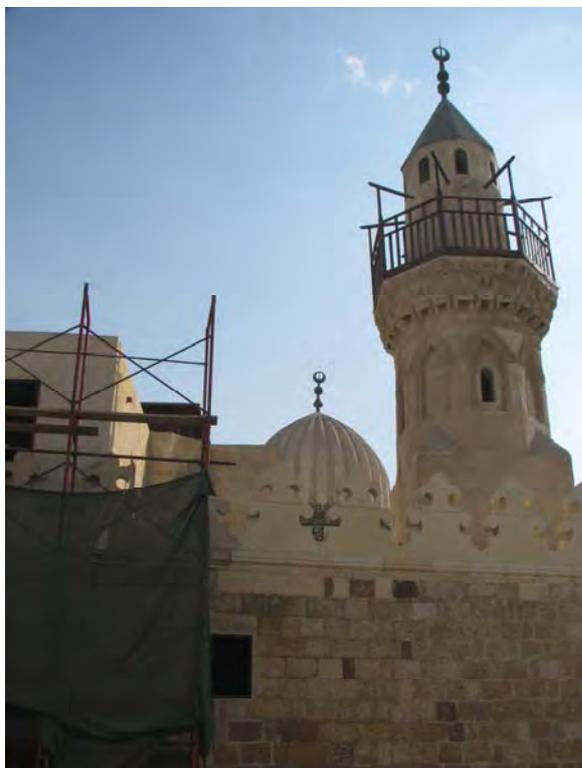
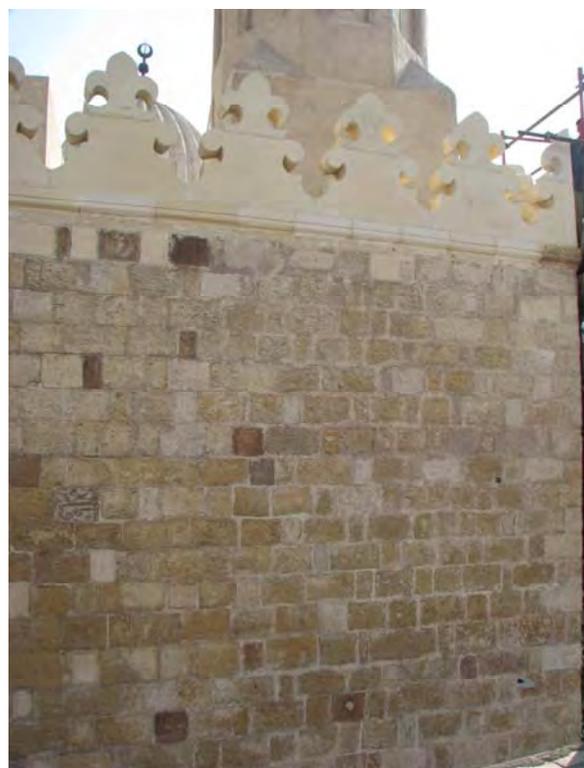
Views of the west façade after cleaning and inserting the restored wooden elements

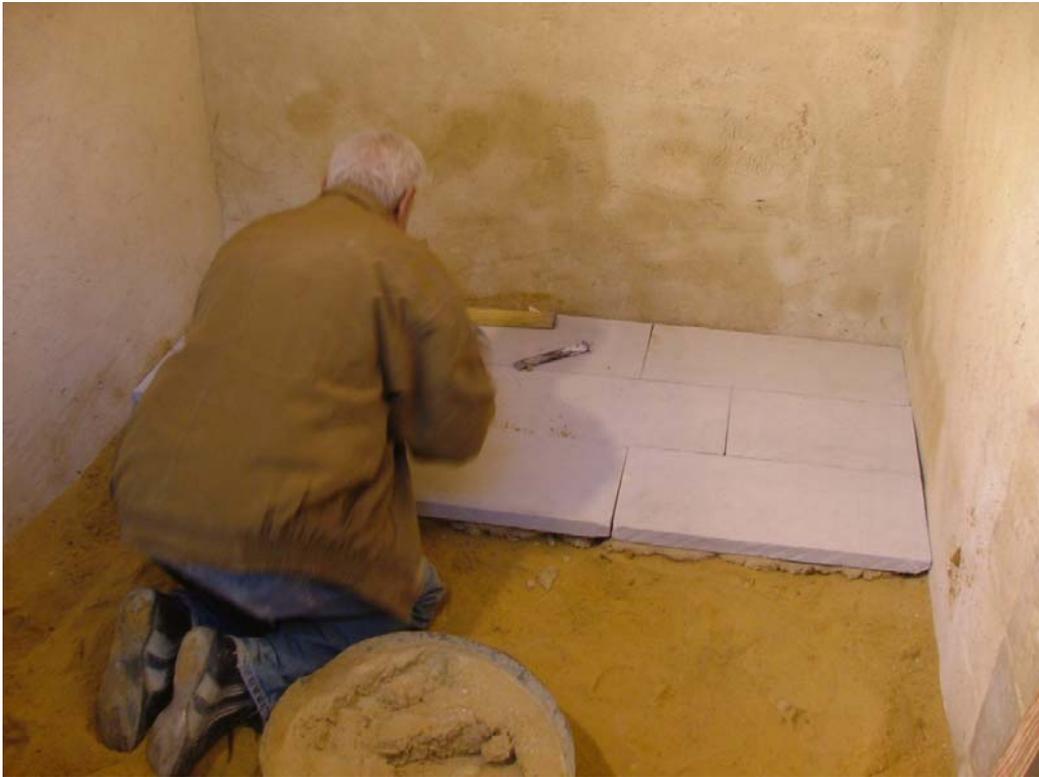
Tiling activities of one of the shops on the west façade

All remaining activities in the five shops were finalized; the walls were plastered and the floors were tiled. Some remaining activities of stone replacement and stone cleaning were also finalized.

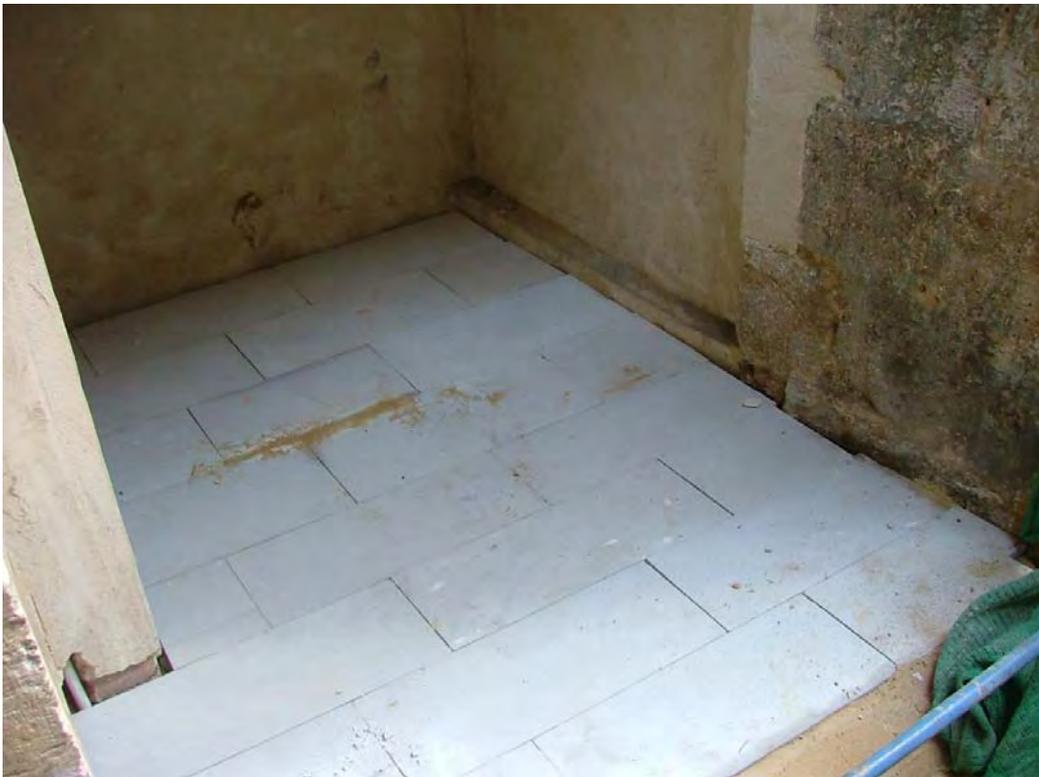
One of the shops after tiling

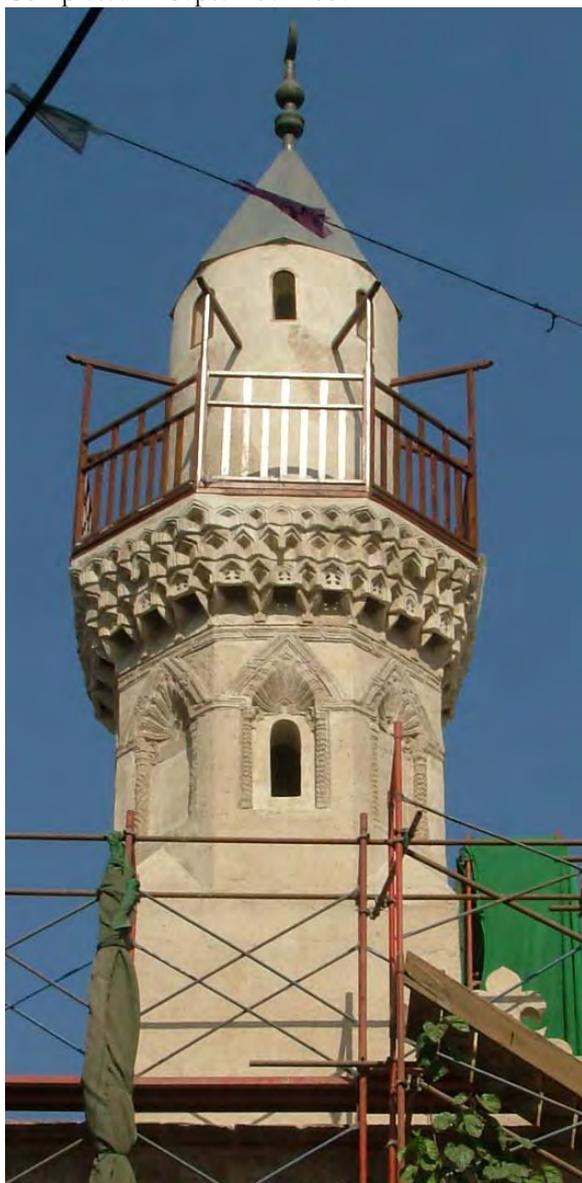
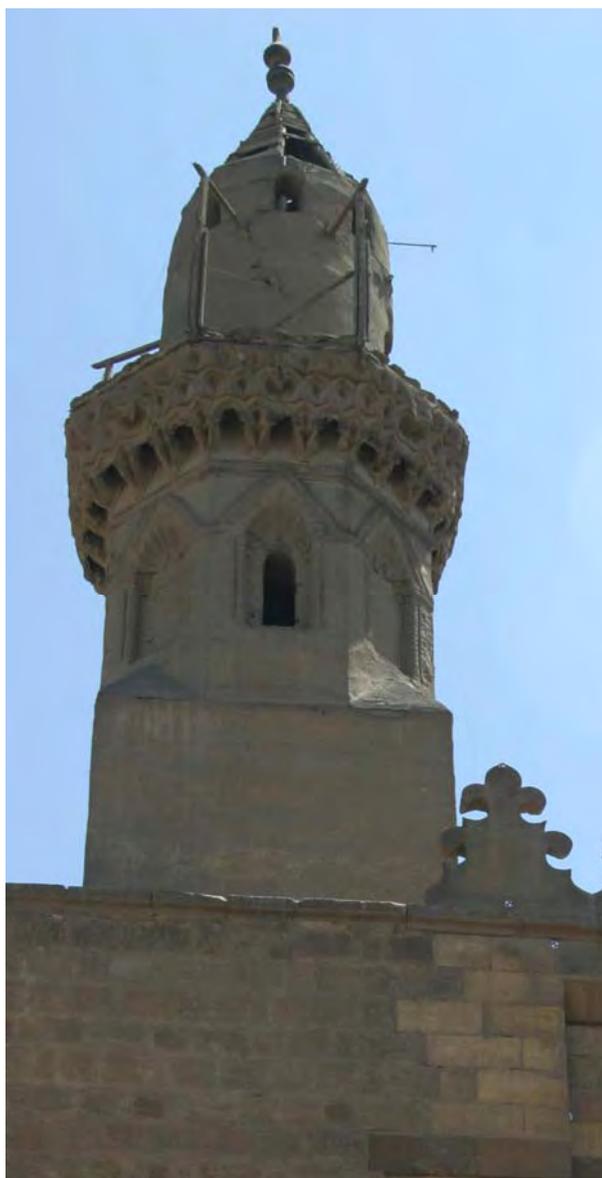
Views of the minaret after restoration and before restoration

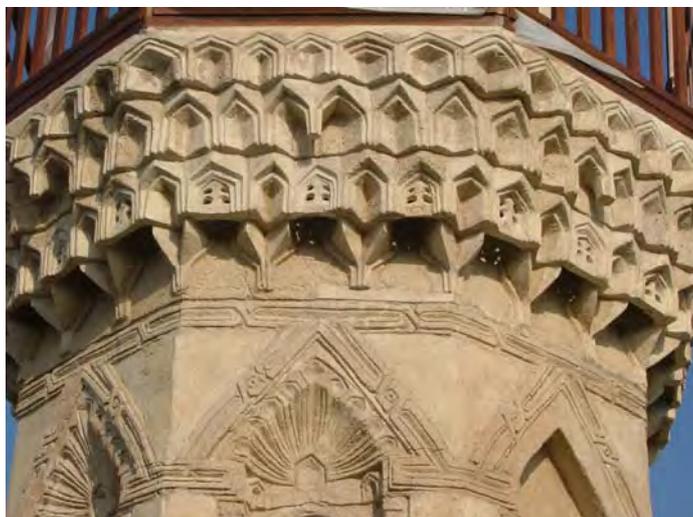
Detail of the minaret's muqarnas after restoration

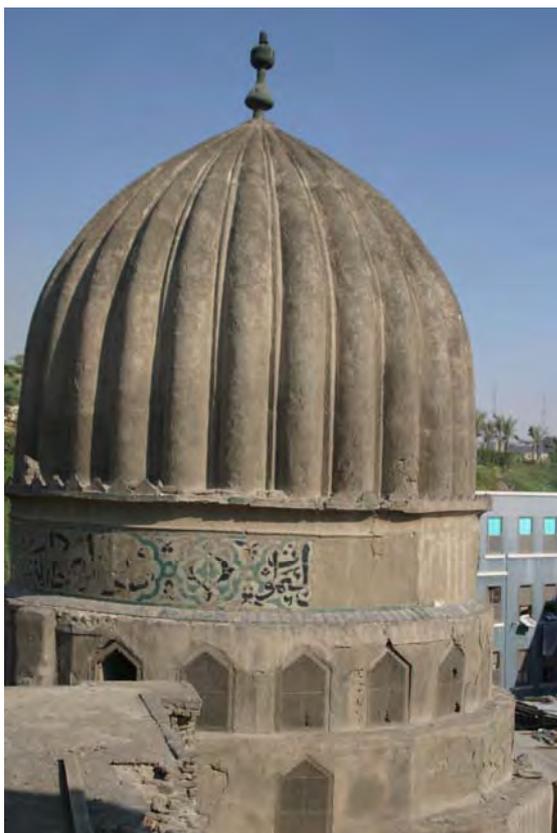
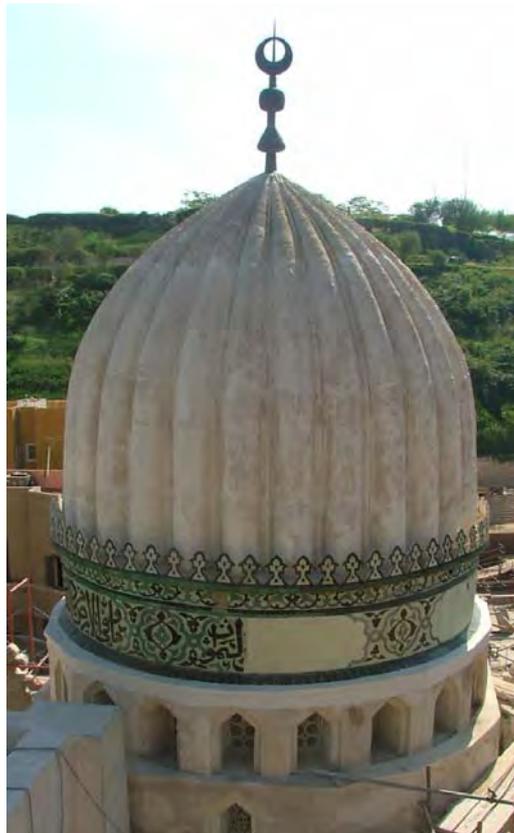
Views of the exterior of the dome before and after intervention

The retouching of the crenellations (made in plaster), the inscription band and its floral decoration was completed. A decision is being studied concerning the completion of the inscription band in the areas where no ceramic tiles are found. The existing gypsum grills with glass on the interior of the mausoleum were cleaned from the outside. As for the exterior gypsum windows (which are missing) designs were proposed to the SCA and discussions are taking place concerning the matter. The scaffolding was dismantled.

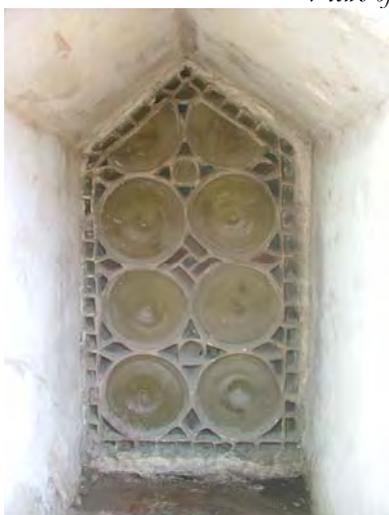
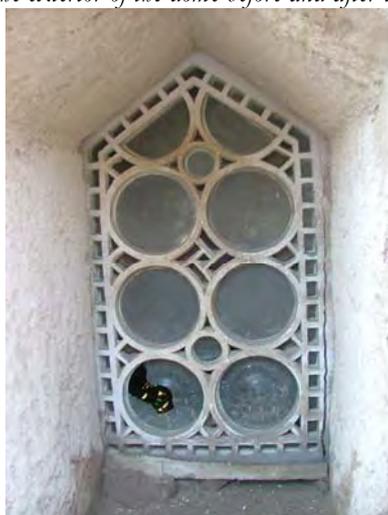
The exterior façade of the interior gypsum windows with glass (the left one is more historic and the only one remaining; the other ones are recent reconstructions by the Comité)

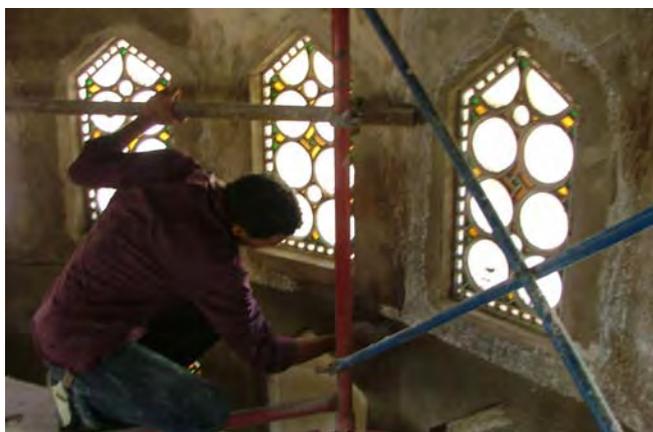
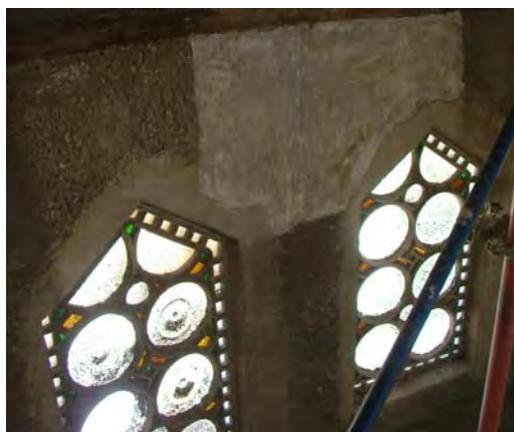
Activities and details of removing the dust and the recent limewash layer around the first level windows of the mausoleum

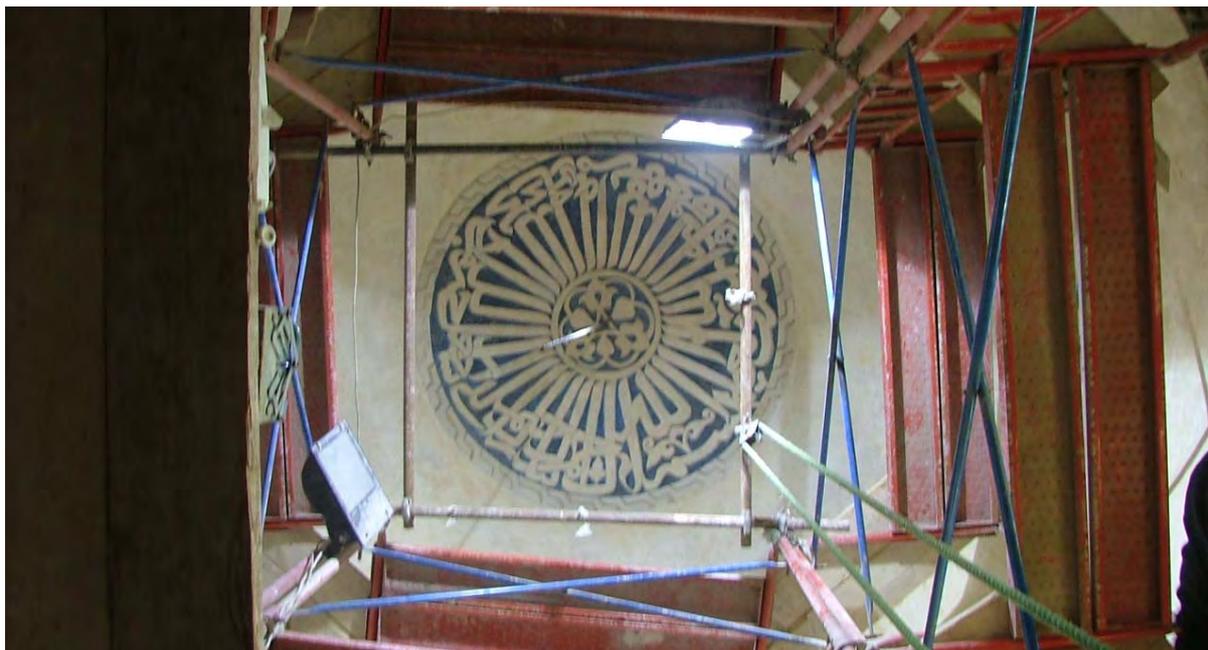
View of the upper roundel after cleaning and retouching the blue background; below: detail of the roundel

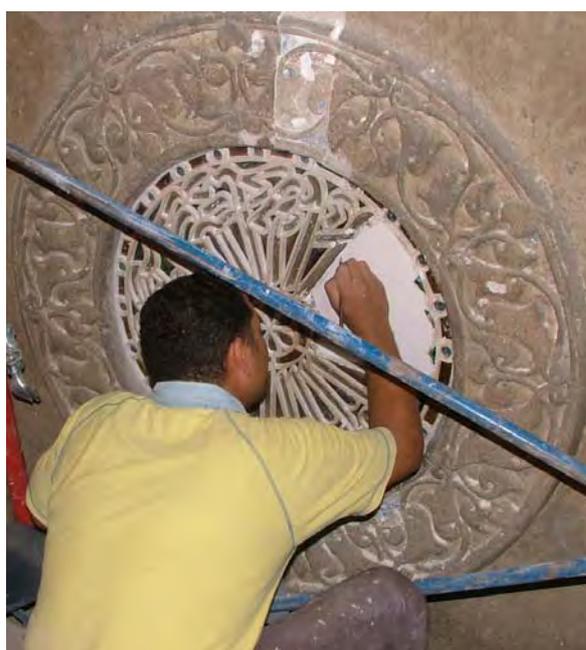
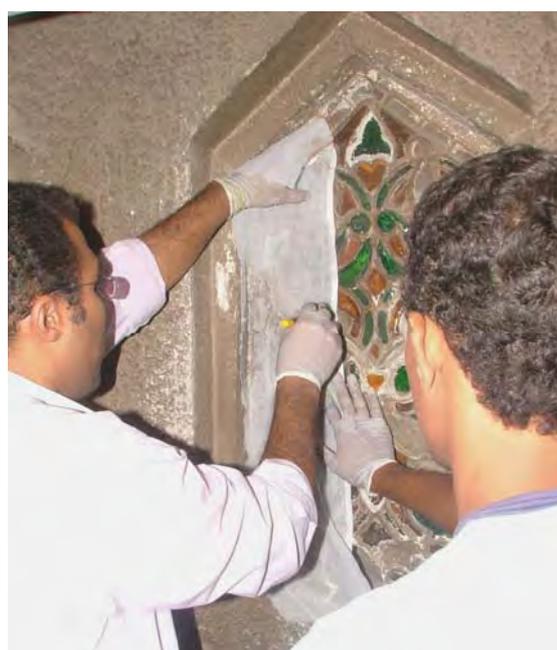
On the lower levels of the mausoleum some gypsum grills and windows were in a very bad condition with numerous missing parts. These are being repaired in-situ. One grill was in a quite bad condition and was dismantled, repaired, cleaned and completed.

Views of repairing and protecting the gypsum decoration in-situ

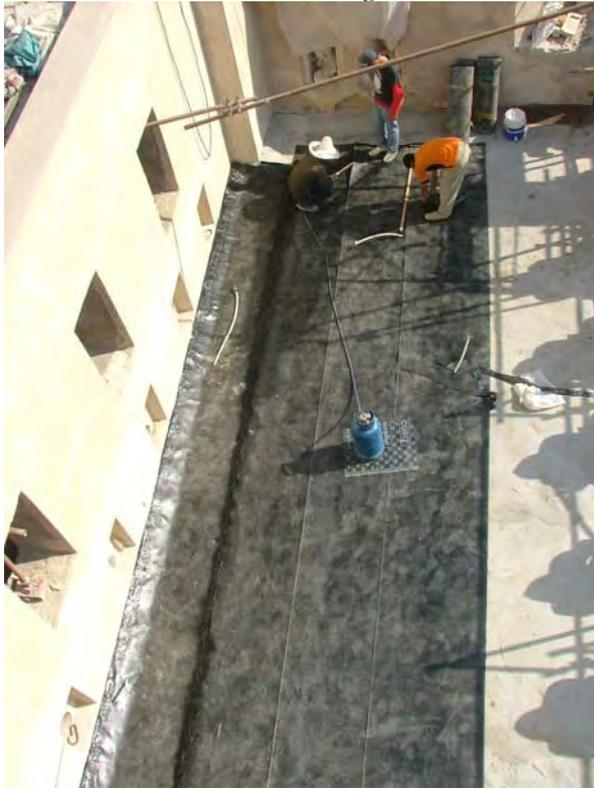
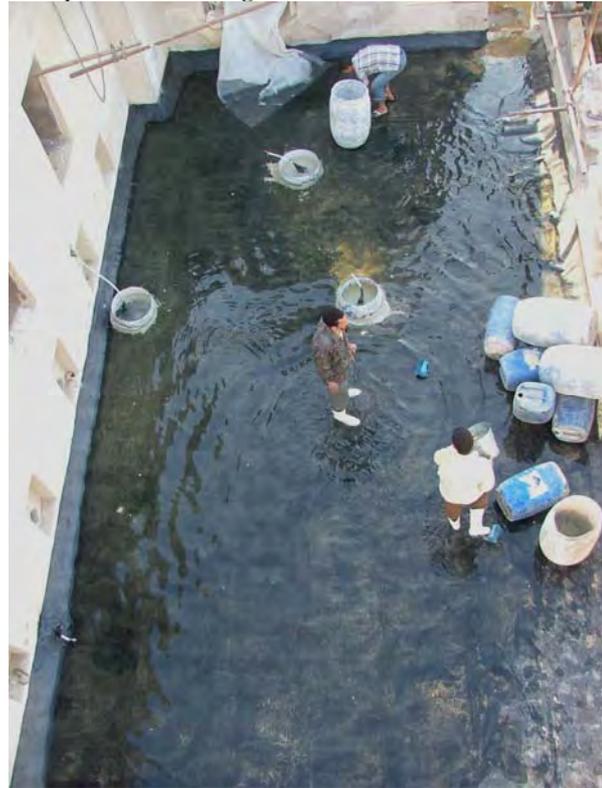
The southern and eastern ceilings were insulated; this completes all roofing and insulation activities.

Insulation activities on the south ceiling and water testing the insulation before applying the upper mortar mix layer

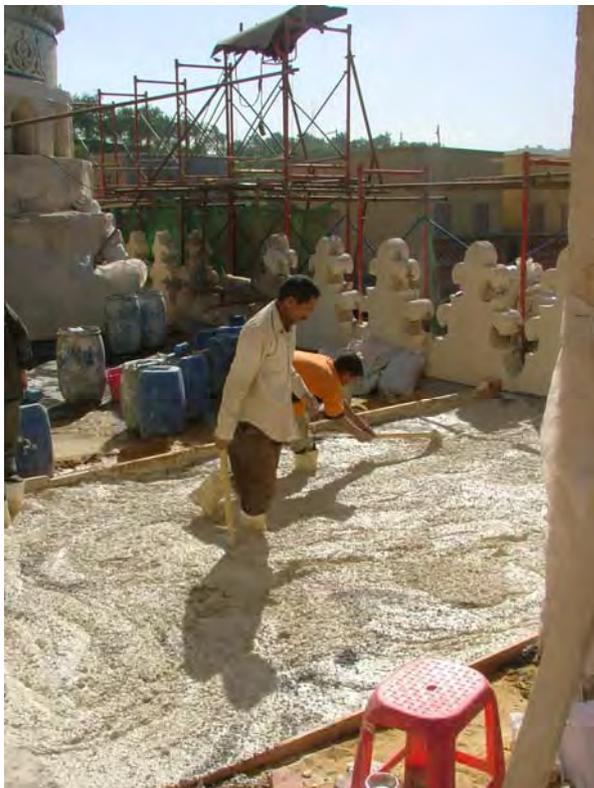
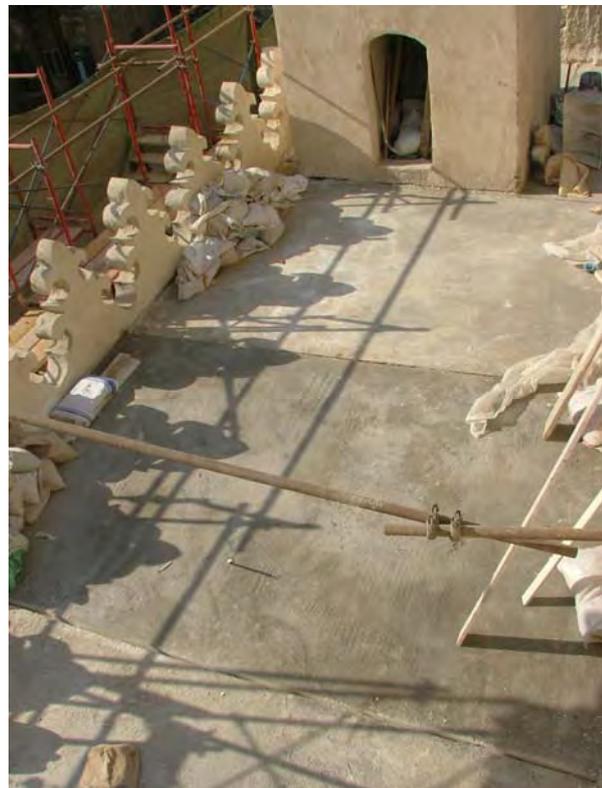
The upper insulation layer during application and after hardening

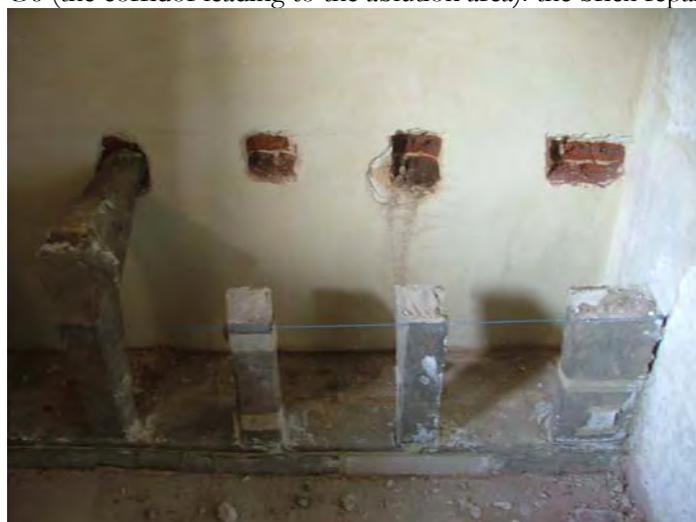
The stone niches in the rooms, (the one in room 1.2 was dismantled earlier to repair the ceilings and the walls), were repaired restored, replacing the damaged or lost ones and cleaning the existing ones.

During erection of the niche in room 1.2

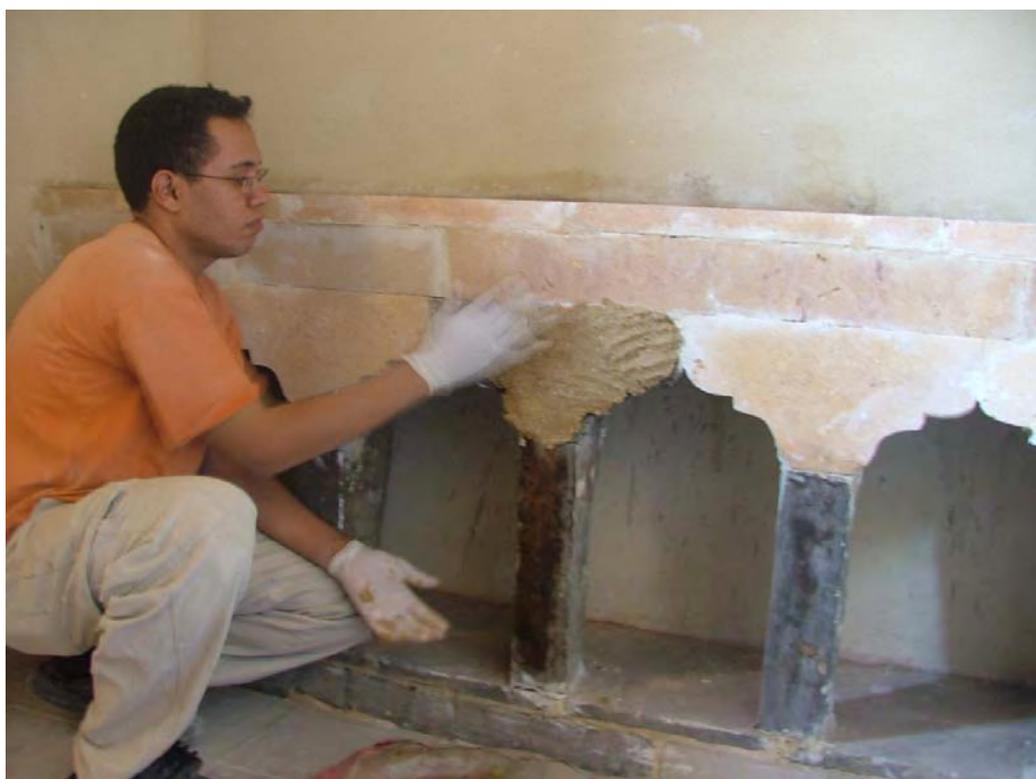
Rooms 1.2 and M1: The rooms around the staircase (rooms 1.2 and M1) were completely restored; after the brick repair activities were finalized and the ceilings restored and repaired, plastering and tiling activities started and were completed, as well as the stone cleaning and plaster cleaning.

Room 1.2 after the niche was installed and during cleaning
