ANNUAL REPORT

“Conservation of the Mosque of Aslam al-Silahdar in Darb al Ahmar, Cairo”

Aga Khan Cultural Services
(Christophe Boleau)

**QUARTERLY PROGRESS REPORT
DECEMBER 2006-FEBRUARY 2007**

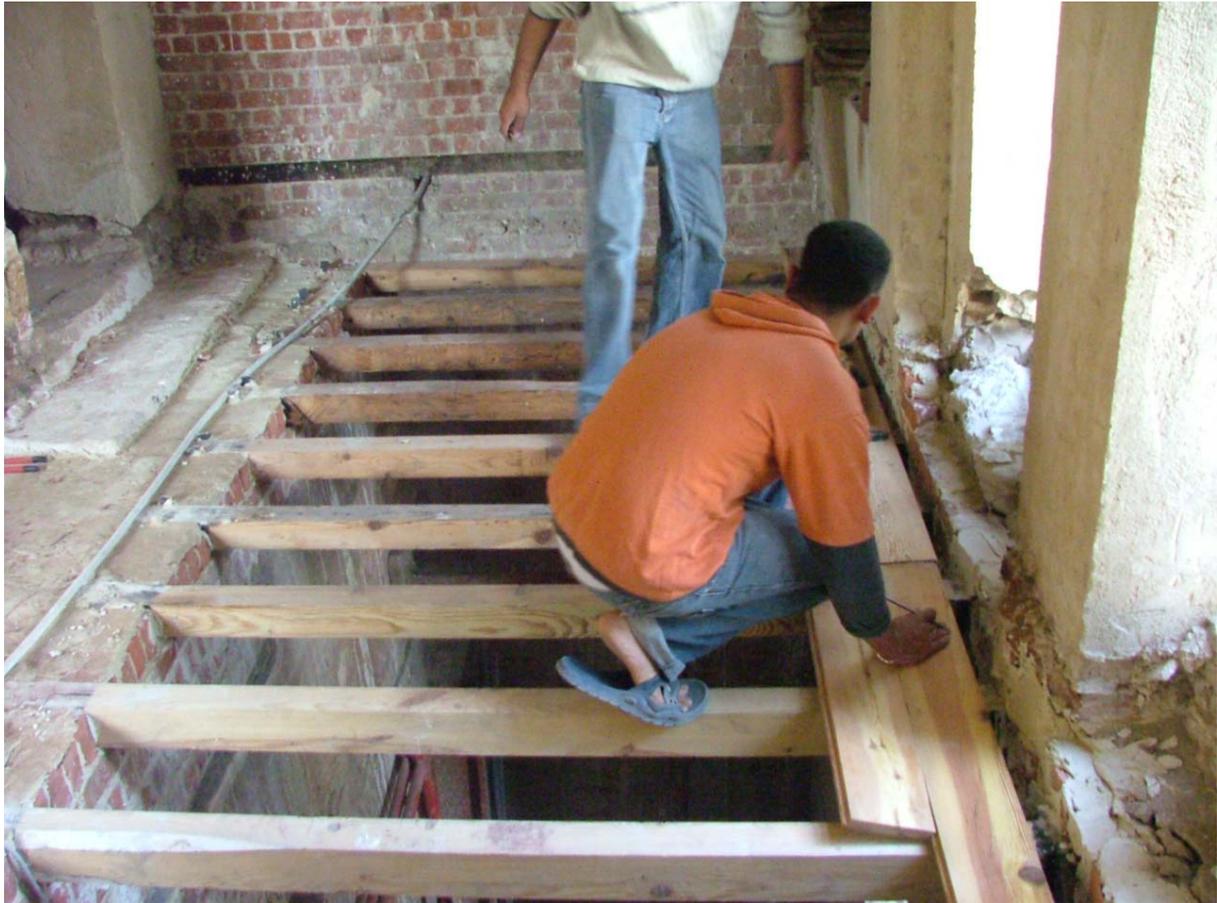
Room M2: the brick repair activities in room M2 was finalized, as well as stitching it to the exterior west wall. The ceiling of the room (also the floor of room 1.3) was in quite a bad condition; the damaged beams and shingles were replaced with new ones.

Wooden ceiling of room M2 (the floor of room 1.3)

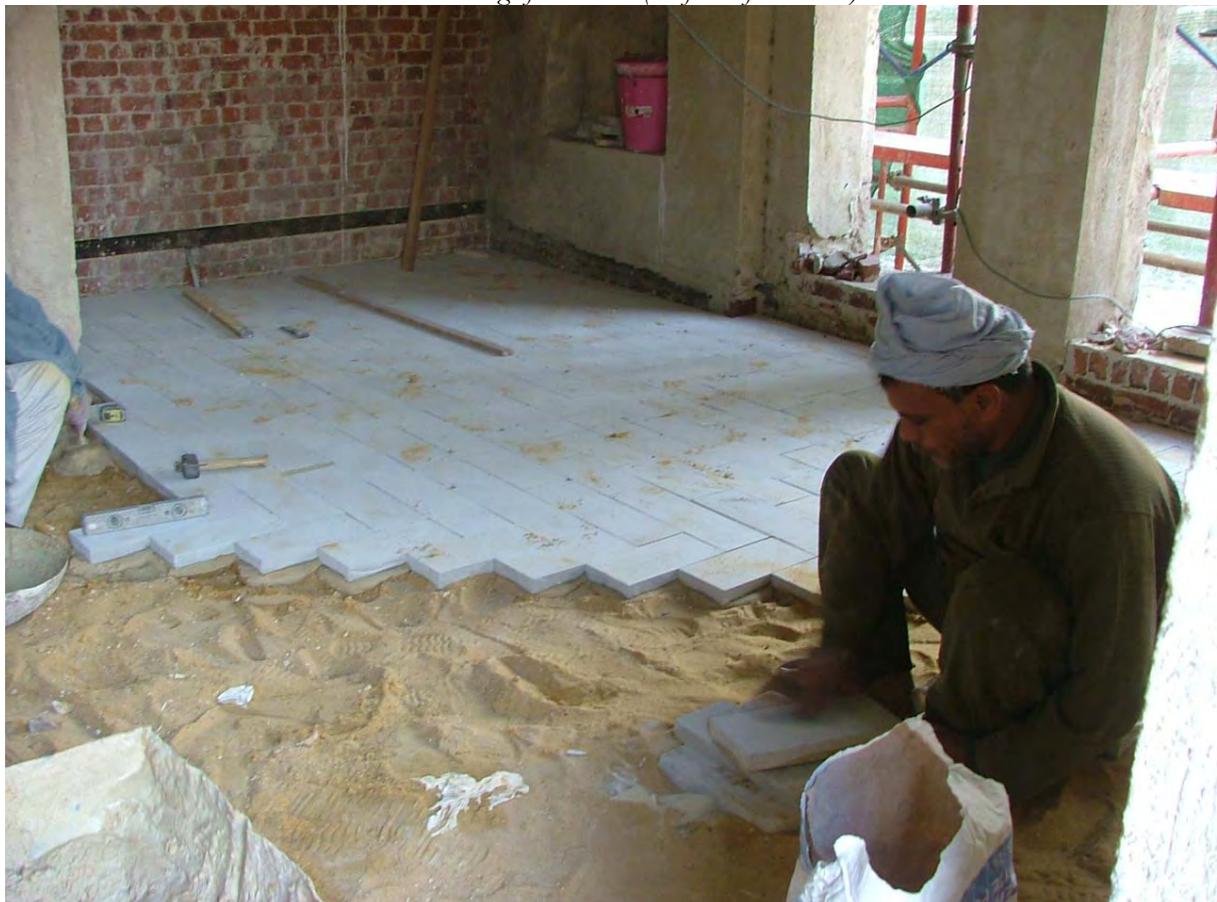
Room 1.3: the brick repair in the room was completed as there was a serious crack between the room and the west iwan. The floor of the room (the ceiling of room M2) was also completed.

Tiling of room 1.3

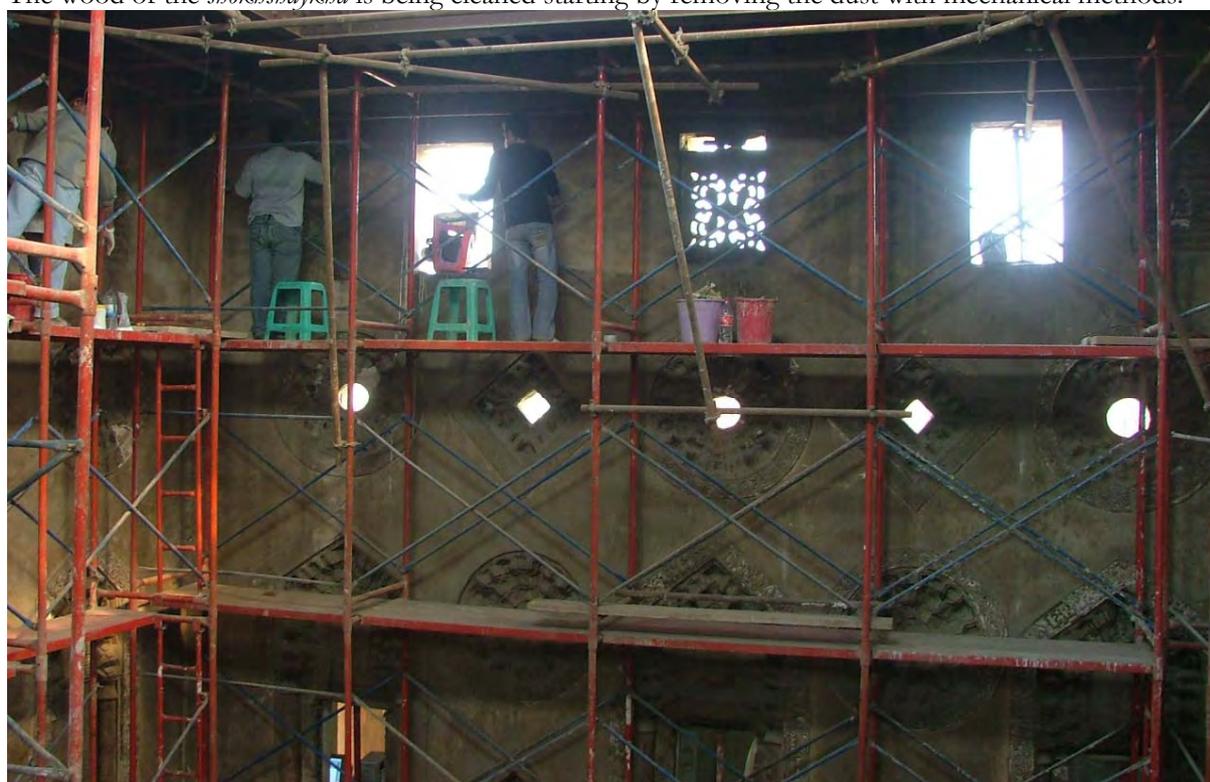
The mosque courtyard during the testing phase

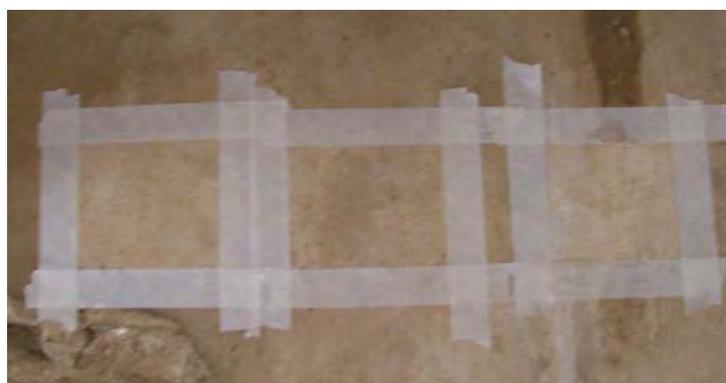
The gypsum plaster was carefully studied and the problems identified. In several areas the plaster is detached from the background brick wall and this needs injection. Also, serious cracks existed and had to be filled. Before the injection activities started, the fine dust covering all the walls was removed with fine brushes. Cleaning tests were also applied to see what kind of method to be applied for cleaning the gypsum. It was decided to use a 2 % ammonium carbonate poultice.

Samples of cleaning the gypsum mortar with poultice and with mechanical cleaning

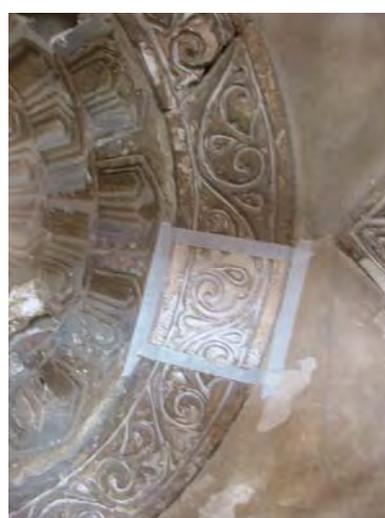
Example of the condition of the gypsum plaster in the courtyard showing serious cracks and detachment

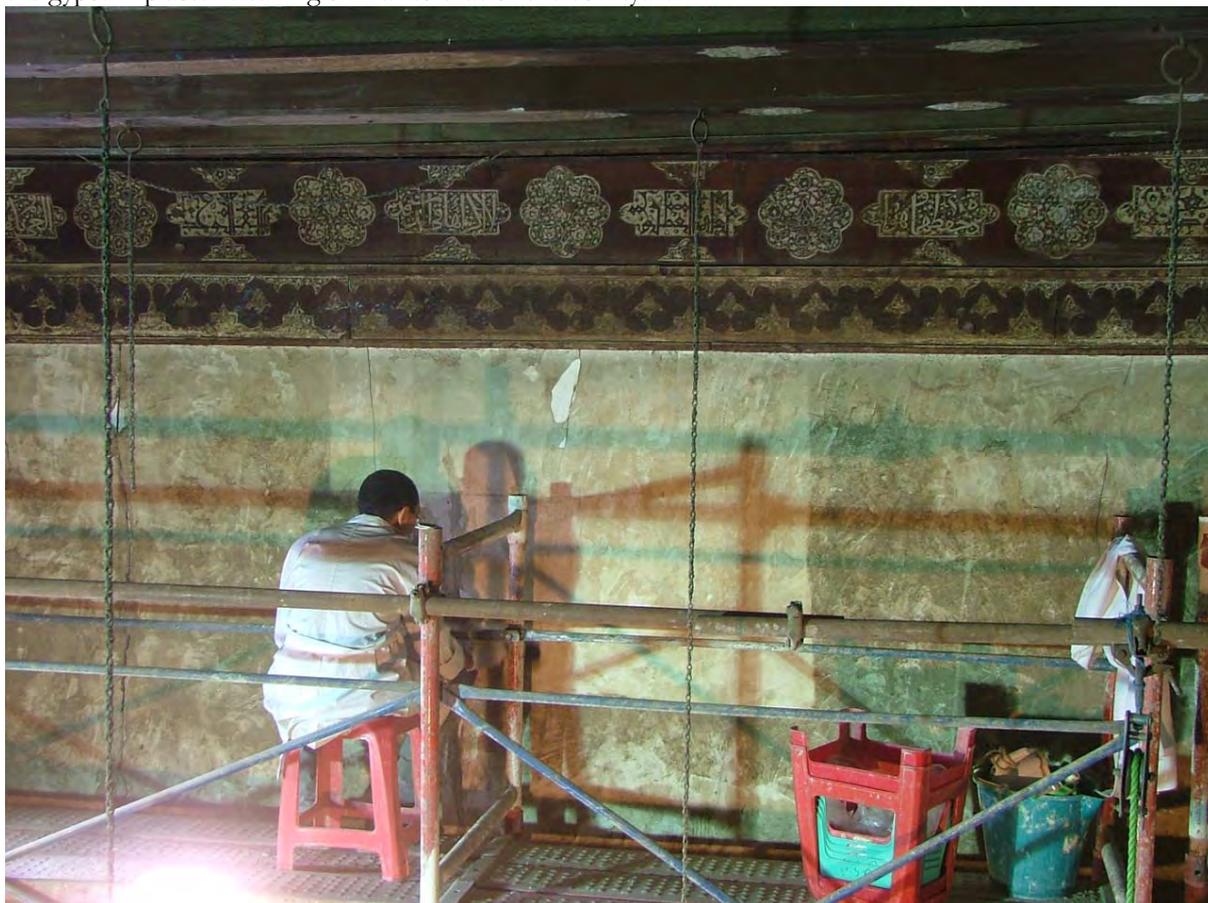
Restoration and conservation activities started also in the East (qibla) iwan. The activities started also with the gypsum plaster cleaning similar to that of the courtyard.

Activities of removing the fine dust from the walls (middle part cleaned; left and right still with fine dust)

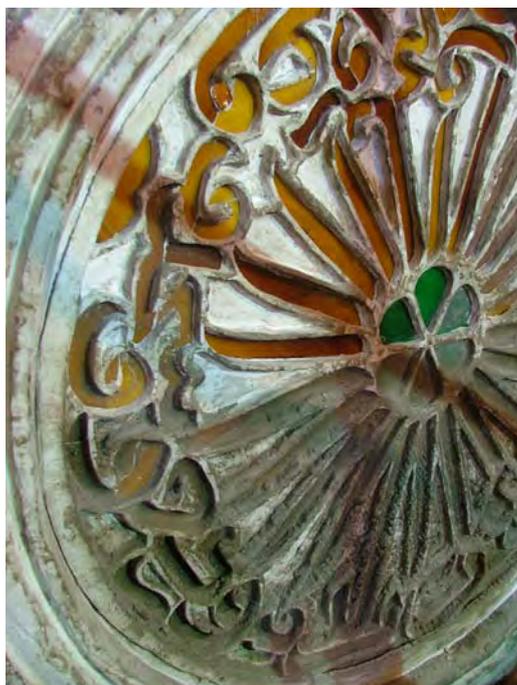
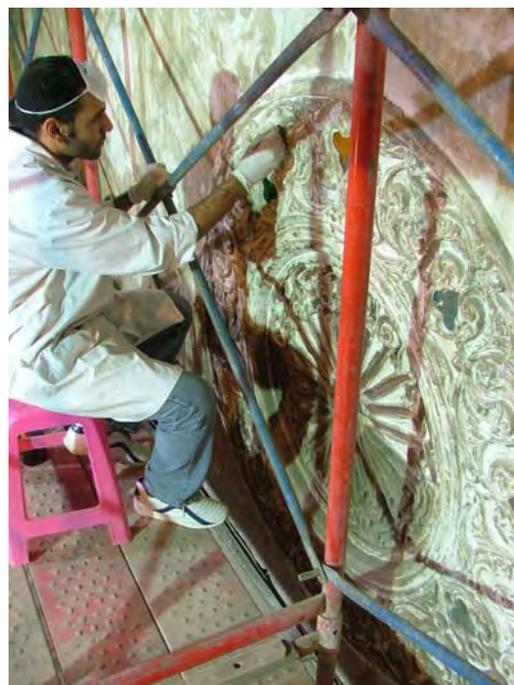
Activities of removing the fine dust from the decorated gypsum roundel in the qibla iwan

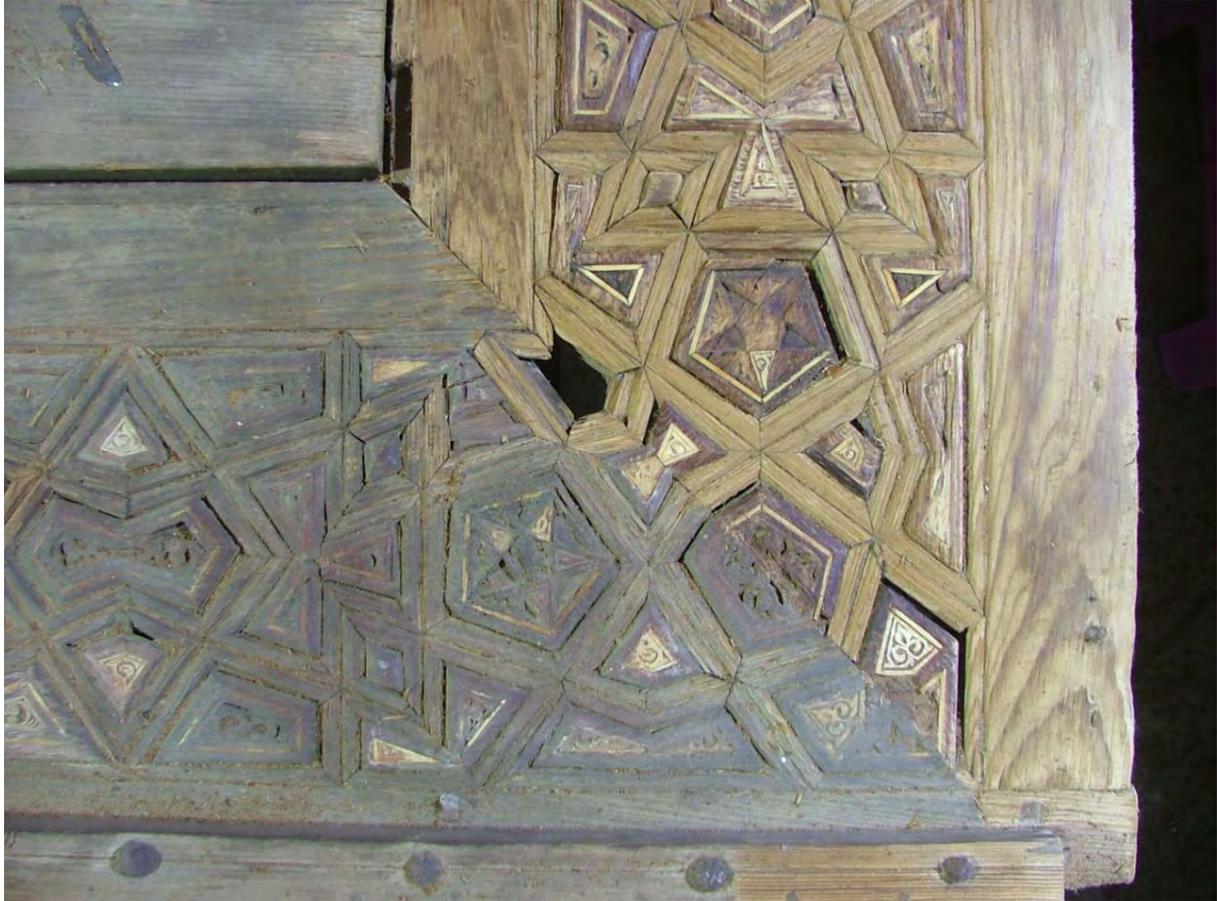
As mentioned in the previous report, the woodwork restoration of doors, windows and shutters is currently in progress and will be proceeding during the following months. In general, depending on the state of conservation of the item, carpentry restoration takes place followed by fine cleaning and conservation of the wooden elements.

Sample of cleaning the wooden shutters of the niches of the qibla ivan
