**DEPARTMENT OF THE INTERIOR
U.S. GEOLOGICAL SURVEY**

**Preliminary Report of Investigations
of the Central Chile Earthquake
of March 3, 1985**

Open-File Report 85-542

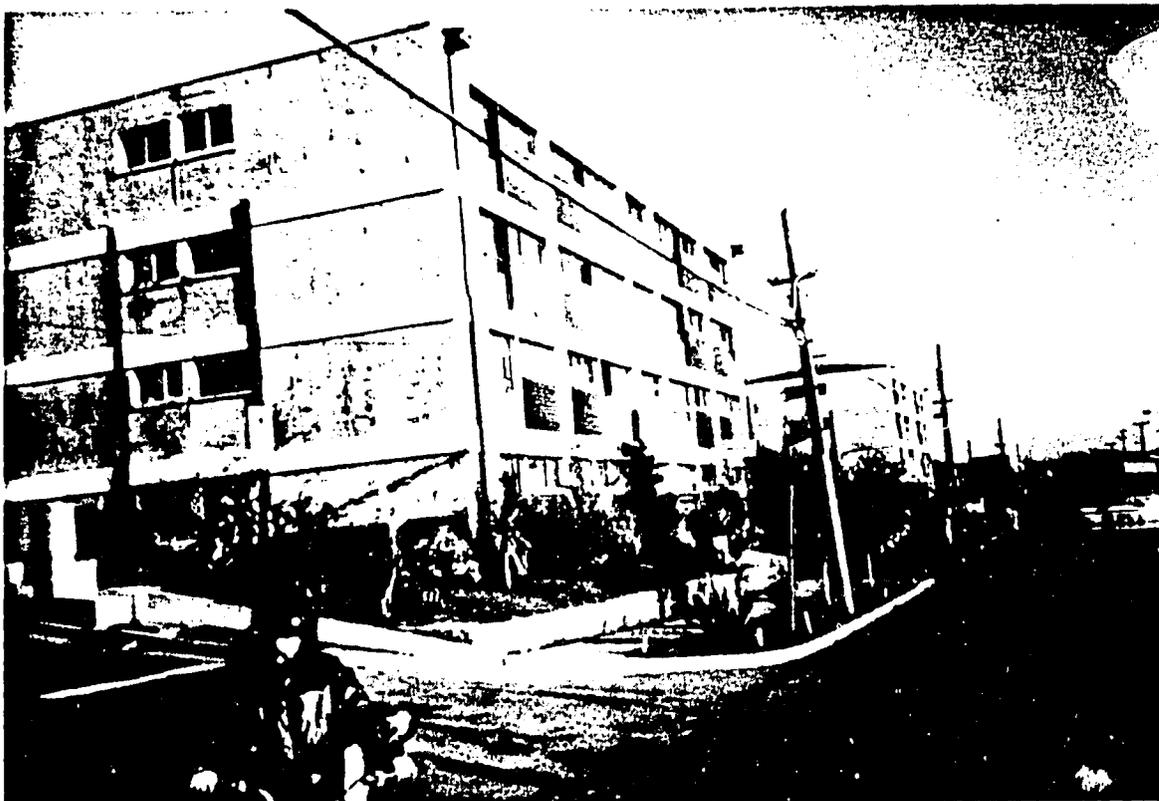
The apartment buildings in figure 12 located only two blocks from Claudio Vicuña Hospital suffered no damage.

Figure 12.—These apartment buildings near Claudio Vicuña Hospital were not damaged.

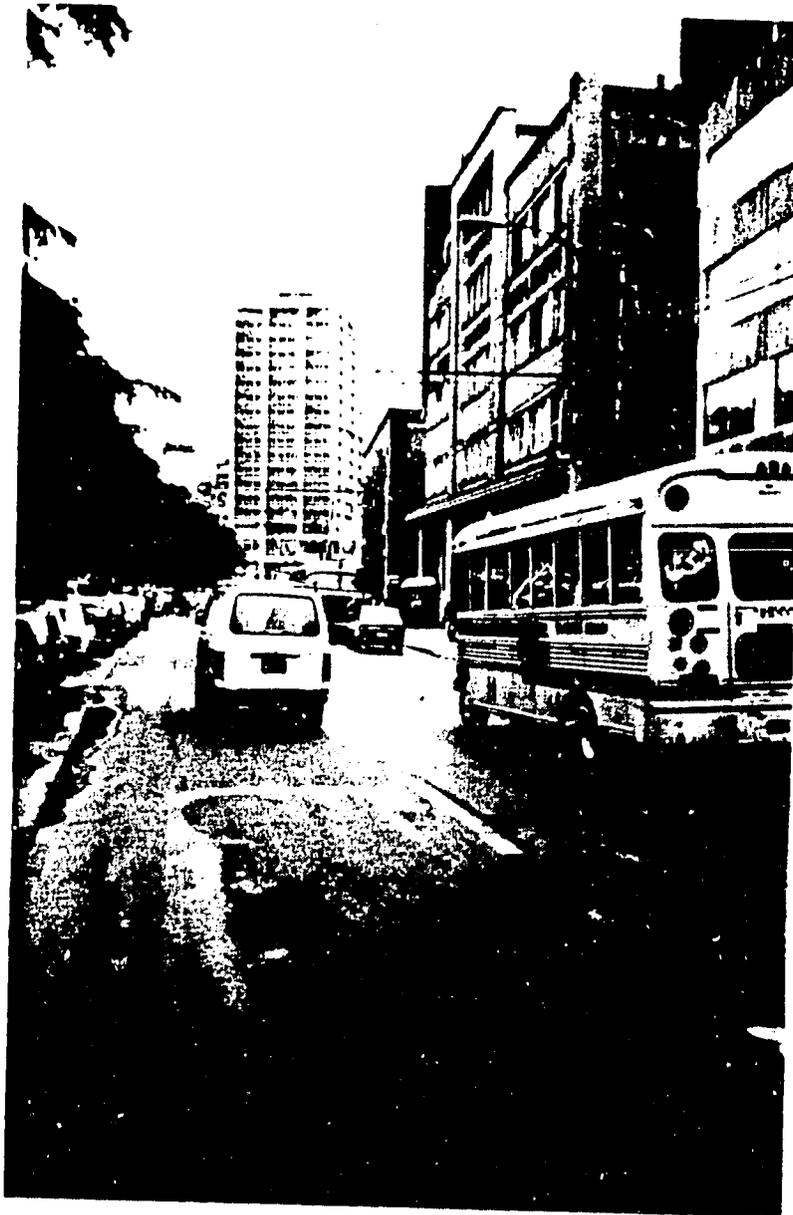
Near this hospital, other structures, particularly modern symmetrical structures with center shear wall core and columns in the exterior perimeter (fig. 16) performed well. This type of construction has been applied also in Vina del Mar and Santiago. No damage has been reported on these types of structures in those towns either.

Figure 16.--A modern symmetrical reinforced concrete structure near the Sermana Hospital. The building had a reinforced concrete core shear wall and columns around the perimeter. No damage was reported in this structure or other similar structures in Viña del Mar and Santiago.

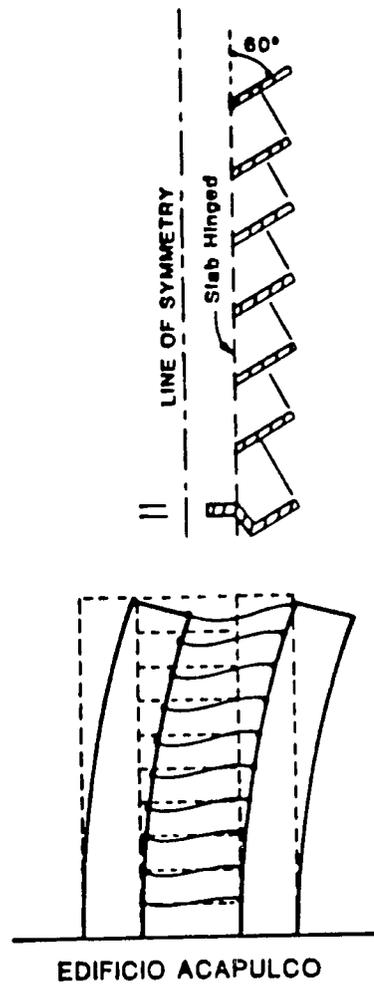
Figure 21.--Qualitative behavior of Edificio Acapulco.

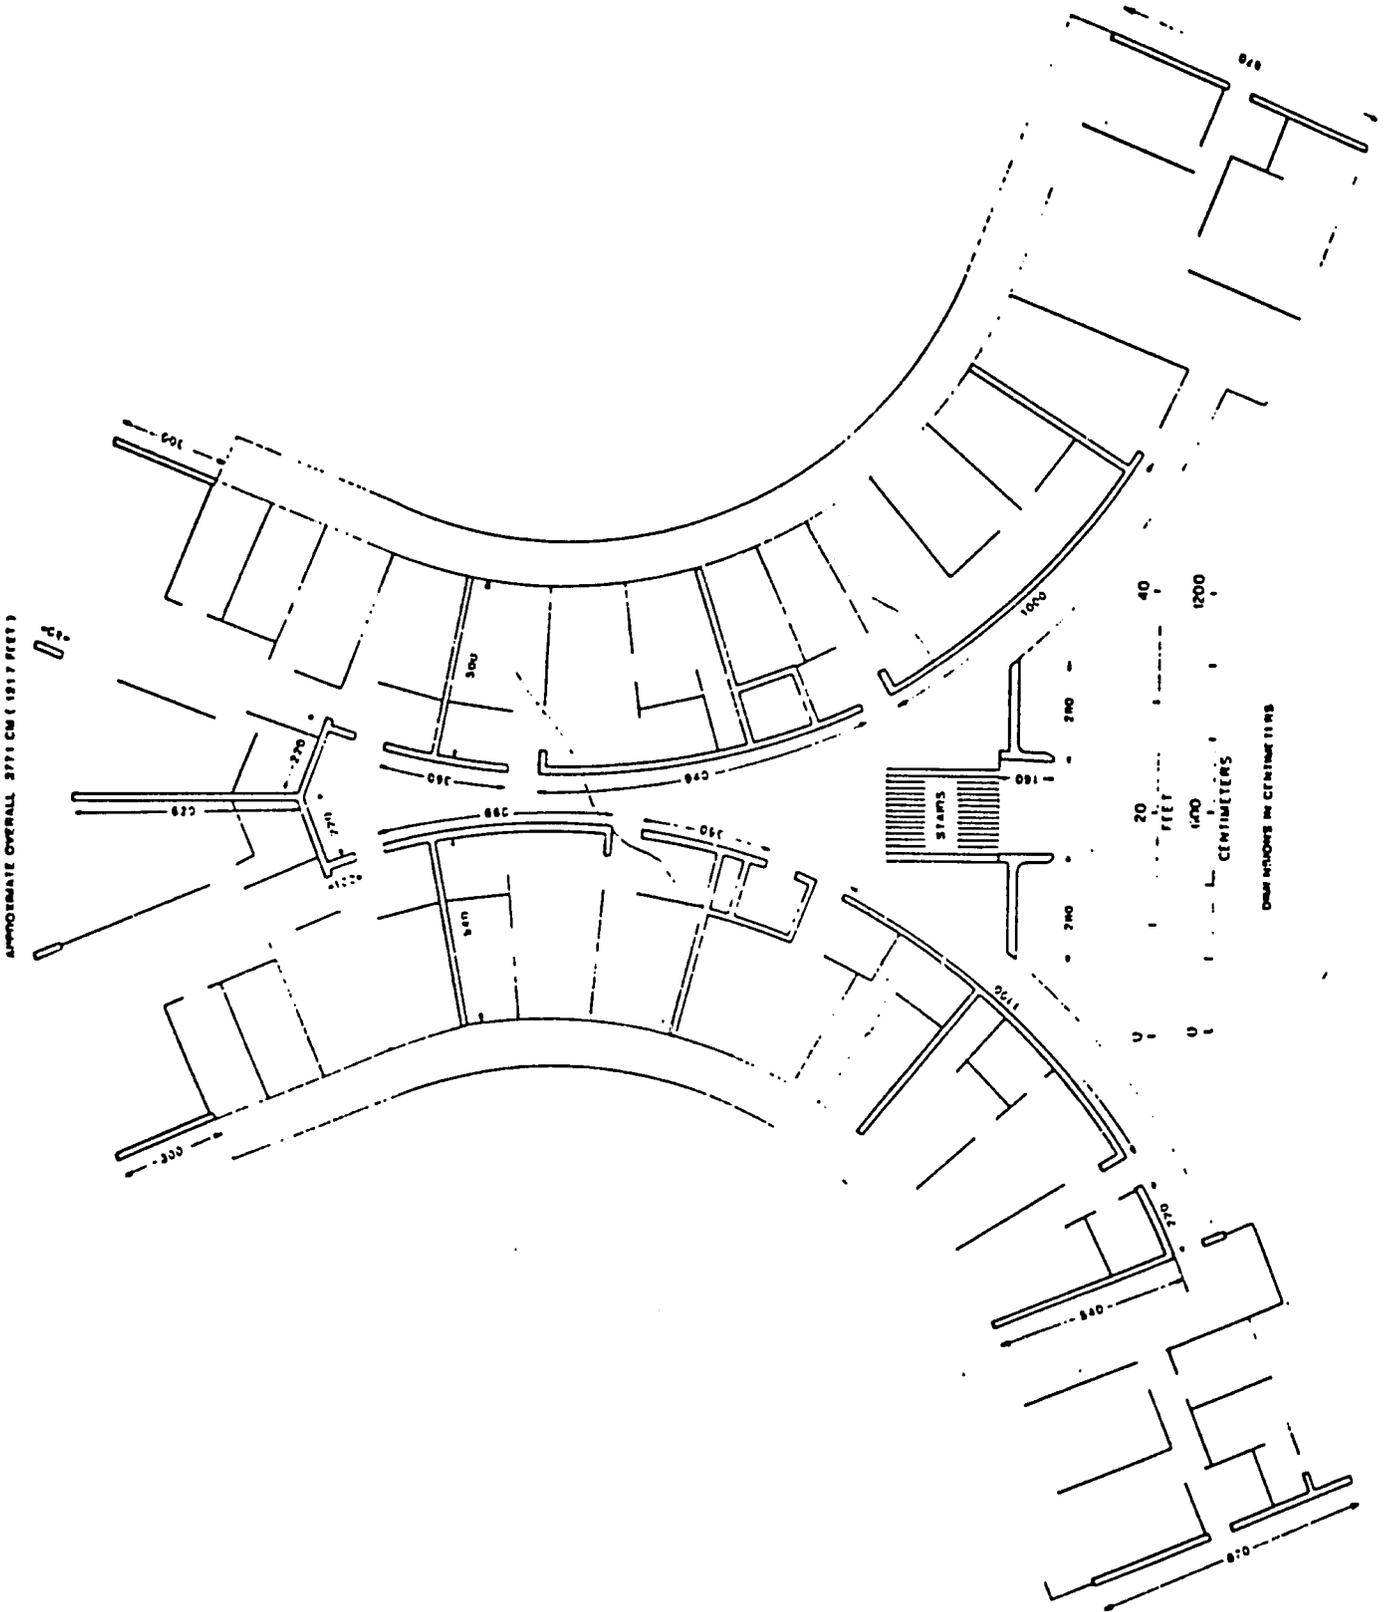
On the coastal end (west) of Vina del Mar and its suburb Renecá, several low rise buildings (5-15 stories) with unique architectural configurations suffered damage. Of these structures, (three are particularly significant) Edificio Acapulco and Edificio H'Angoroa, both on the beach and next to one another, were severely damaged. Locations of these buildings as well as others in the immediate vicinity are qualitatively shown in figure 18. Edificio Acapulco (fig. 19) had very serious cracking on the exterior shear walls (fig. 20). The floor slabs of the building were completely "hinged" and the structure, in essence, behaved as shown in figure 21. Edificio H'Angoroa (fig. 22), on the other hand, had fifteen stories of walls and slabs cracked continuously throughout each its floors. The cracks and extensive damages were concentrated particularly in the right wing as qualitatively shown in figure 23.

Figure 23.--Qualitative propagation of cracks in Edificio H'Angoroa.

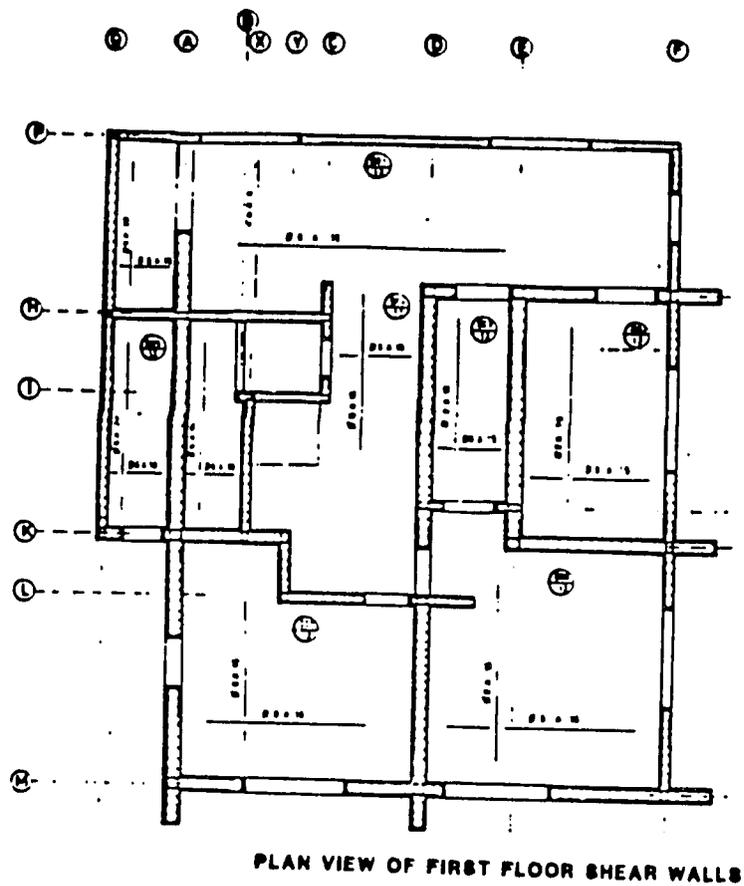
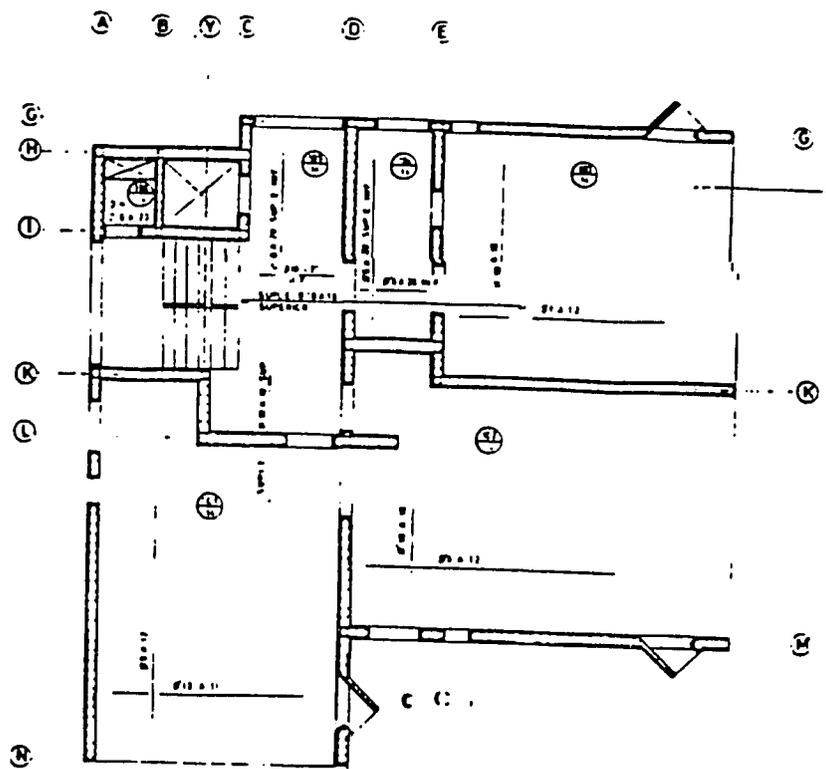
The third structure, Edificio El Faro, on top of the sand dunes of Reneca was a shear wall structure constructed on a continuous wall footing foundation. The foundation was not embedded effectively. The footing thickness was consistently 0.50 meters and the footing wall thickness varied between 0.20-0.30 m (only in one location the wall of the footing was 0.85 m thick, while generally the footing wall height is 2.5 m). The footings extended throughout the whole plan of the structure, leaving very small uncovered areas; therefore, for all practical purposes, the footing acted as a mat of 0.50 m thickness and with openings. The highly unsymmetrical layout of the shear walls is exhibited in figure 24. The total floor area accommodating three units of apartments per floor was 140 m². The total weight of the structure was estimated to be 800-900 kips. At the entrance floor level there was approximately 11.5 m² of shear wall in each direction. In the upper floors the shear wall area was approximately 5.50 m² in each direction. If

Figure 24.—Plan view of the shear walls of Edificio El Faro - on the hilltop of sand dunes of Reneca.

only direct shear forces are considered, the available shear walls appear to be sufficient even when minimum concrete shear resistance is considered. However, preliminary evaluations point out that the structure may have been subjected to rocking and uplift, particularly since its foundation had little or no effective embedment. Also, it may have been subjected to torsional effects. Considering the fundamental period of the structure incorporating soil structure interaction as compared with that of sand, it is totally conceivable that the structure was also in resonance. During the earthquake, the walls in the first floor of such a structure were completely crushed and the structure tilted off its vertical axis by 12-15° (fig. 25). As a consequence, the structure was dynamited to level it off on the ground. Further detailed analysis into the failure aspects of this structure is being performed by the author.

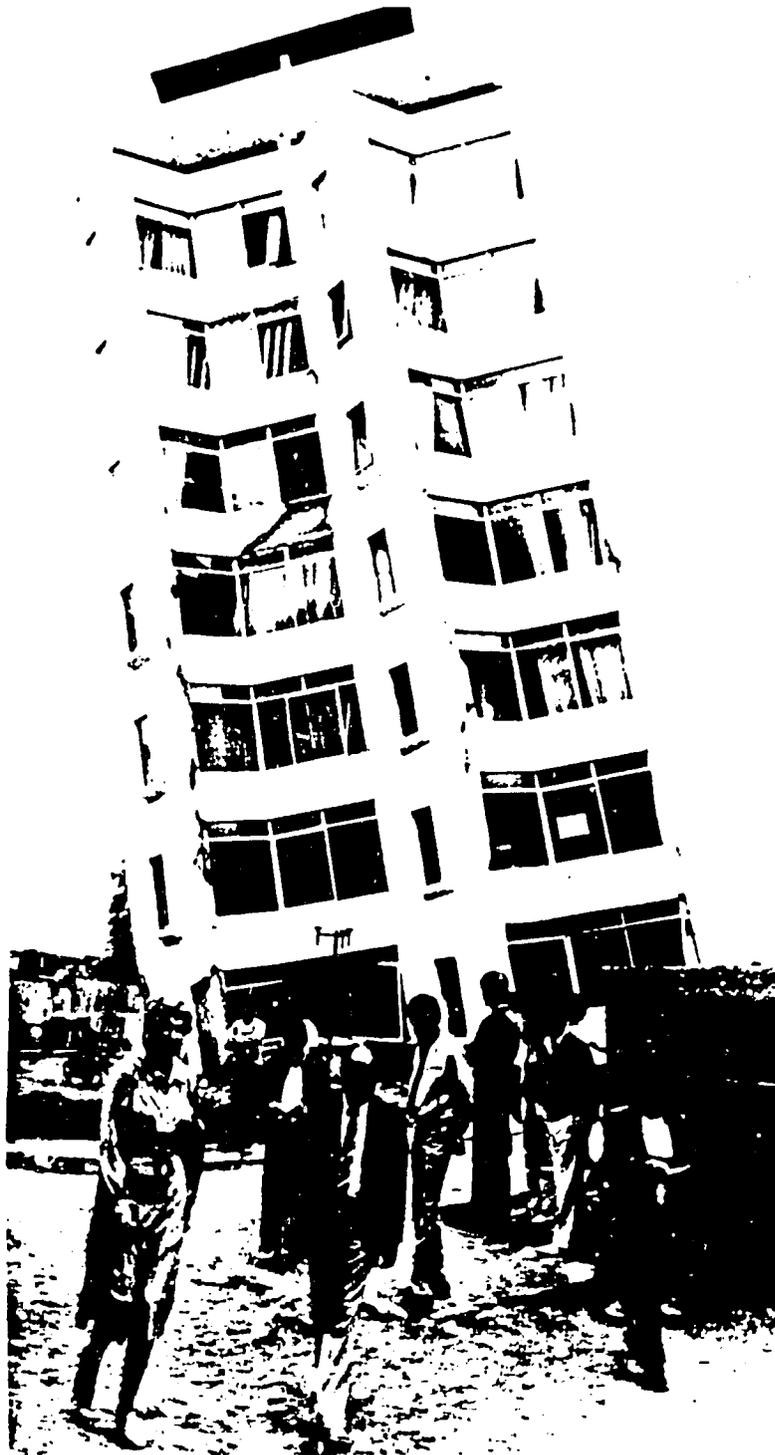
Figure 25.--Tilted view of Edificio El Faro before it was dynamited. The first story shear wall had been completely crushed.

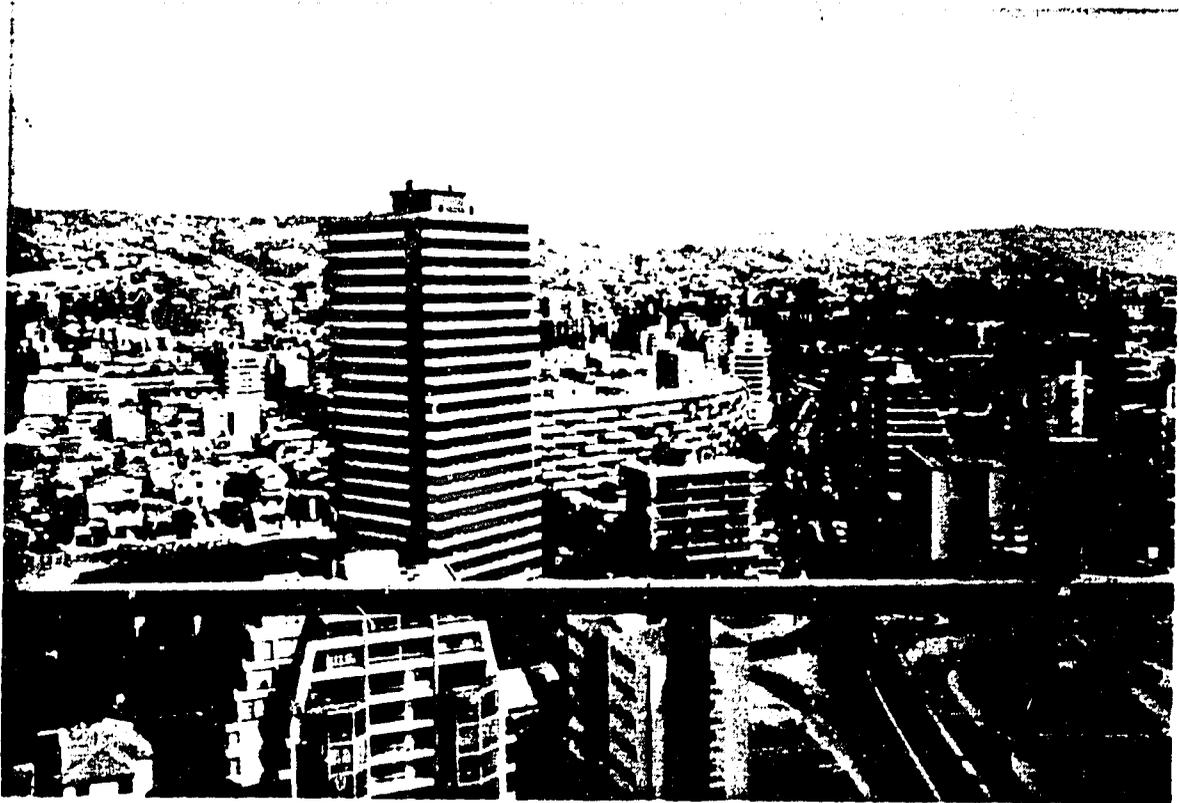
Only two blocks away from the structures in figure 18, the 23 story symmetrical structure (fig. 30) with central core shear wall performed well without distress.

Figure 30.--Another symmetrical structure with central concrete shear wall core on Avenue San Martin performed well.

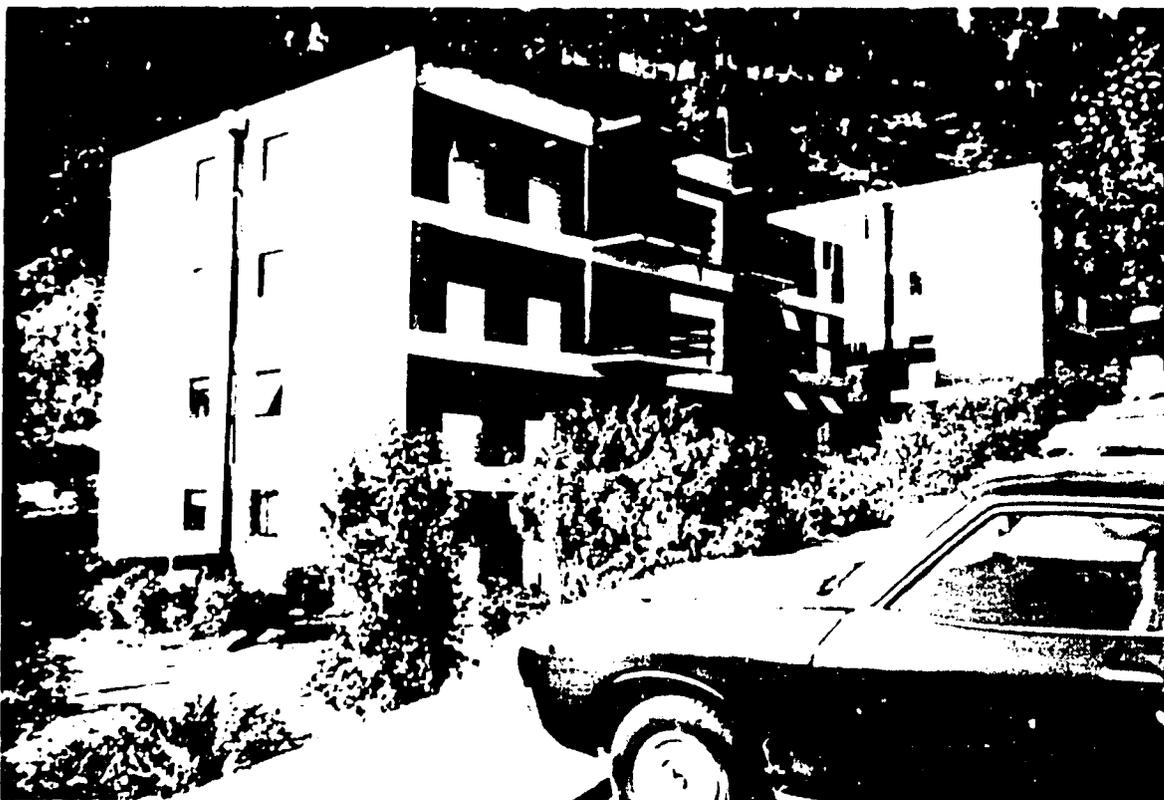
- Fig 1. Two Type B structures (fig. 34) at entrance to the Canal Beagle Subdivision were not damaged at all. These two structures were constructed on relatively flat land at the foot of one of the ridges.

Figure 34.--These two Type B structures at entrance to the Canal Beagle subdivision were not damaged at all. These two structures were constructed on relatively flat land at the foot of one of the ridges.

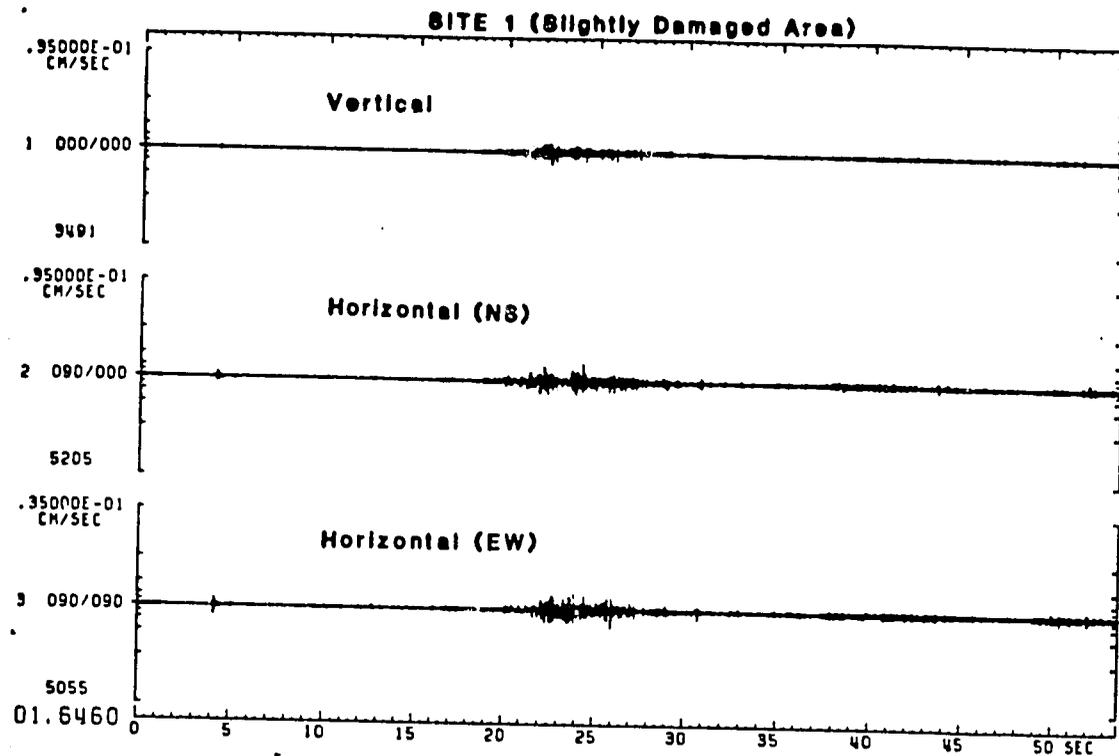
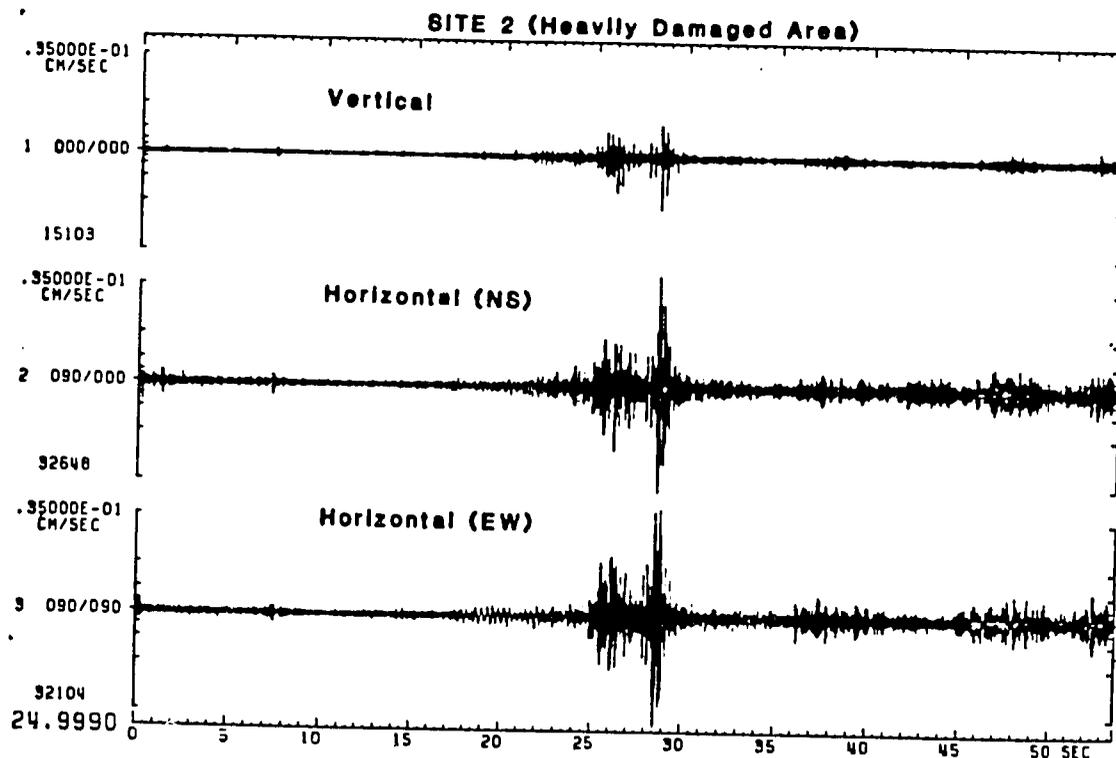
Figure 40.—Comparison of three components of velocity responses of noise at two sites at Canal Beagle (Site 1 was slightly damaged, whereas Site 2 was heavily damaged). Although this is a very limited and preliminary result, it indicates qualitatively that there is amplification at Canal Beagle topography.

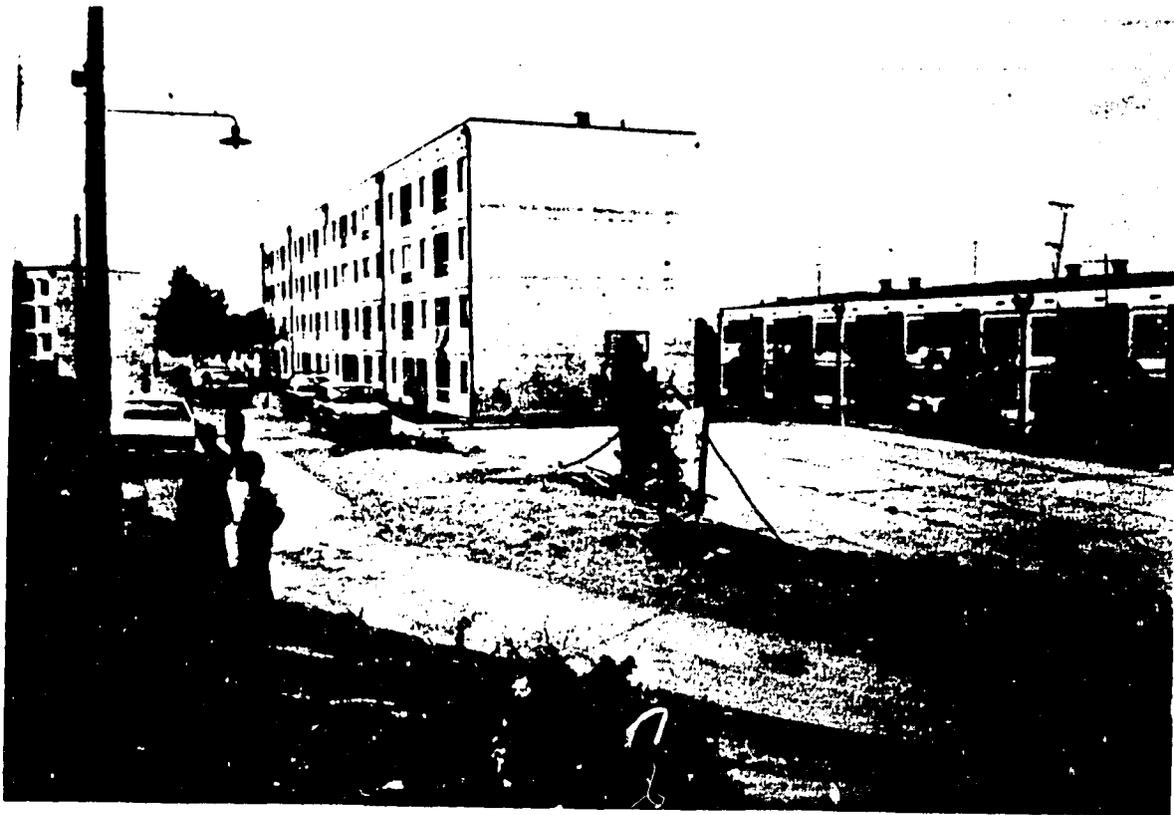
Figure 52.--Single story social housing structures in Melipilla. These structures were not damaged. They are in the next block from the three story reinforced framed structures that were damaged.
