## Endline Survey Report, Emergency Shelter and WASH interventions for IDPs living in unfinished and abandoned buildings in Duhok Governorate, Kurdistan Region of Iraq

Endline Survey Report, Emergency Shelter and WASH interventions for IDPs living in unfinished and abandoned buildings in Duhok Governorate, Kurdistan Region of Iraq

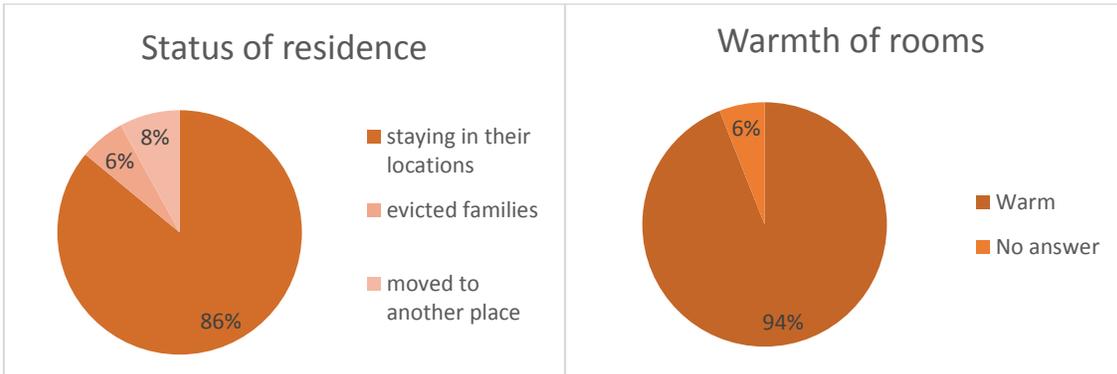
The majority of buildings (94%) are warm after installing doors and windows, there were no response of 6% of buildings because the buildings were empty or the landlords did not agreed to sign a contract for staying these IDP, by comparing with baseline 5% of buildings were warm, 31% of the buildings were somehow warm, and 64% of buildings were cold.

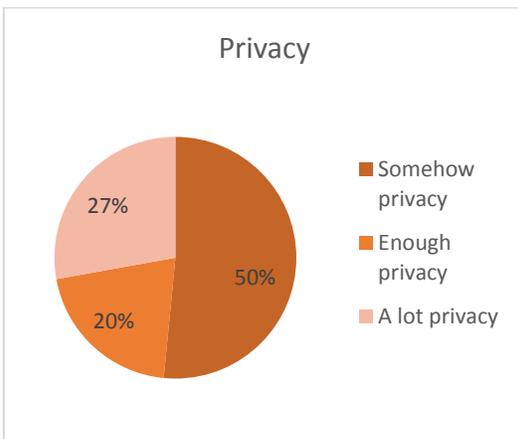
With regards to privacy, 50% of female respondents argued that their dwellings offer them somehow privacy, with the 20 % of respondents saying that they had enough privacy- 27 % of respondents said that they have a lot of privacy- as the family was residing in one room.
