TECHNICAL REPORT

THE GLACIAL LAKE HANDBOOK

REDUCING RISK FROM DANGEROUS GLACIAL LAKES IN THE
CORDILLERA BLANCA, PERU

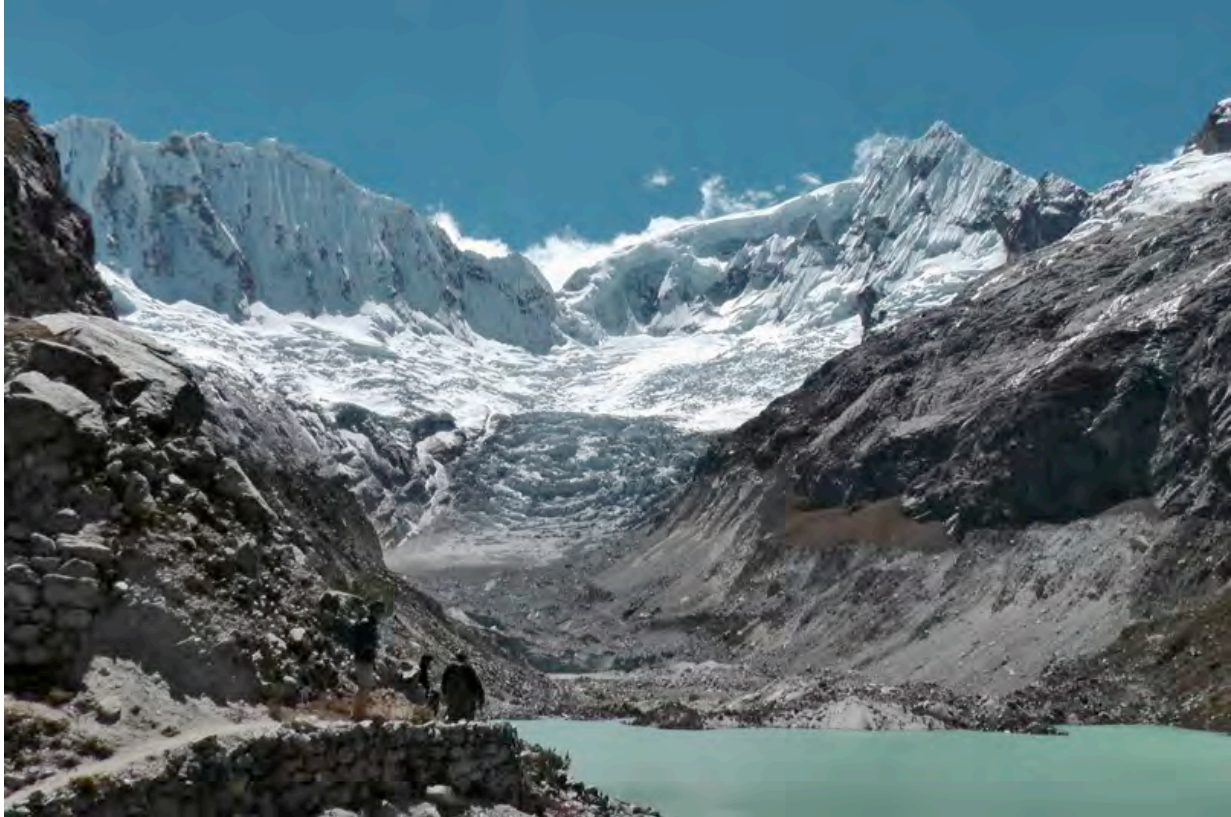
Llaca Lake, Huascarán National Park, Peru, is dominated by ice-covered peaks. Large hanging glaciers suspend from the shoulder of the peak on the right (Ranrapalca, 6,162 meters). Flatter, thicker glaciers lie below. As the glacial tongue retreats, it leaves Llaca Lake where the glacier used to be. Large icefalls from the tops of these peaks are capable of reaching the lake.

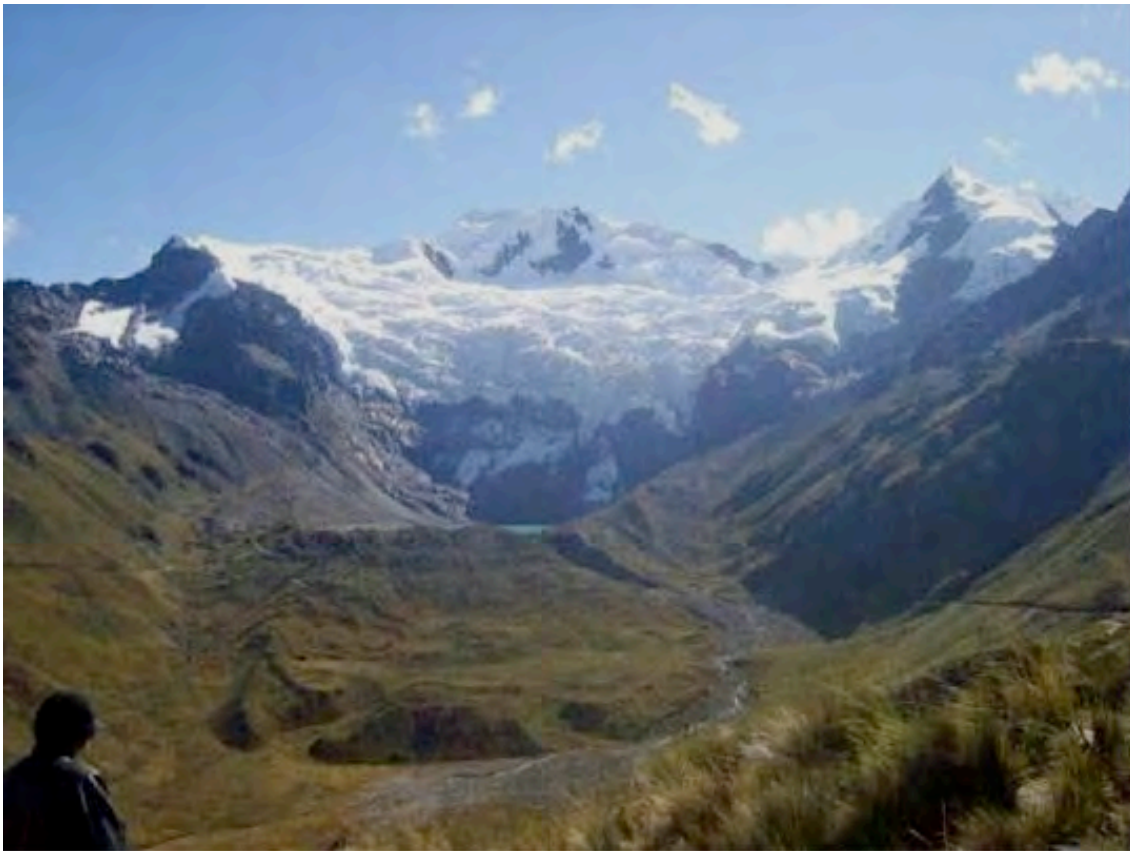
Large hanging glacier over Lazo Huntay Lake in the Cordillera Huaytapallana, in central Peru, 1990. Photo: César Portocarrero

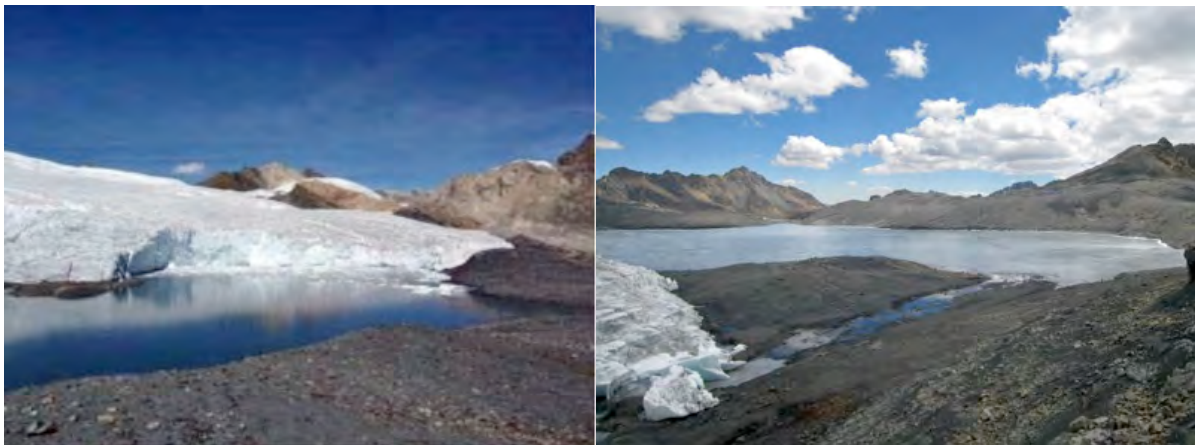
Pastoruri Glacier, Peru, in contact with an emerging lake, showing the calving process. Photos: César Portocarrero (left), Daene McKinney (right)

As glaciers retreat, it often leaves behind empty spaces that are gradually filled with meltwater and eventually form lakes. As these lakes are still in direct contact with the glacier tongue, the temperature difference between the water and the glacier produces an eroding effect that eventually causes the ice to break off and cascade into the lake. This can create a dangerous surge wave, depending on the mass of the ice and the volume and shape of the lake. This phenomenon has caused natural disasters in many places. Examples include the event in [Case Study 5.1: Palcacocha Lake](#), which flooded the city of Huaraz. Also in [Case Study 5.16: Lazo Huntay Lake](#), which flooded the town of Huancayo, and, more recently, in an unnamed lake at the foot of the Nevado Chicón (see [Case Study 5.17: Riticocha Lake](#)).

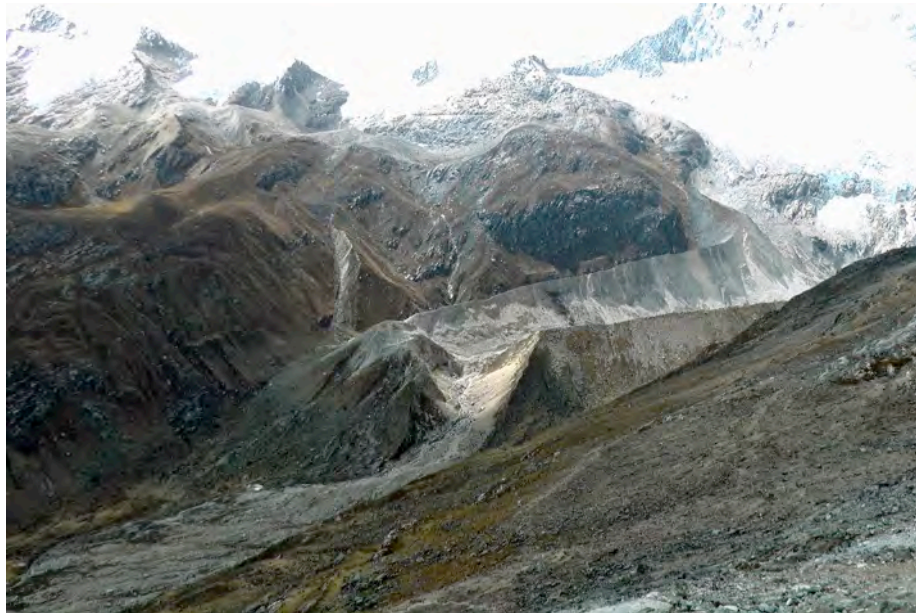
The terminal and lateral moraines that contain Palcacocha Lake, showing the 1941 breach that released a GLOF that devastated the city of Huaraz. Photo taken in 2013. Photo: John Harlin

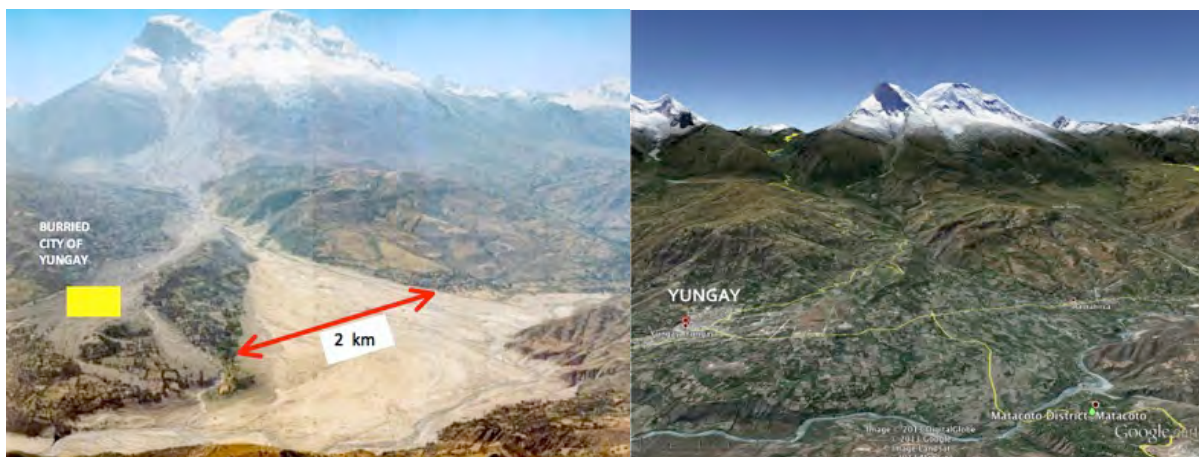
Left: Nevado Huascarán in May 1970 after a 7.9 magnitude earthquake triggered a massive avalanche from the north peak that turned into a debris flood. Approximately 6,000 people are believed to have died in the flood. Photo: Walter Welch.
Right: A Google Earth view of Yungay and Huascarán in 2013. Many homes have been built on the debris of the 1970 flood.

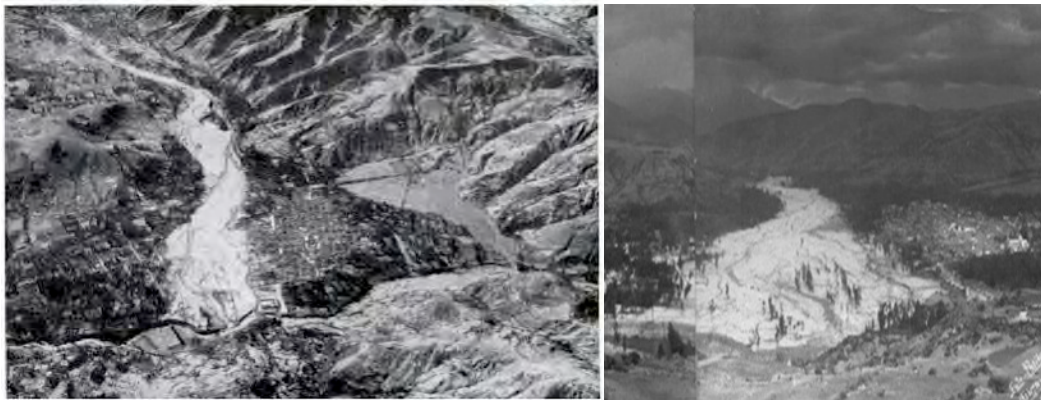
The GLOF's destructive path through the city of Huaraz in 1941. Servicio Aerofotográfico Nacional del Perú

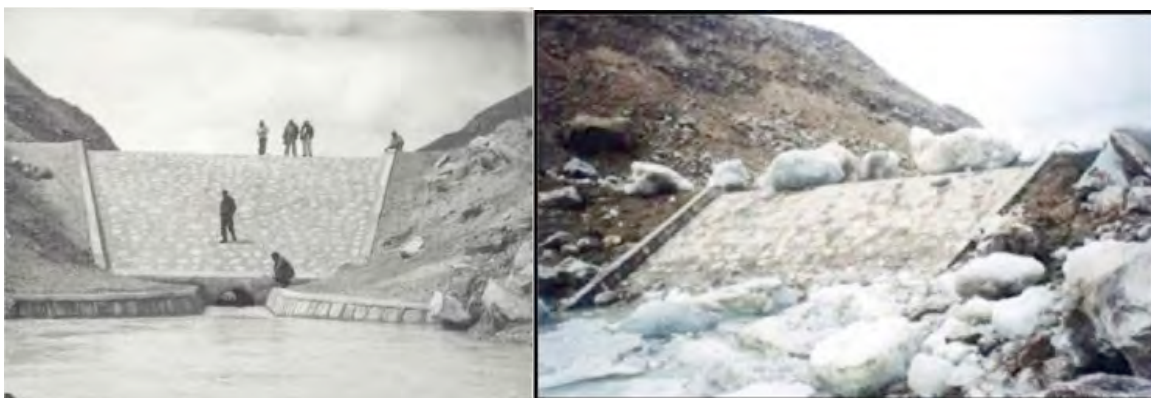
The safety dam on Palcacocha Lake as construction was being completed in 1974 (left) and with ice debris following the 2003 landslide that launched a flood that was mostly contained by the dam. Left photo: César Portocarrero. Right: Glaciology Unit Office Archives

At that time the Lakes Safety and Glaciology Unit decided to lower the lake's level by one meter, which they concluded was enough based on its low volume of 500,000 m³. In 1974, they installed a 48 inches (1,219 millimeters) diameter steel pipe capped by a new, tightly compacted dirt dam 8 meters high. They also strengthened the right side of the moraine outflow to reduce erosion from outbursts. This provided a freeboard of 8 meters in the lake as a buffer against future surge waves.

Nineteen years later, in March 2003, the moraine along the lake's left flank slipped, launching a violent diagonal wave that traversed the lake and heavily eroded the reinforced dam. Photographs, taken five days after the 2003 event, show chunks of ice still sitting on the 8-meter dam, and water levels still 4 meters above its normal level. This event frightened the Huaraz city authorities. The regional government quickly repaired the damaged structures.

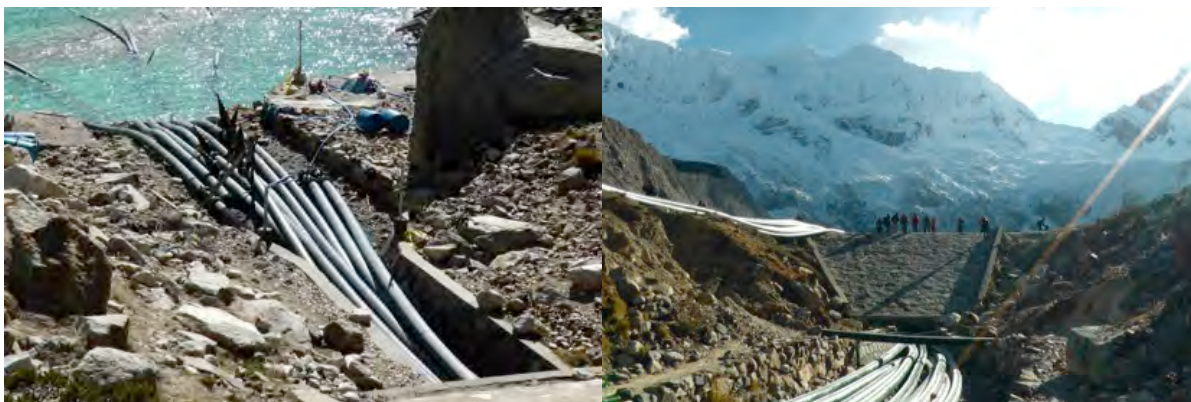
Palcacocha Lake in 2013 showing the siphon pipes entering (left) and exiting the tunnel under the dam. Photos: John Harlin

The Glaciology and Water Resources Unit prepared a plan in 2010 to lower the water level of Palcacocha Lake by an additional 15 meters. The cost estimate for this work came in at US\$4 million. Later in 2010, Peru's National Water Authority unexpectedly relieved the Glaciology and Water Resources Unit from responsibility for glacial lakes and turned the lake-lowering plan over to the regional government in Ancash. Ancash officials did not think they could authorize these funds quickly, so they searched for an interim, cheaper way to reduce risk from the lake. They decided to use six 10-inch (254 millimeters)-diameter pipes about 700 meters long to siphon off approximately 7 million cubic meters of water. Two years later (in 2011), the siphons started draining the lake though at a slower rate than planned due to design defects. As of July 2013, the water level had been lowered approximately 3 meters, roughly half the amount needed before the drainage ditch can be started.

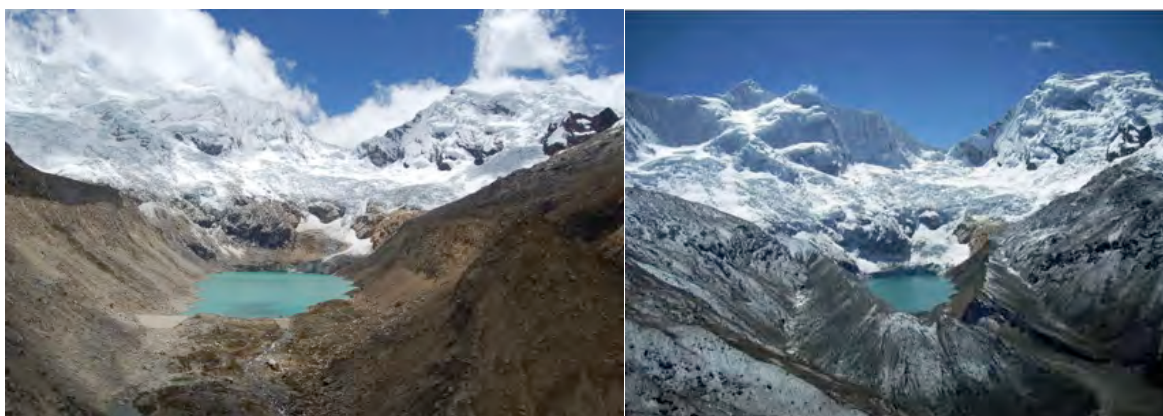
Left: Palcacocha Lake in 2013 taken from the top of the moraine. The two safety dams can be seen. The dam on the right contains the drainage pipes. Photo: César Portocarrero. Right: Palcacocha Lake in 2008 showing its enclosing moraine; the 1941 breach is visible in the lower right. Photo: Colette Simonds

In an effort to mitigate the risk of the lake, two 36 inches (915 millimeters) steel pipes were placed in the notch that had been cut into the moraine by the GLOF. Then, an 8-meter rammed earth dam was built over the top. These safety works continued working properly until the May 31, 1970, earthquake (magnitude 7.9) destroyed the dam's foundations, breaking the drainpipes installed underneath.

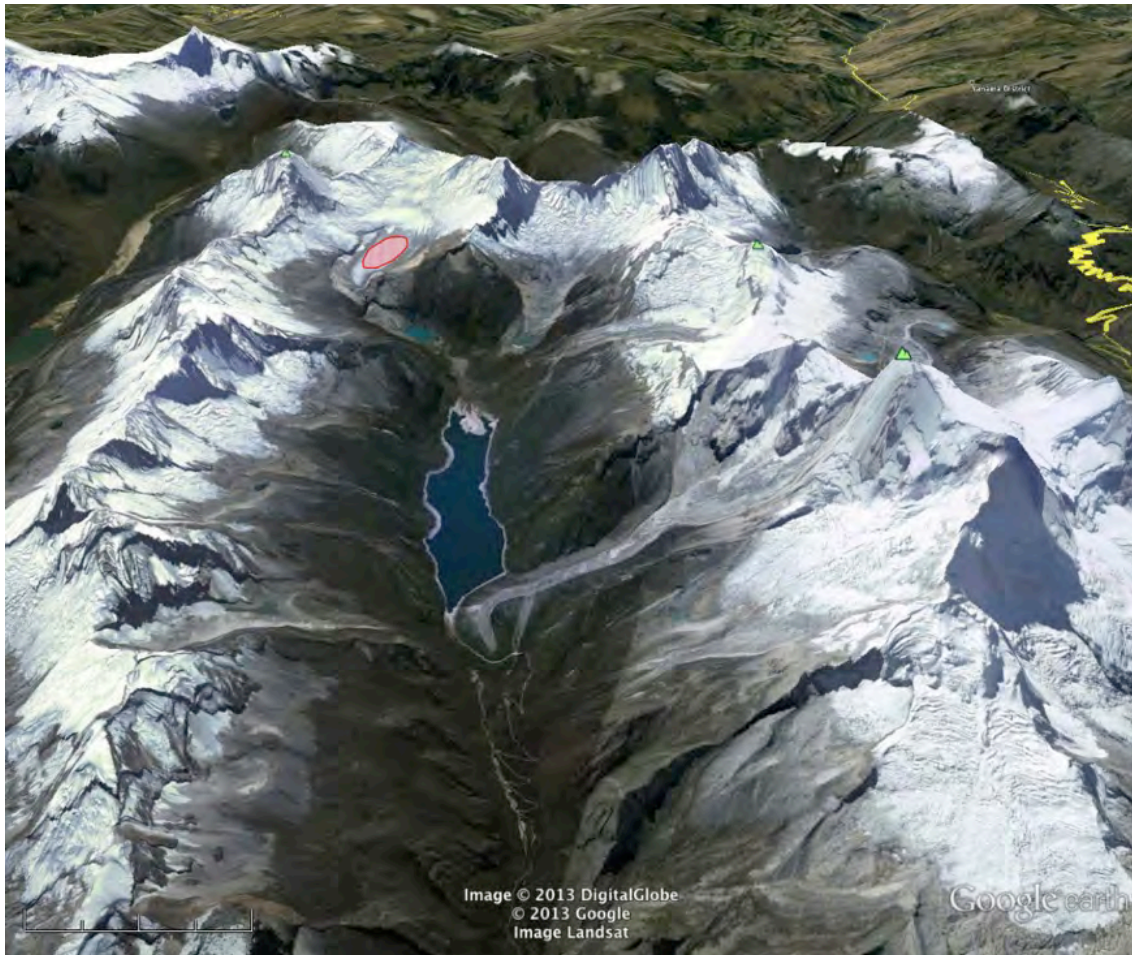
Lake Parón is surrounded by high peaks, including Huandoy (6,395 m) on the south (right). The red circle is the location of an emerging glacial lake. Below that is Artesoncocha, which GLOF-ed twice in 1951.

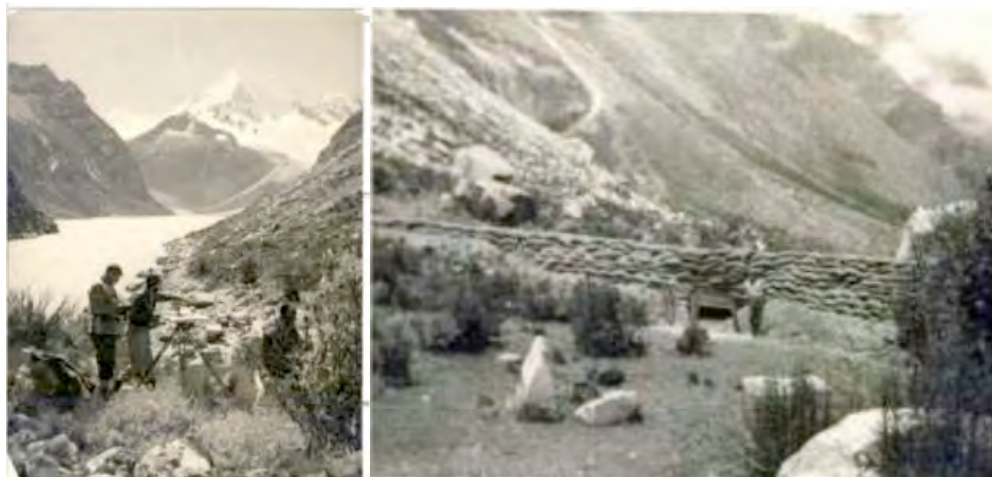
1951 photos of surveyors and a sand bag dam built as a temporary barrier below Lake Parón. Photos: Glaciology Unit Office Archives

Some safety measures were implemented after the 1951 outburst floods from Lake Artesoncocha including placing sand bags over the natural dam. Topographical studies examined lake characteristics for future drainage projects.

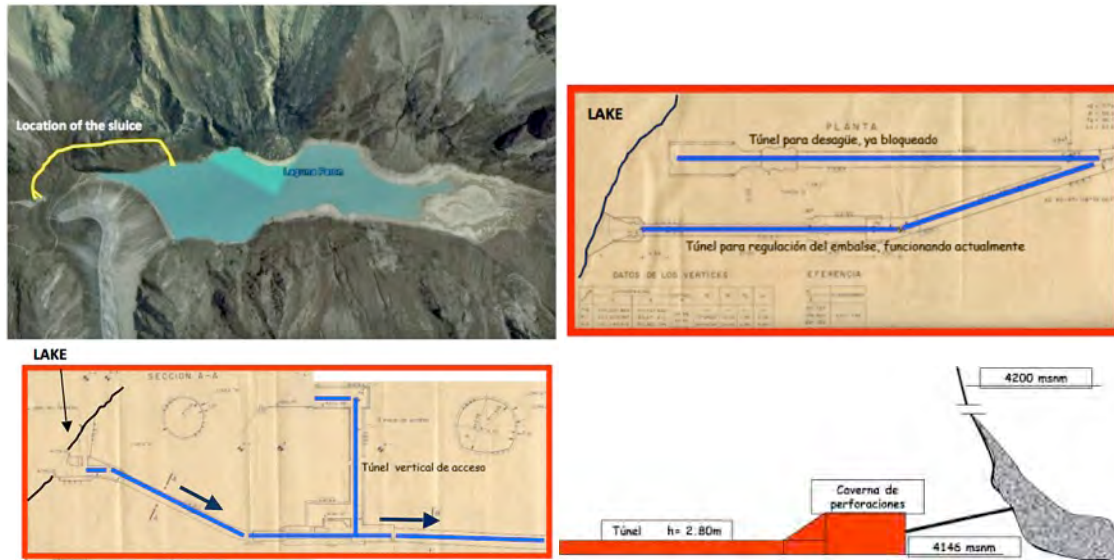
Diagrams of the sluice and tunnels of Lake Parón. The Google Earth view is from 2012. The diagrams were drawn for construction in the 1980s. Source: César Portocarrero

While drillers celebrated the success of the first hole, engineers who measured the lake's outflow found that it was only half of what was projected. Despite a 54-meter head and a 60-centimeter diameter hole, only about half of the calculated 4 m³/second was being delivered. It turned out that the level of the tunnel, and hence of the entrance holes, was too low—it was practically adjacent to the sediments at the bottom of the lake. The holes had been drilled at 4,146 meters of altitude, while the recommendations from engineering company Coyne et Bellier called for the holes to be drilled 9 meters higher—at 4,155 meters.

The work's supervisor was blamed for allowing material from the digs to be thrown at the foot of the talus, thus obstructing the orifices. Later, when the final tunnel connection was completed, the designer was careful to ensure that the mouth was at the 4,155-meter level as recommended by Coyne et Bellier.

Drainage began midway through 1983 and continued into 1984, but was interrupted by a landslide into the spillway at the junction between loose material at the entrance to the canal and the rocky massif. Repairs took several months in 1984, delaying completion of the drainage process until 1985.

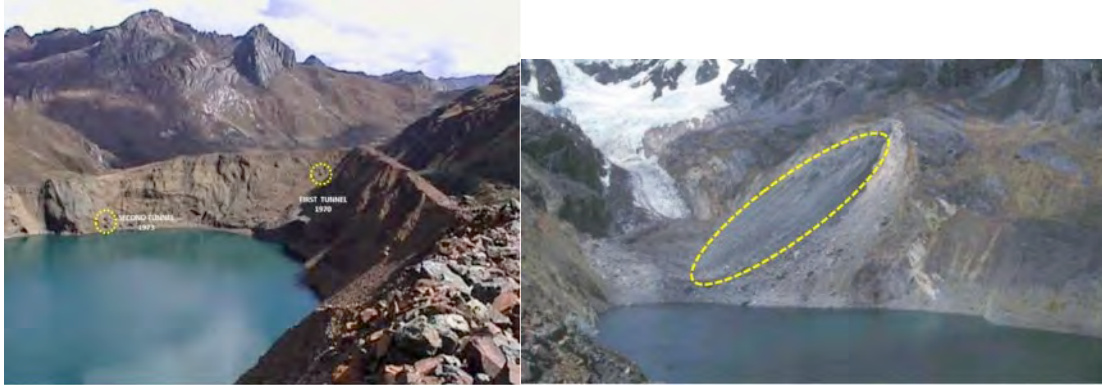
Safuna Alta Lake. Left: Locations of the two tunnels drilled into the moraine in the early 1970s as the lake's level dropped on its own. Right: The source of the landslide in 2002 that launched a wave at least 80 meters in height. Photos: César Portocarrero (1974)

History of work: In the early 1960s the Glaciology Unit recommended building a 47-meter-long drainage tunnel that would prevent the lake's water level from rising above 4,360 meters. In April 1970, a tunnel was completed that was supposed to reduce the water level by 38 meters (Ames and Francou, 1995). However, by then the water level had dropped by 30 meters, so that the tunnel was above the lake's new water level. A month later, a large earthquake severely damaged the tunnel. A new 159-meter-long tunnel was built that, like the previous tunnel, had to be excavated through morainic material. (Report of the Glaciology and Lake Control Office of the Corporation Peruana del Santa, 1972).

In 2002, a rockslide created a wave of at least 80 meters in height (Reynolds, 2003). The wave damaged both tunnels, but did not destroy the moraine.

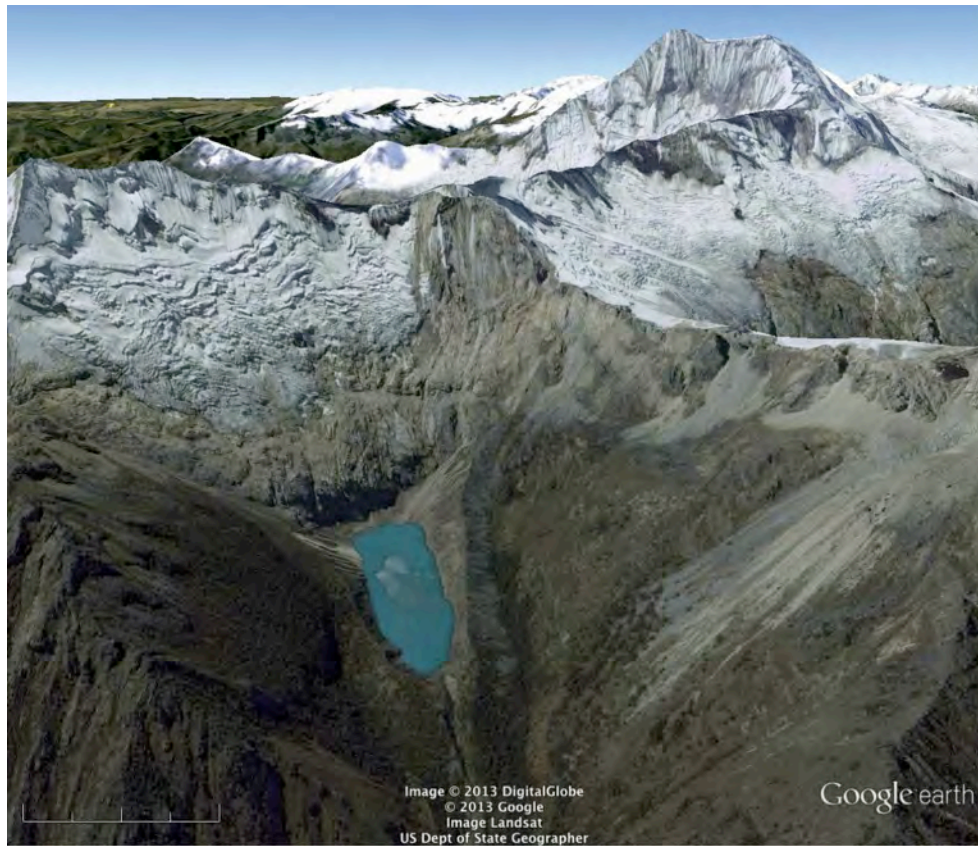
Huallecacocha Lake with its safety dam visible lower right.

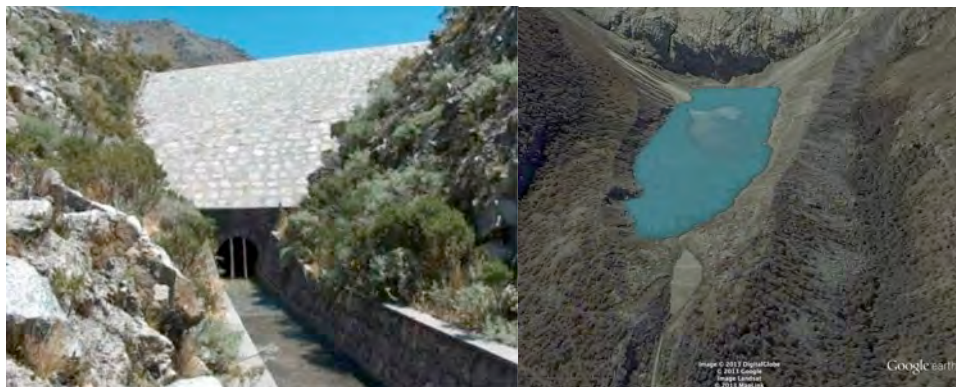
Huallecacocha's completed safety dam from below (1978) and above (2013). Photo: César Portocarrero

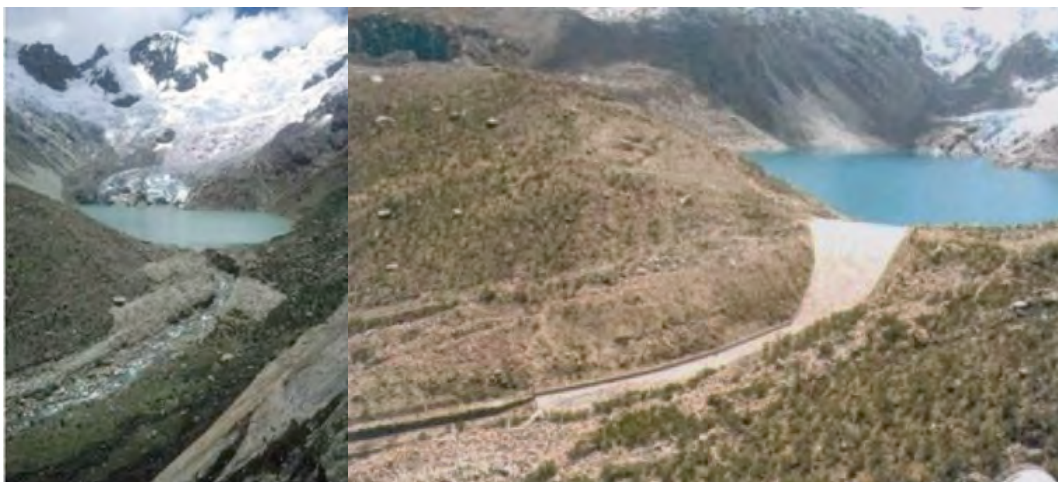
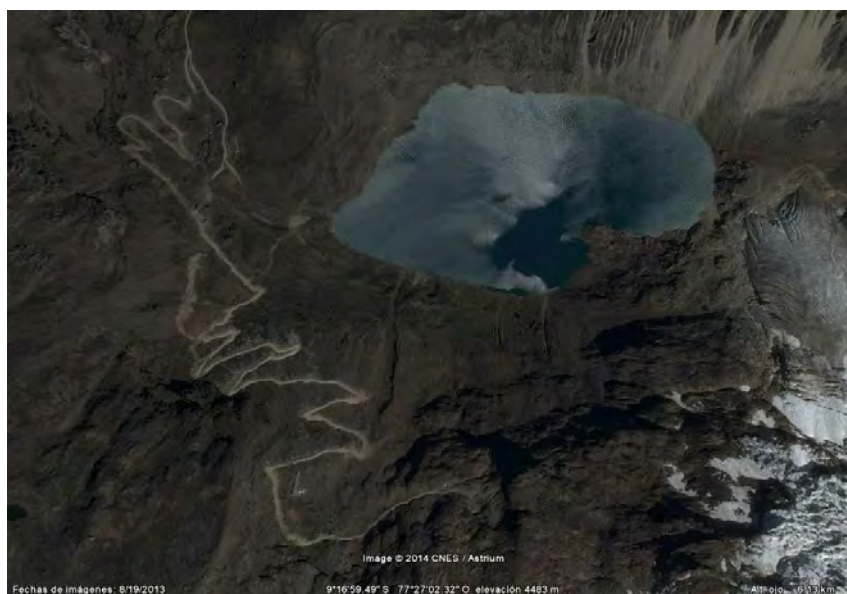
Paccharruri Lake showing the sluice cut to lower the water level (left) and the completed safety dam and outflow canal beyond the covered sluice. Photos: César Portocarrero

Work began in the early 1980s to lower the level of the water surface by 10 meters. A covered sluice 71 meters long and 1.8 meters in diameter was built, over which an 18-meter-high safety dam was added. As in other works of the same type, covered access and exit conduits were built to prevent erosion of the moraine material and safely move water downstream.

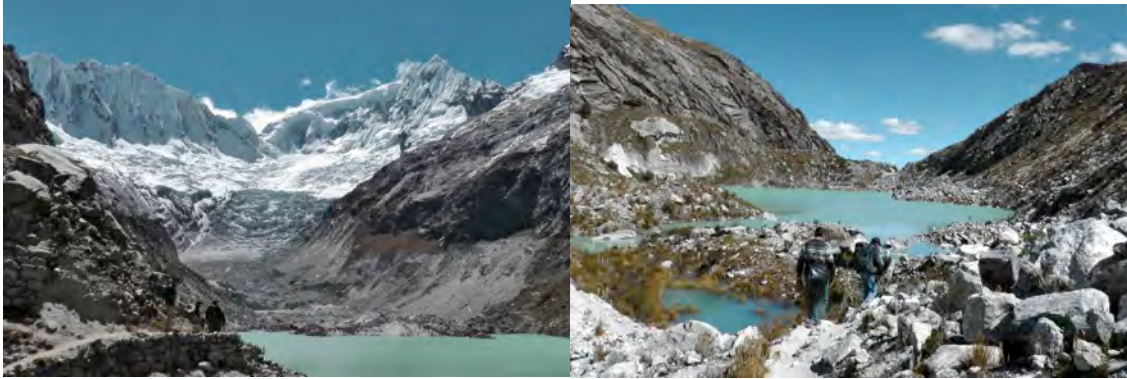
Left: Looking upstream from the safety dam at Llaca Lake. Right: The view downstream across Llaca Lake. Photos: John Harlin

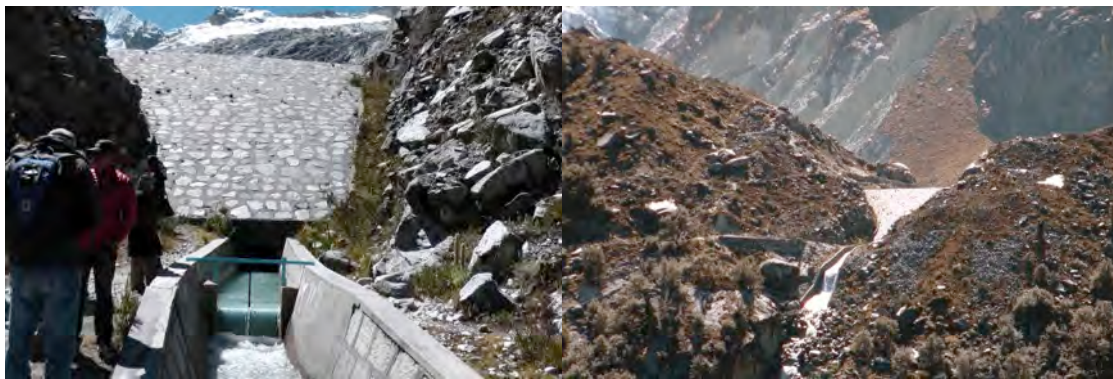
Llaca Lake's safety dam and sluice in 2013. Photos: John Harlin

History of work: First, steps were taken to improve access roads and camp sites. Once these improvements were finished, engineers lowered the lake by 10 meters through an open pit cut. After the lake was lowered, a 48-inch(1,219 millimeter)-diameter steel pipe was installed. When completed in 1974, the lake's maximum depth was 19 meters.

From 1976 to 1977, the second stage of the project involved building a 10-meter-high earth dam inside the open pit cut (on top of the steel pipes), with an impermeable core and stone walls finished with cement mortar-sealed joints.

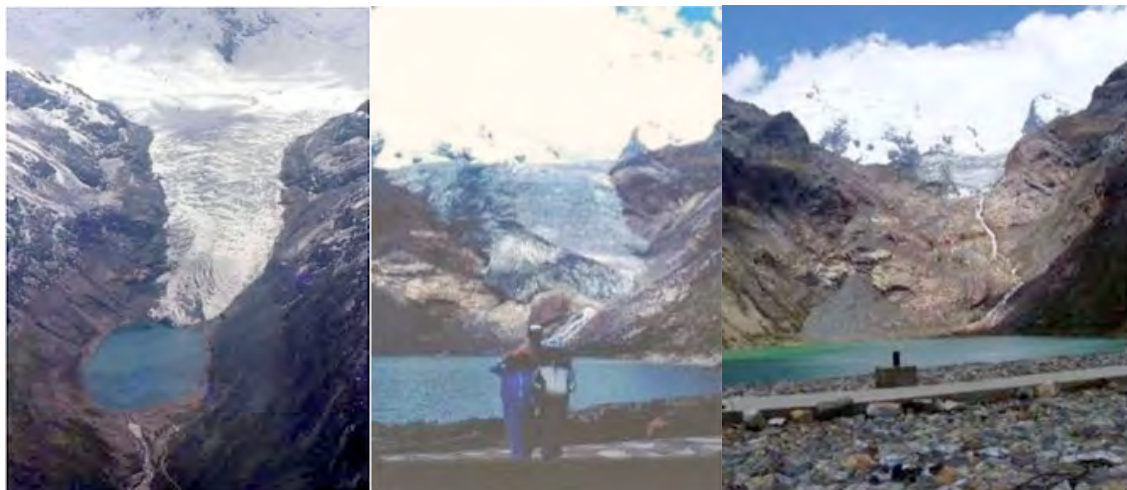
The retreating glacial tongue above Shallap Lake in 1974, 1980, and 2010. Photos: César Portocarrero

Conclusions: Today, the glacier’s tongue is far from the lake and the lake does not present a threat to the city.

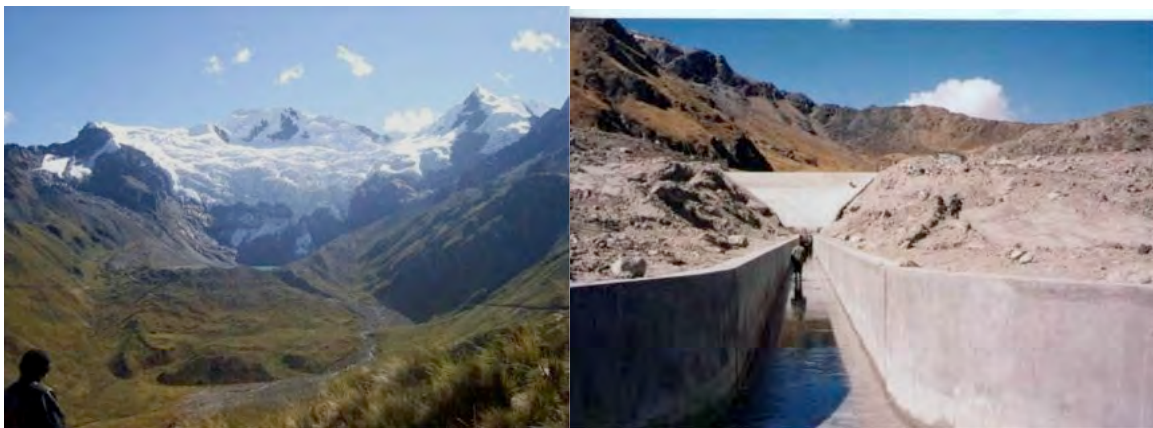
Lazo Huntay Lake showing the still-massive hanging glacier in 1990, and the newly completed safety works in 1990. Photos: César Portocarrero

In 1977, the Glaciology Unit initiated work (with support from The National Institute of Civil Defense of Peru) to partially drain the lake. Then, in early 1990, the Glaciology Unit recommenced work to complete the project by further lowering the water level, building an exhaust duct, and installing a dam.

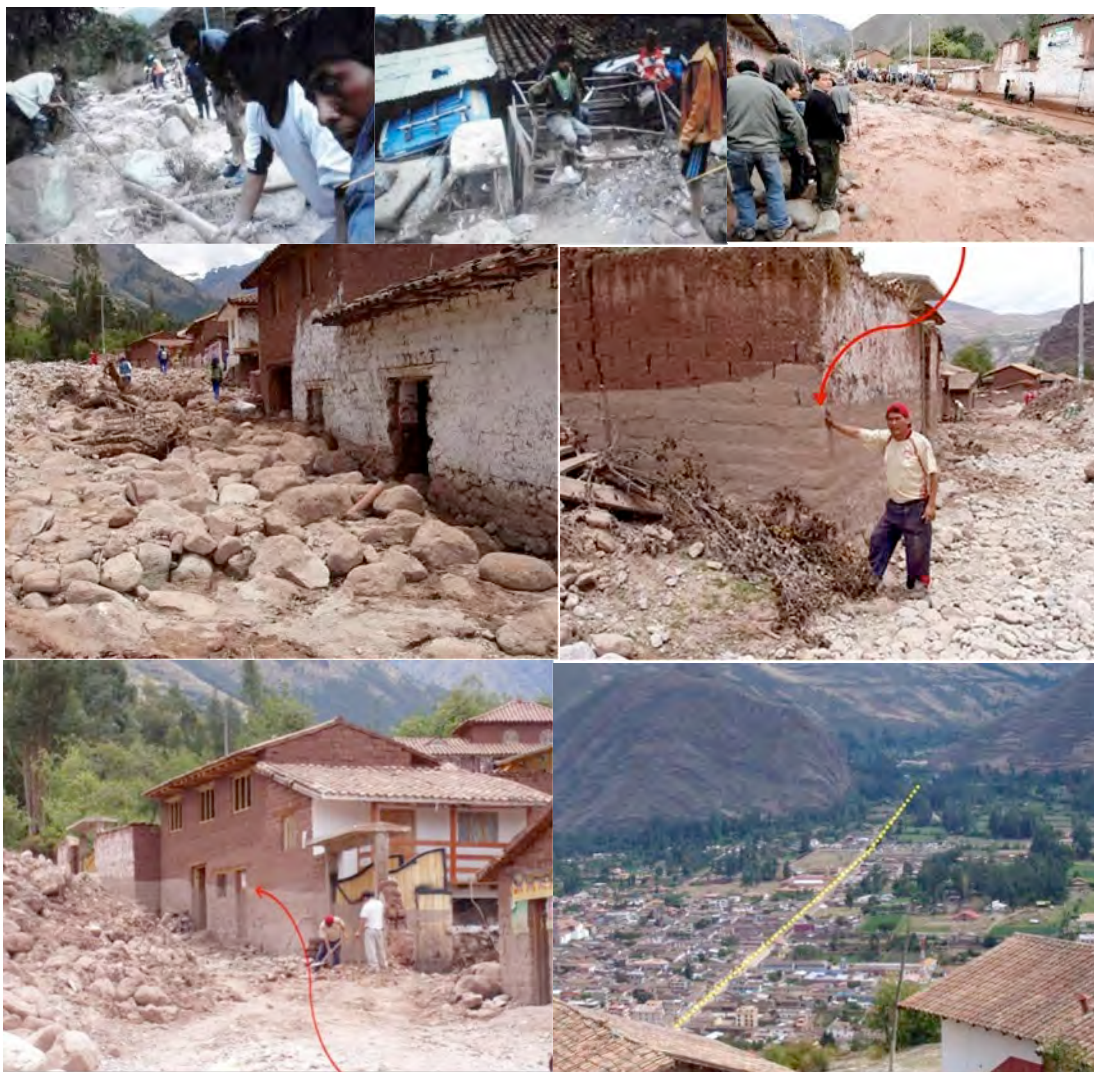
Top row: Photos from the flood of the Chicón River in San Isidro and Urubamba resulting from the Riticocha GLOF on 17 October 2010. **Middle row:** Debris and flood lines on walls in Urubamba in 2010. **Lower right:** The path the Chicón River took through Urubamba in 2010. **Top row photos:** Municipality of Urubamba. **Other photos:** César Portocarrero

On October 17, 2010, a large flash flood of the Chicón River damaged small towns as the water descended to the city of Urubamba. Investigations revealed that the flash flood was a GLOF from a new lake that had appeared at the foot of the Chicón Glacier: Riticocha Lake. Videos taken from helicopters revealed blocky fragments of ice on rock walls near the lake, indicating that one or more large waves had deposited them. It appeared that an original mass of water had triggered a second, lower lake to also be partially emptied.

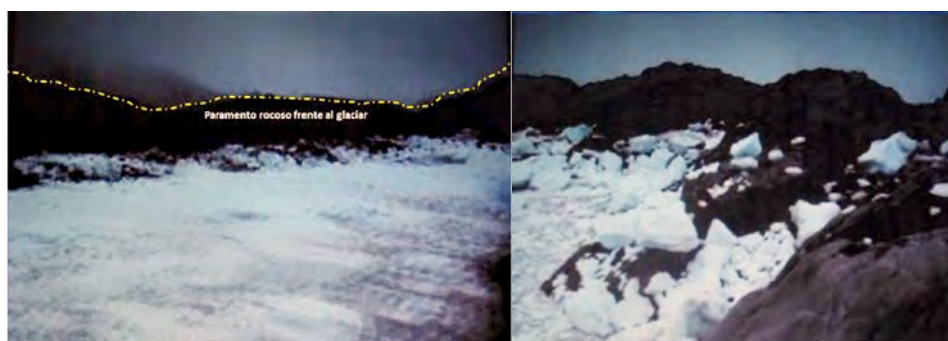
Waves deposited these large ice fragments high on Riticocha's rock walls. These photographs were taken a few days after the event and were taken during daylight, but are dark because it was captured from video. The dashed yellow line indicates the edge of the glacier. **Photos:** Urubamba Civil Defense

Such heavy destruction leads scientists from the Cusco Civil Defense to believe that the volume of the GLOF was larger than the volume of the present lake. Clues include the magnitude and size of transported rocks, the volume of debris, and the boulders that reached the town of Urubamba. The floodwater's destructive power was increased by recent road building activities. Construction had loosened the earth and construction debris, including broken tree trunks, had been dumped into the riverbed.
