Sri Lanka Tsunami Reconstruction Program (SLTRP)
USAID Contract # 386-C-00-05-00166-00

Environmental Assessment

Vocational Education Reconstruction Component

December 2006

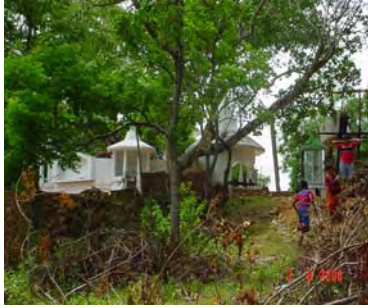
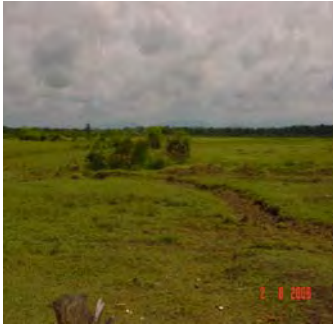
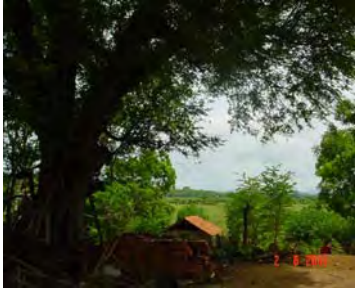
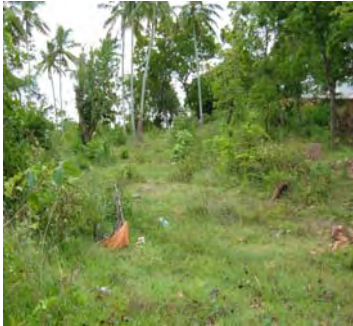
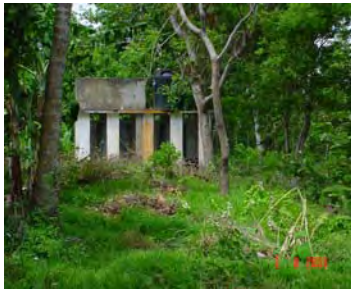
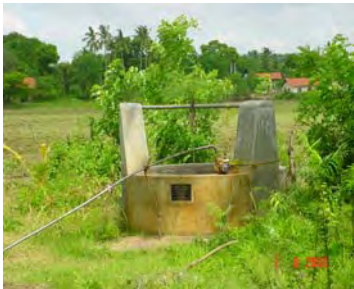
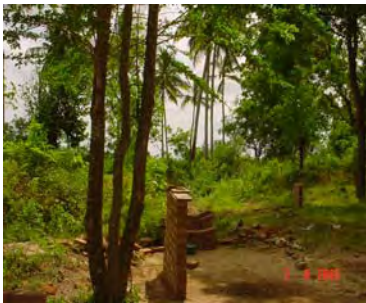
Figure 3 - Photographs of the Tangalla site

a) View of the chaitya from the site

b) Fallow paddy fields with irrigation channel

c) Trees on one part of the site

d) Open areas of the site with weeds

e) Existing toilets in the temple area

f) The existing well used for the toilets only

g) A view of the trees on the site

The difference in elevation from the highest point to the lowest point on this site is less than 20 meters. The paddy fields are situated below the temple. The view from the front of the proposed VTA center is scenic and allows for uninterrupted views of the paddy fields (see Figure 3). A strong breeze is usually present at all points of the site. Most of the construction will take place at the lower levels of the site. The soil is reddish and mixed with sand and mud particles. The temple has a well (Figure 3), which contains brackish water and is used only for toilets. Most surrounding homes have wells, but all contain brackish water. Water scarcity is a serious problem in the Tangalla area and has been an issue over a long period of time. Residents spend a considerable amount of time and effort transporting water from a fresh water source that is approximately one km inland. Toilets (mostly pit latrines) are found in every home and wells are situated more than 15 to 20 meters away from each other. The latrines are at a slightly higher ground elevation than the wells, which are nearer to the edge of the paddy fields. During the tsunami of 2004, seawater entered this area through the paddy fields, as they provide a natural depression that continues up to the coast. However, the temple site was for the most part unaffected by tsunami waters. The most significant drawbacks of this site includes the potential for flooding of the front area of the VTC and its access road; the potential disturbance to religious activities of the temple during to construction. There is also currently a severe scarcity of potable water in the area, but this problem should be addressed by the time construction begins as NWSDB is currently replacing the existing water system.

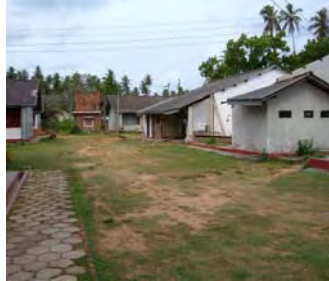
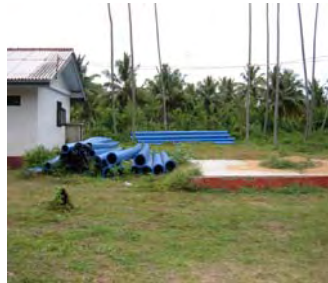
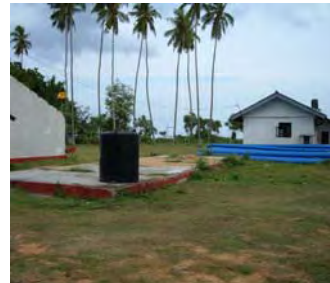
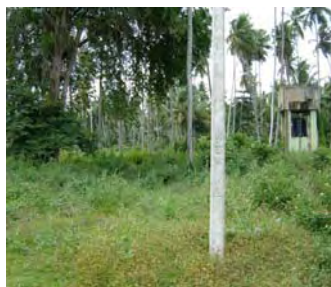
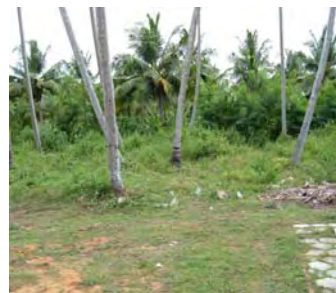
Figure 6- Photographs of the Talalle site

a) Sides of existing VTC
with bare patches of
sandy ground and grass

b) Sides of the existing VTC and the foundation of
a destroyed building

c) Sides of the existing VTC overgrown with
weeds

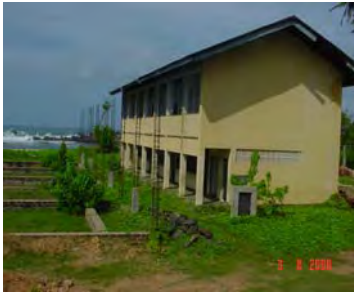
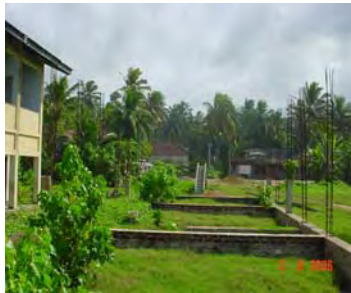
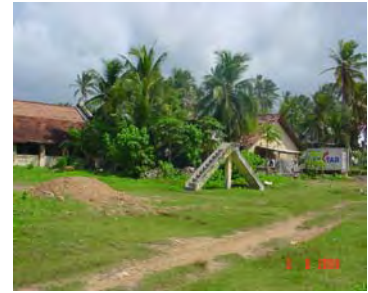
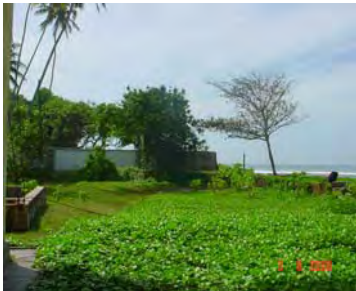
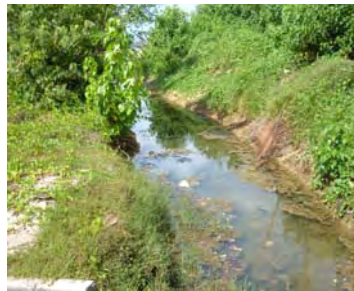
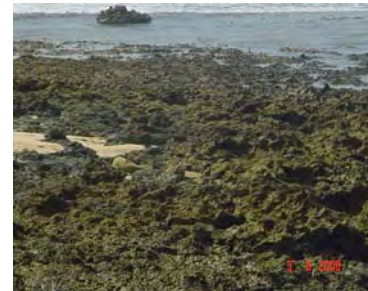
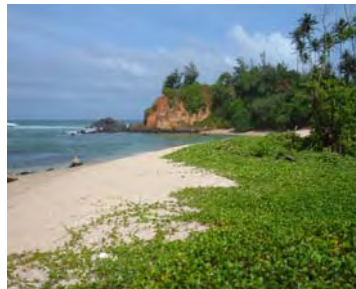
Figure 9- Photographs of the Ahangama site

a) The existing building on the site with the foundations of the tsunami destroyed building on the left hand side of the picture

b) A closer view of the foundations of the destroyed building

c) A play structure of the former school on the site

d) The area of the site with sea shore plants facing the sea

e) The drainage canal opening to the sea on one boundary of the site

f) A section of the coral reef

g) A view of the shore line from the site

Vidyalaya) which has now been relocated inland due to serious structural damage caused by the tsunami. There is a two-story building still standing (constructed with external donor funds and opened for use a few months before the tsunami), which has some damage on the end closest to the ocean. Another, older building is partly standing, but has been severely damaged. The foundation of a completely demolished building and a play structure (slide) of the school can also be seen (see pictures in Figure 9). Part of this site falls within the set back

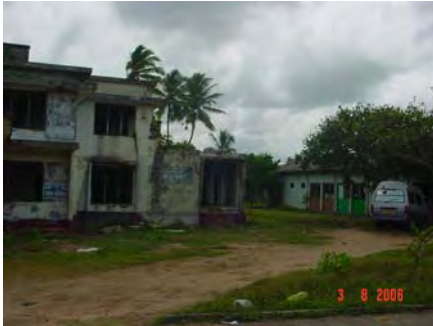
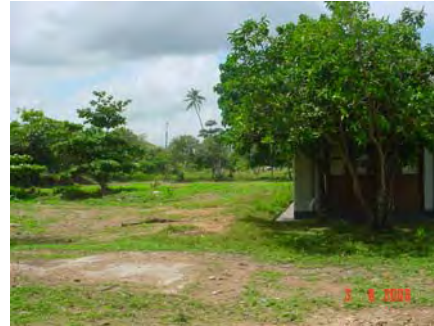
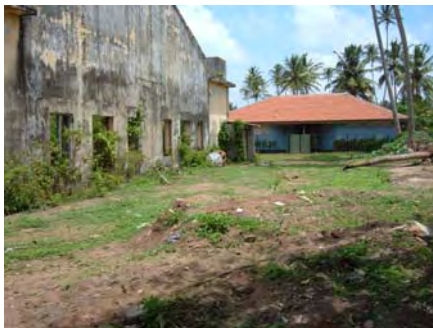
Figure 12- Photographs of the Koggala site

a) The existing partly destroyed building at the site

b) Sides of the site with part of an existing building where VTC activities are currently conducted

c) Sides of the existing building with parts of the site

The proposed site is a former Koggala police station, which has now been abandoned. The building occupies the center of the site, and is dilapidated with crumbling masonry, and missing doors and windows. The concrete on the front porch is seriously decayed, posing a potentially significant danger. Other parts of the building show signs of structural damage in the wall plaster and may not be safe. The vacant area around the building is used as a park by taxi drivers, as there is no fencing around the property. The site is bordered on two sides by commercial buildings. The one on its right hand side is the larger one and contains several shops (see Figure 11.). The site faces the main A2 road and hotels occupy the area between the road and the beach, some of which were partially flooded by tsunami waters. A vocational training program in information technology is currently operating in a small area adjoining commercial building.

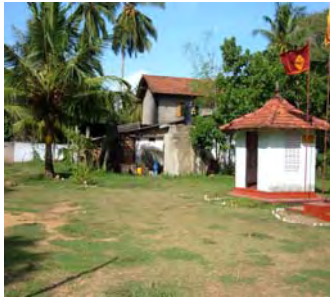
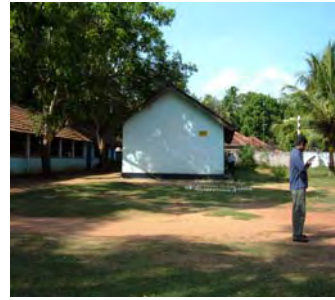
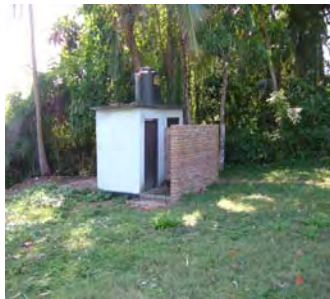
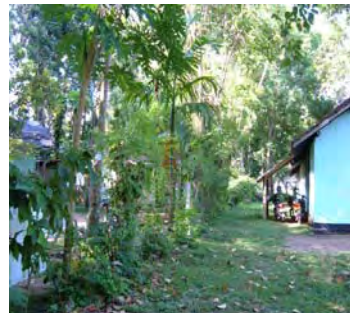
Figure 15- Photographs of the Hikkaduwa site

a) The entrance area of the site

b) View of the existing VTC buildings

c) An existing toilet of the VTC

d) View of the backyard of the existing VTC

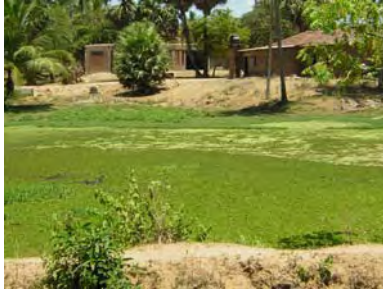
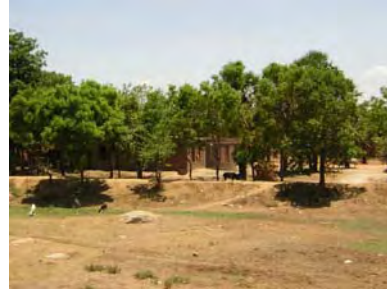
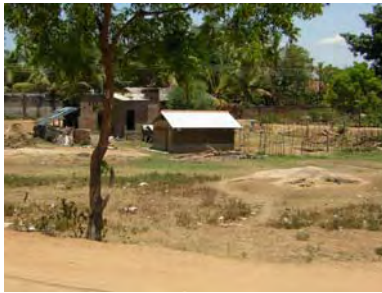
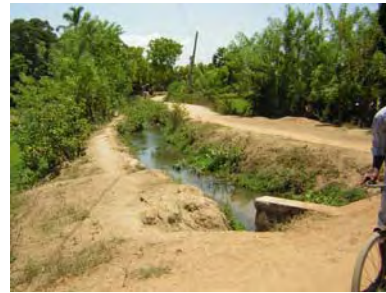
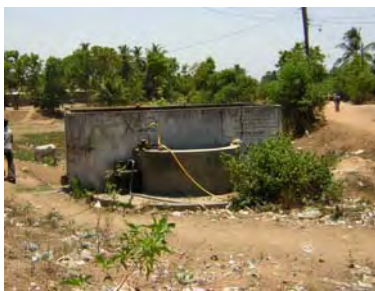
Figure 17- Photographs of the Central Camp site

a) A marshy area adjacent to site

b) A view of the section of the site which is at a lower level than the surroundings

c) A section of the site with human settlements

d) Water canal from Igniyagala reservoir

e) A common dug well and a bathroom for females

The proposed site is about 200 meters from the main road that connects Kalmunai and Sammanturai, in Chalambaikerny Central Camp, Ampara. Administratively, it belongs to Grama Sevaka No-3 of the Navithanveli DS Division. This site has been donated by A.L.A. Jabbar, Chief Trustee of the mosque of Central Camp. Figure 17 shows the photographs taken during the field assessment.

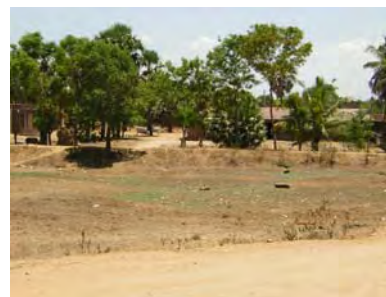
f) A view of the site indicating the height of the surrounding area

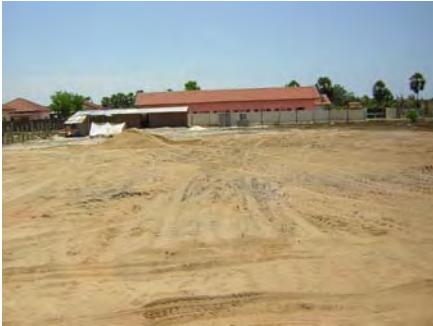
a) A front side view of site

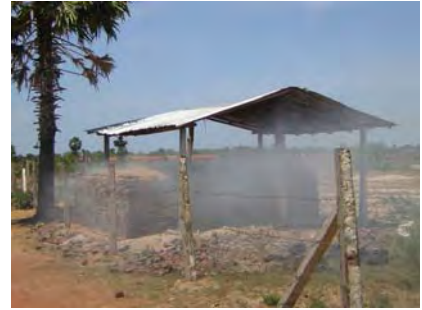
b) A kiln within 500 meter radius area of the site

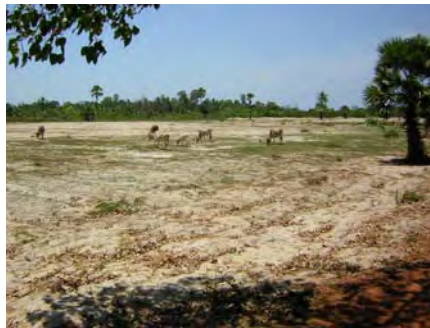
c) An area cleared of vegetation adjacent to the site

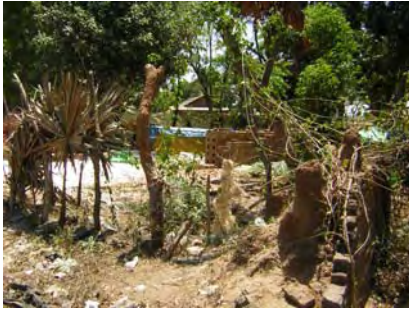
a) A kiln located opposite to the site, along the road

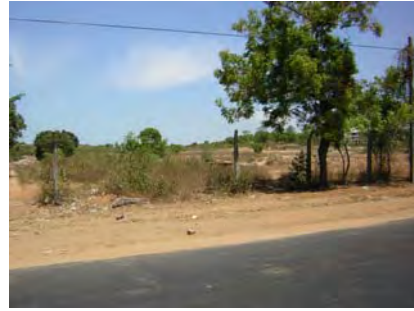
b) A front view of proposed site

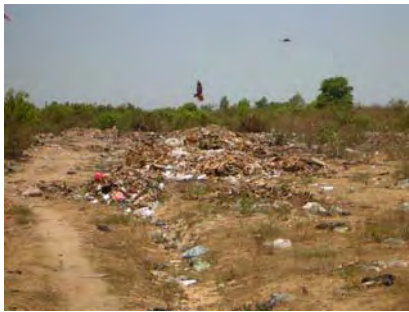
c) A dump site of solid waste behind the site

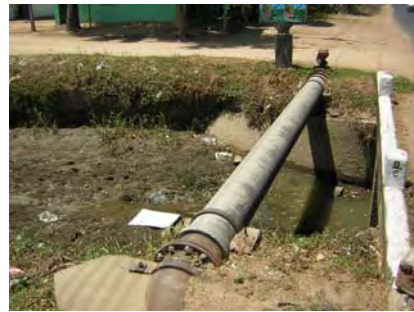
d) The water supply from Weeragoda

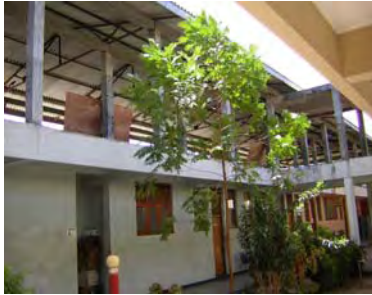
a) Interior section of VTC showing the first floor stage

Construction work of the first floor is presently in progress. The dug well in the premises was noted as having polluted water and, as such, the VTC depends on potable water supplied from a privately owned source about 150 meters away.

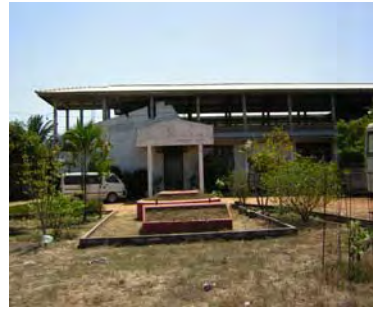
c) View from the back of the VTC centre showing the paddy fields

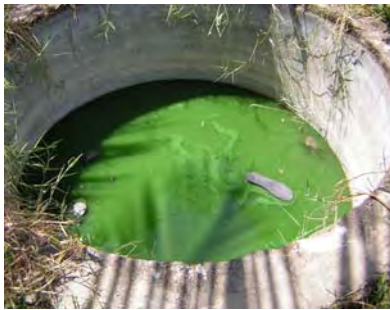
b) A dug well at VTC showing an algal bloom and amphibians

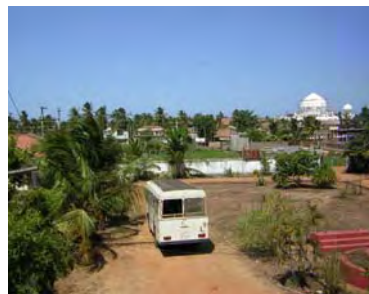
d) View of the front of the VTC
