## **PERU HEALTHY KITCHEN/HEALTHY STOVE PILOT PROJECT**

**December 2008**

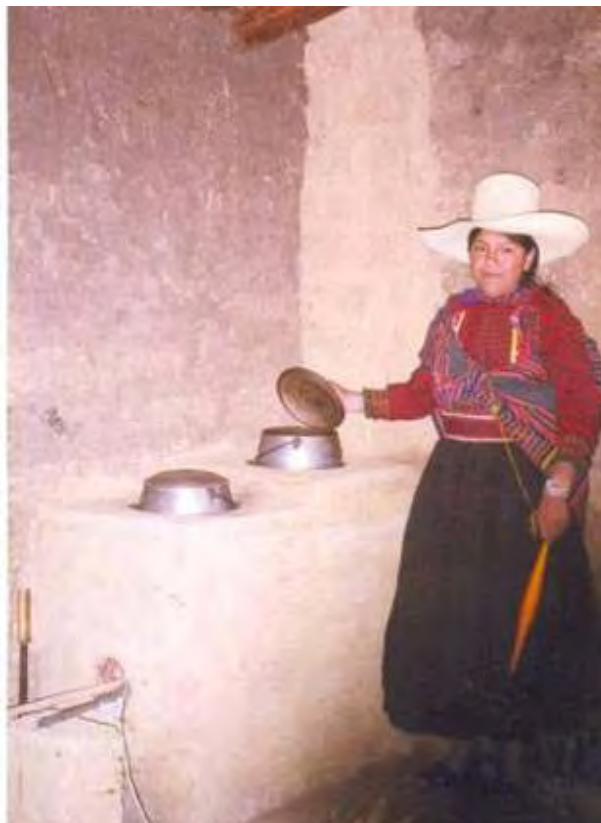
**A project beneficiary with her Inkawasina stove.** *Photo credit: Centro Eco*

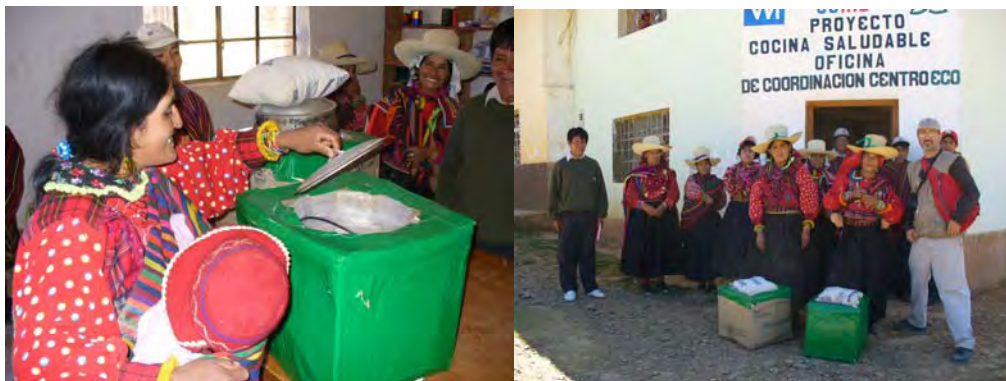
**Training sessions on retained heat cooker (or “haybox”) construction at Uyurpampa.**

Easily available cardboard was used to frame the haybox, which was insulated with locally available materials such as rice husks or wool and covered with plastic to protect against humidity. The haybox cover was a small pillow of cloth and insulating material.

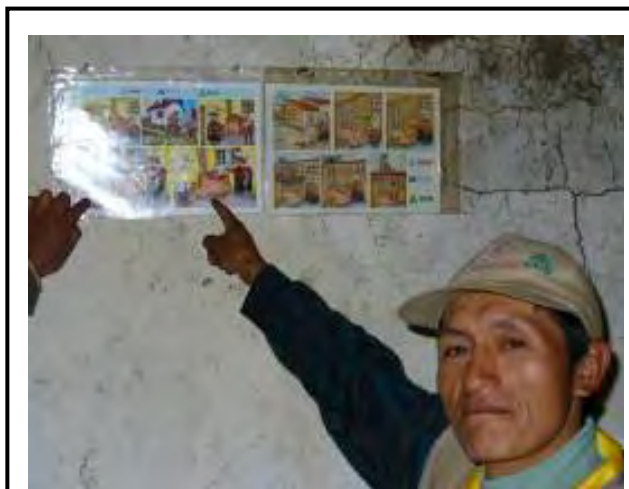
**A promoter points to illustrations on the kitchen wall of a beneficiary household depicting proper stove operation and maintenance.**

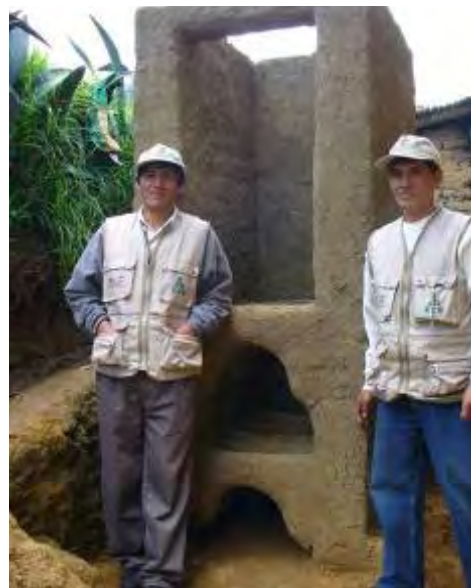
**Engineer Jose Humberto Bernilla (right) and a ceramic artisan trained to produce rocket elbows in Uyurpampa stand in front of a newly built ceramic kiln.**

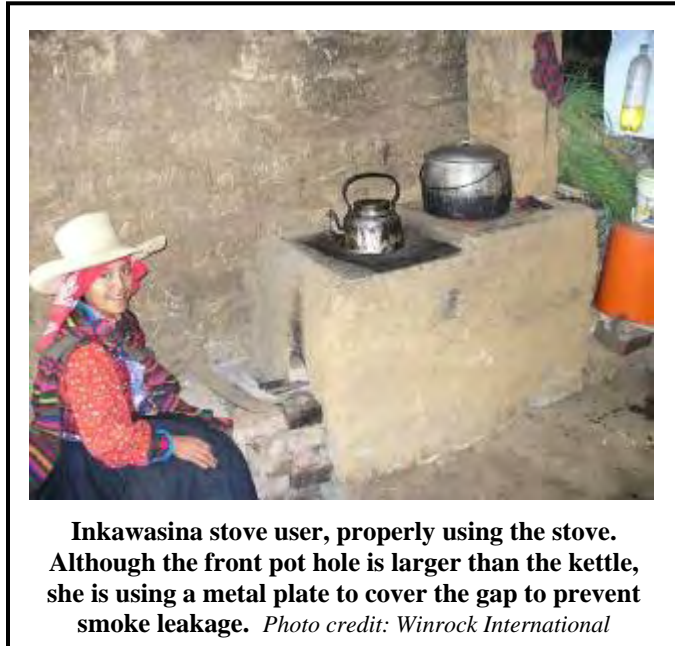
**Inkawasina stove user, properly using the stove. Although the front pot hole is larger than the kettle, she is using a metal plate to cover the gap to prevent smoke leakage. Photo credit: Winrock International**

significant smoke leakage. ECO’s engineer Bernilla thus designed a metal plate fashioned out of large oil cans commonly found in the region, cutting a hole the size of the kettle (or smaller pot) to block the gap between it and the larger hole. The metal plate can also be used without a hole as a cover for the pot hole and to place the kettle or small pot on top of it (as shown at right). It is uncertain at this point how many of the households with kettles have been shown this technique, however, and how effective the metal plate is in reducing smoke leakage.

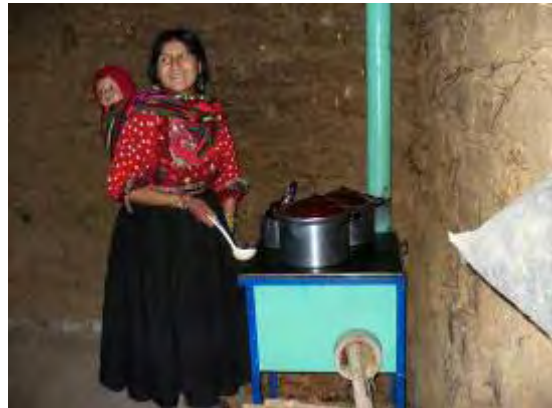
***This Inkawasi resident tested the Ecostove for five months in Uyurpampa.***

The two alternative models had the same insulated ceramic “elbow” combustion chamber as the Inkawasina stove, but modified heat transfer systems. In both cases, an iron plate replaced the concrete “pot hole” frame of the Inkawasina stove. The first alternative design had two pot holes with three graduated-diameter metal discs to accommodate pots of different sizes. This is similar to the heat transfer system of traditional wood stove designs in Europe and the United States. The second alternative design used a solid metal griddle cooking surface, similar to the Ecostove.<sup>20</sup> The griddle surface has the advantage of eliminating smoke leakage from the cooking surface and enabling the simultaneous use of multiple pots and/or direct grilling of tortillas or other foods.

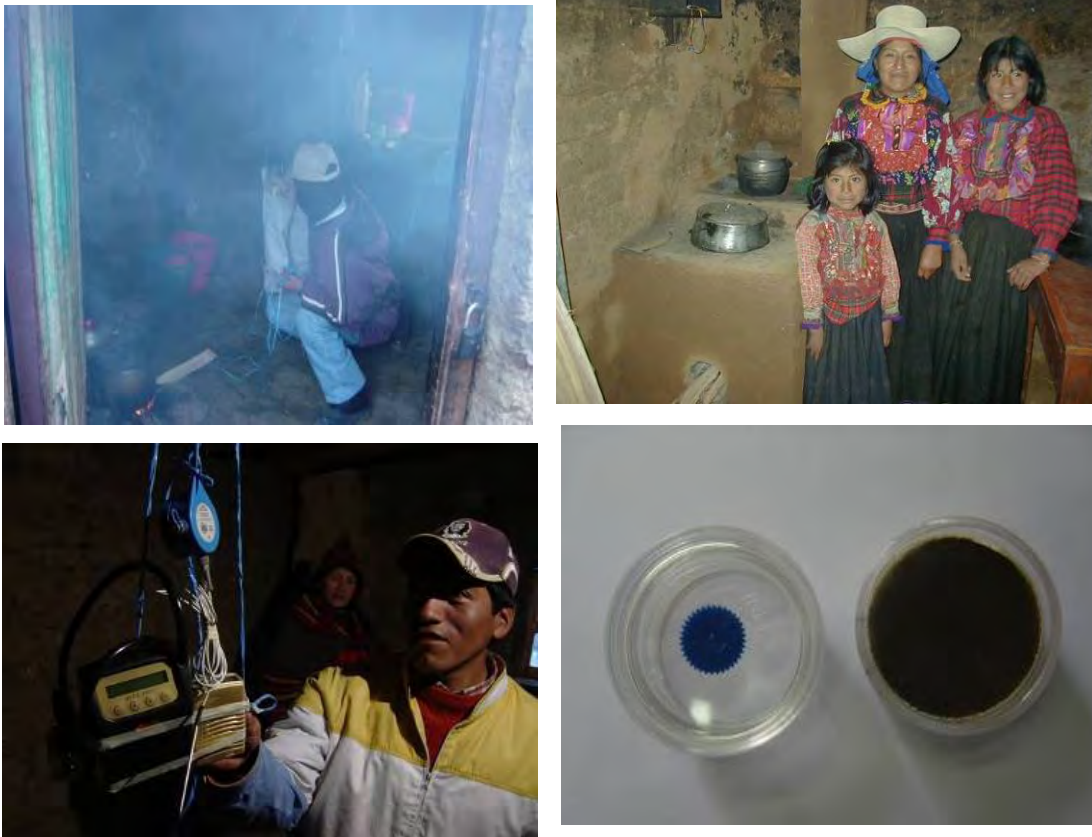
**Clockwise from top left: Kitchen smoke levels before and after stove installation; filters from monitoring equipment before and after monitoring; monitoring equipment and staff.**

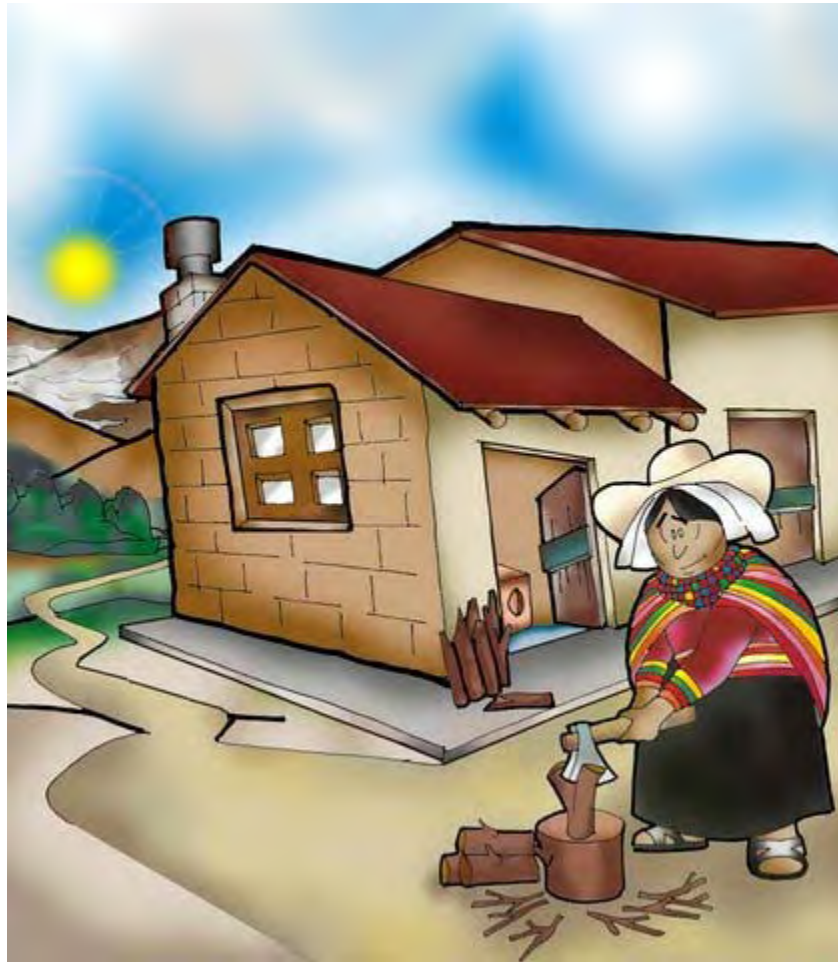
Graphic illustration demonstrating the need for small twigs and logs cut into small pieces for use in Inkawasina improved stoves

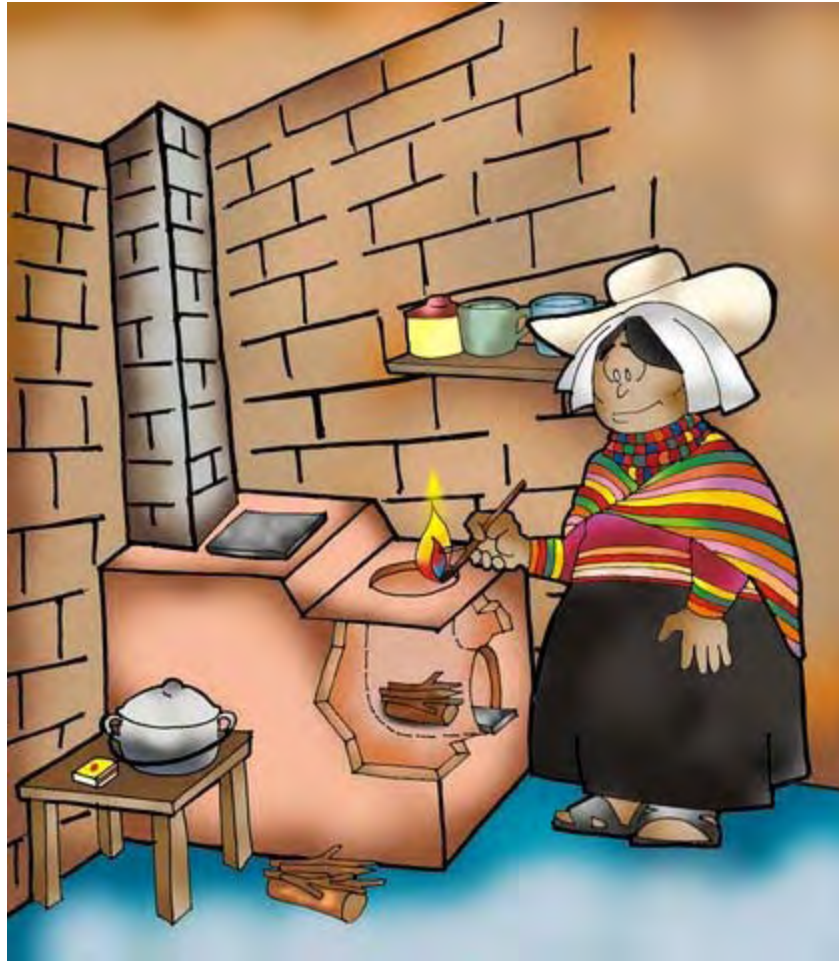
Graphic illustration demonstrating proper use of a small amount of firewood at a time in an Inkawasina improved stove

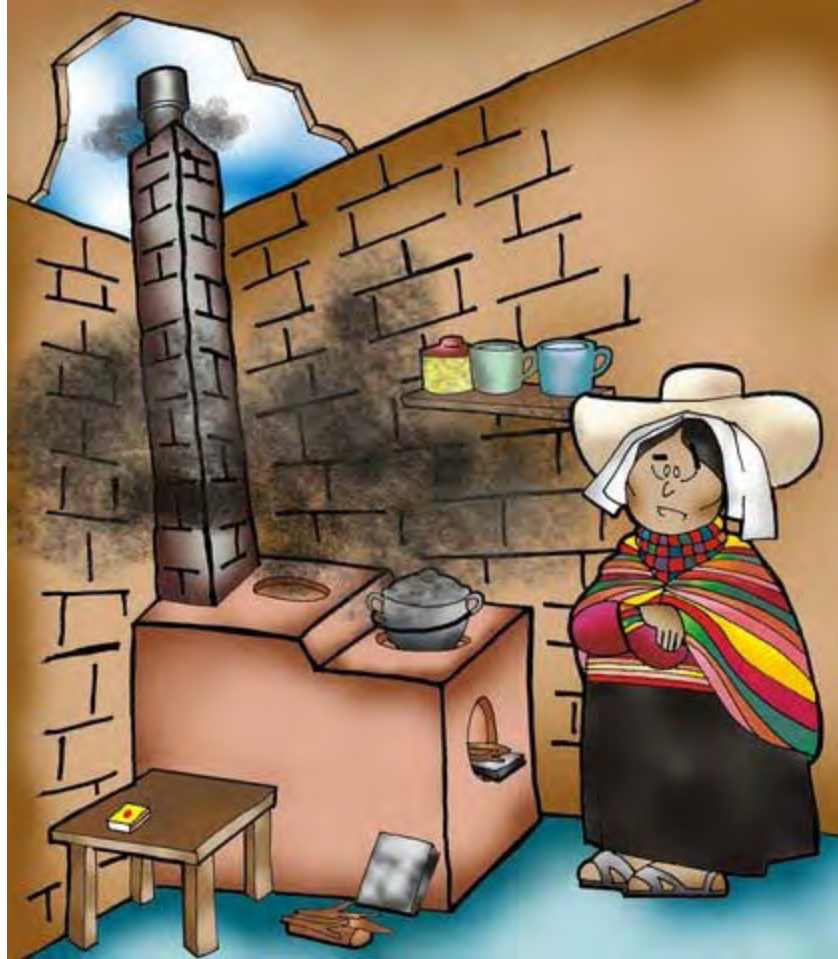
Graphic illustration depicting the smoke that is released into the room when one hole of the stove is left uncovered

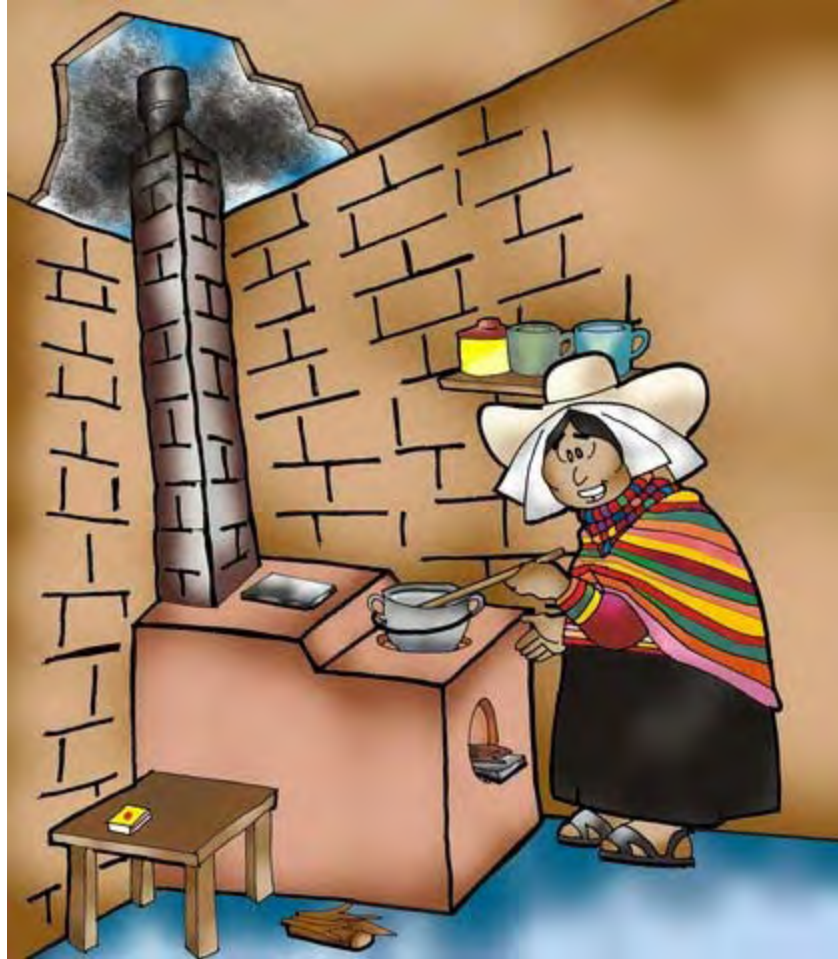
Graphic illustration depicting the proper release of smoke outside the house through the chimney when the second stove hole is properly covered

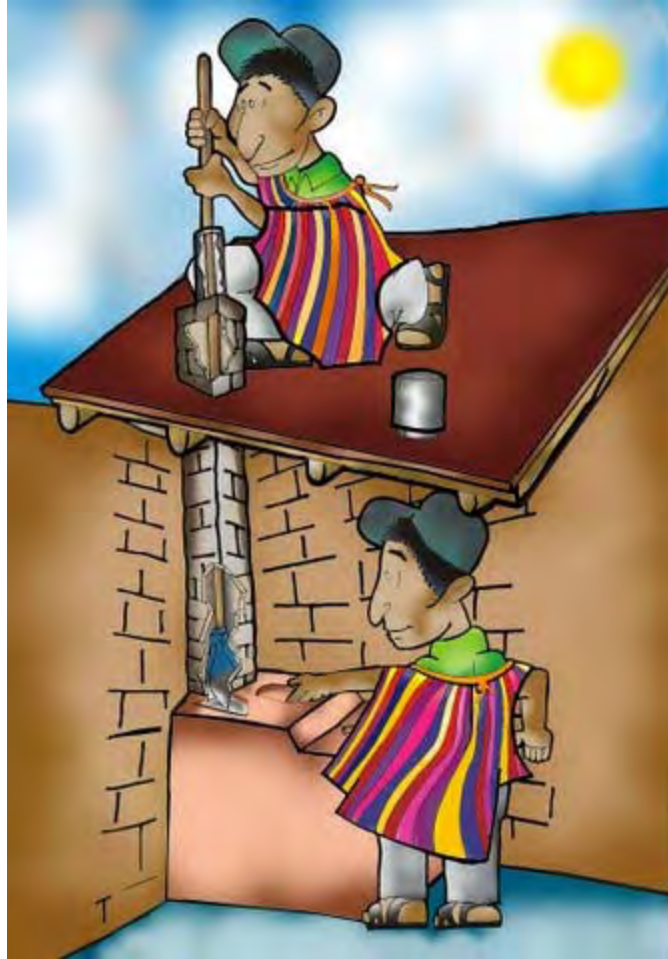
Graphic illustration demonstrating proper chimney maintenance techniques

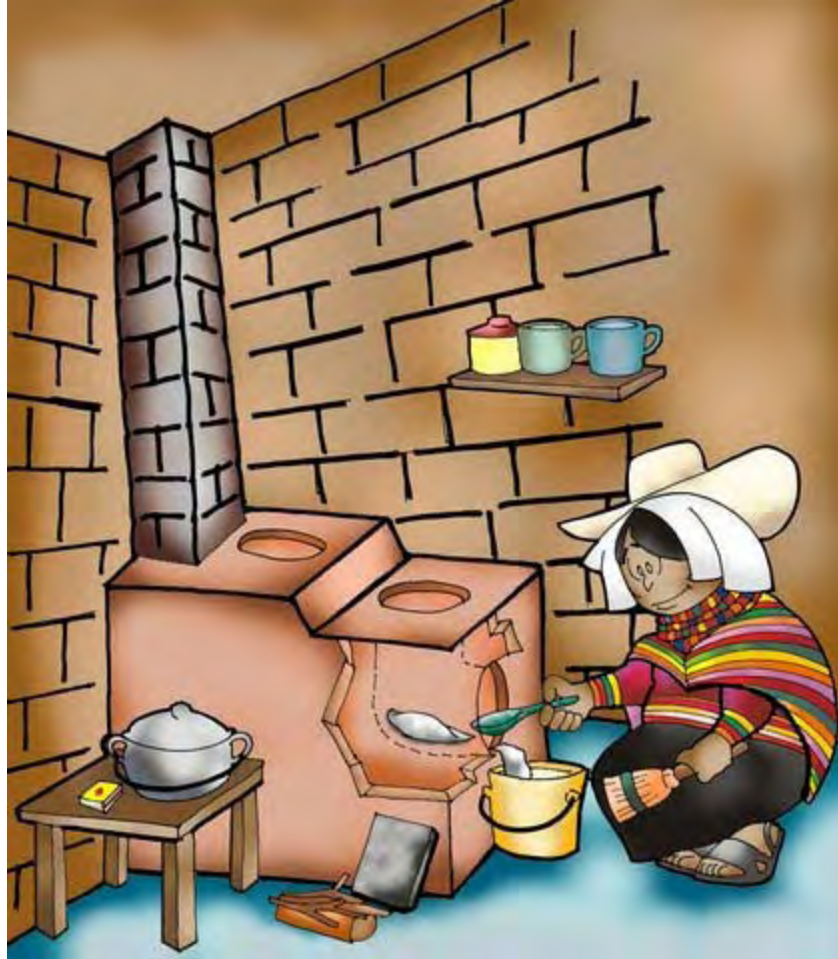
Graphic illustration demonstrating proper regular ash removal from the combustion chamber of the stove

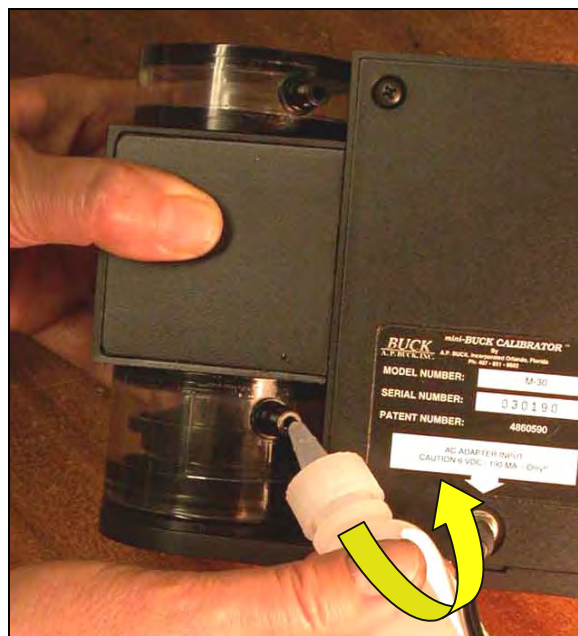
**Figure 1:** Place a few drops of soap solution into the bubble chamber through the lower opening.

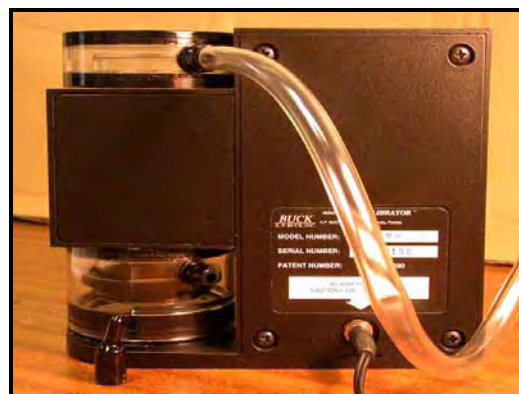
**Figure 3:** Tube to cyclone connects to upper outlet of calibrator.

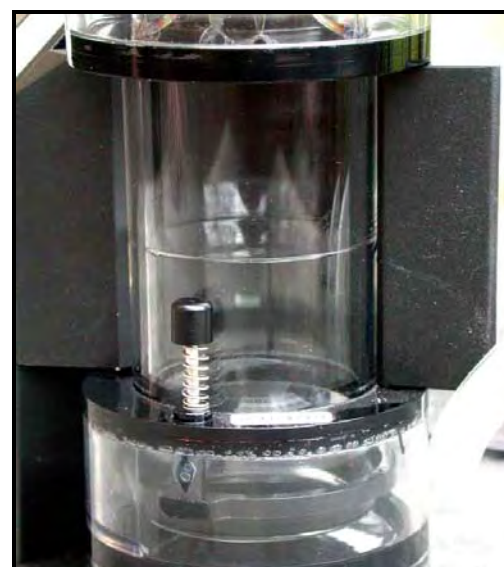
**Figure 5:** Soap bubble moving up the chamber. Make sure it reaches the top freely before starting measurements.

9. Move arrow to calibrate "CAL."
10. Clear current calibration – move arrow to YES and press ENTER.
11. Warning "Will Erase." Move arrow to YES and press ENTER.
12. You will hear the pump run.
13. If display shows 2200 press ENTER. If display is not showing 2200, then use arrows to change it to 2200. This is our target flow rate.
14. Switch on the Buck calibrator unit. Display should show 0000.
15. Keep pump running for 2 minutes to allow it to stabilize.
16. In the meantime, wet the glass chamber by releasing many bubbles (Figure 4 and Figure 5).

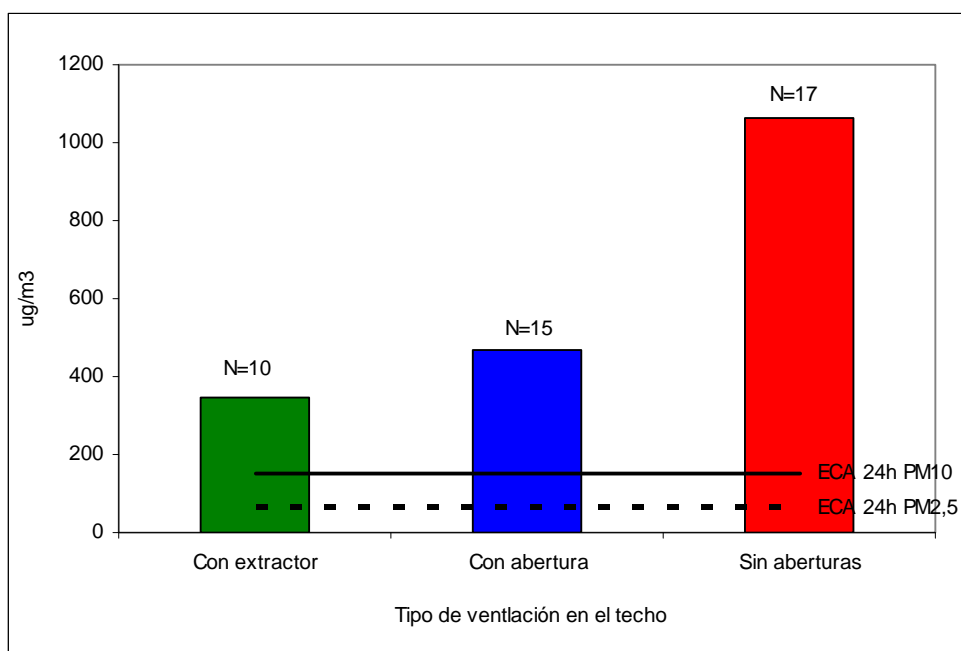
**Figure 7. Average CO hourly concentration by type of venting on kitchen roofs**
