Feasibility test of an approach and prototype for ultra low cost housing, final report

FEASIBILITY TEST OF AN APPROACH AND  
PROTOTYPE FOR ULTRA LOW COST HOUSING

FINAL REPORT

**INSTRUCTOR'S MANUAL FOR CONSTRUCTION OF THE  
CARNEGIE-MELLON UNIVERSITY REFUGEE HOUSING SHELTER**

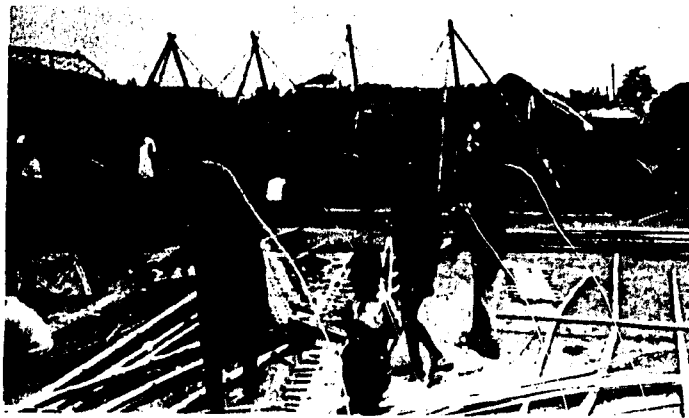
2. Demra Bustee Camp (10 miles south of Dacca) -- The Bangladesh Red Cross funded the construction of one two-family unit at the Demra Camp. The object of this test was to test the costs (Tk 500 per family) and the stability of the unit under high wind conditions and in a refugee camp environment. The structure is made of bamboo frames with a sungrass covering. The staff sited the structure, trained a team to construct it and provided occasional supervision to the construction team. This project was also supported by the League of Red Cross Societies.

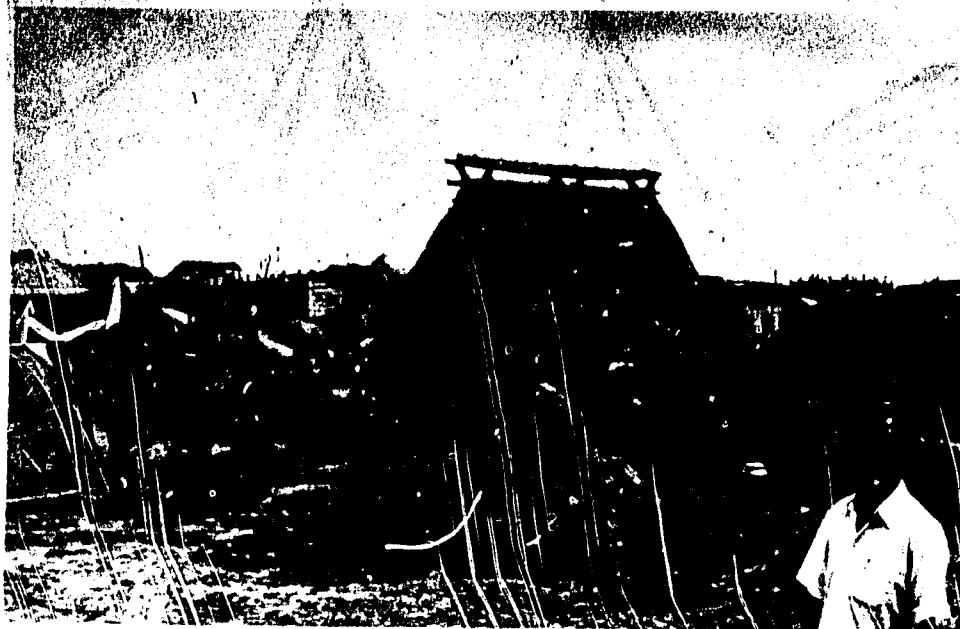
Figure 10. Bustee Camp (Demra)

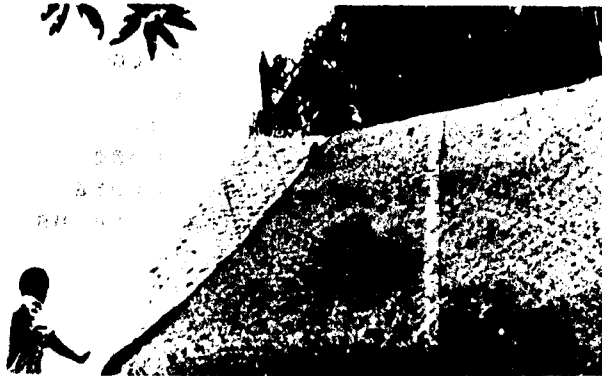
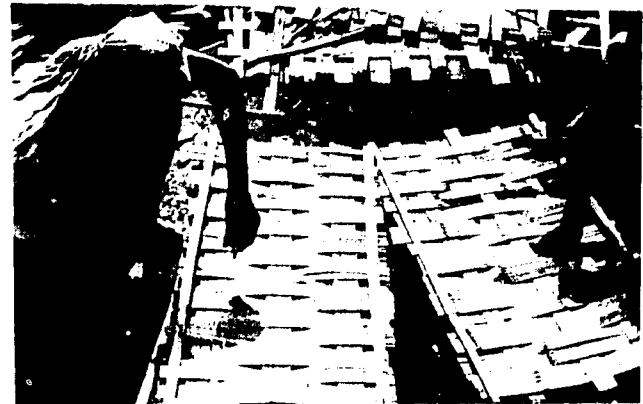
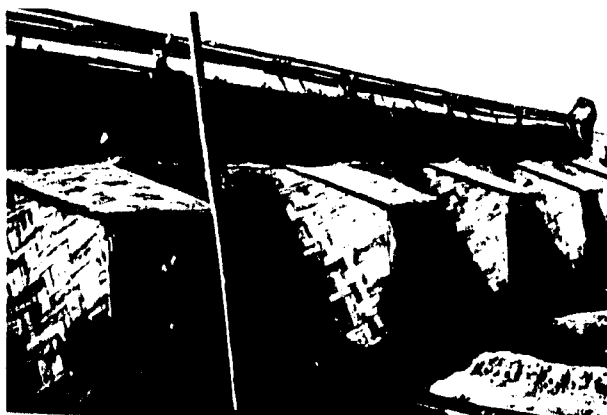
ROOFING TESTS

Bamboo Shingles: At the Tongi Bustee Camp, and in the first block of structures at the Mirpur Non-local Camp, bamboo shingles made of split, thin culm bamboos were used. These were tied directly to the frame. This proved to be the most expensive method using strictly local materials but offers the most strength. At Mirpur there were complaints that the roofs leaked during the first rains but once the bamboo had swelled the leaks stopped.

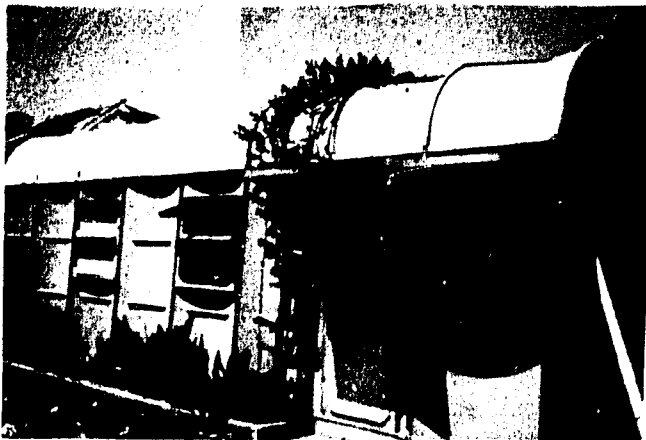
CARE Jute-polyester Resin Structures - Bill Woudenberg of CARE is currently experimenting with a process for developing prefabricated structures which utilize the material most found in abundance in Bangladesh; jute. The process is similar to working with fiberglass. First, a wooden mold is made for producing the prefabricated panels. Jute cloth is layed on the mold, saturated with polyester resin by means of a spray gun and then the process repeated. After the desired thickness is achieved, a final pigment coat is added to give color; the panel is cured, then taken off the mold and is ready for use.

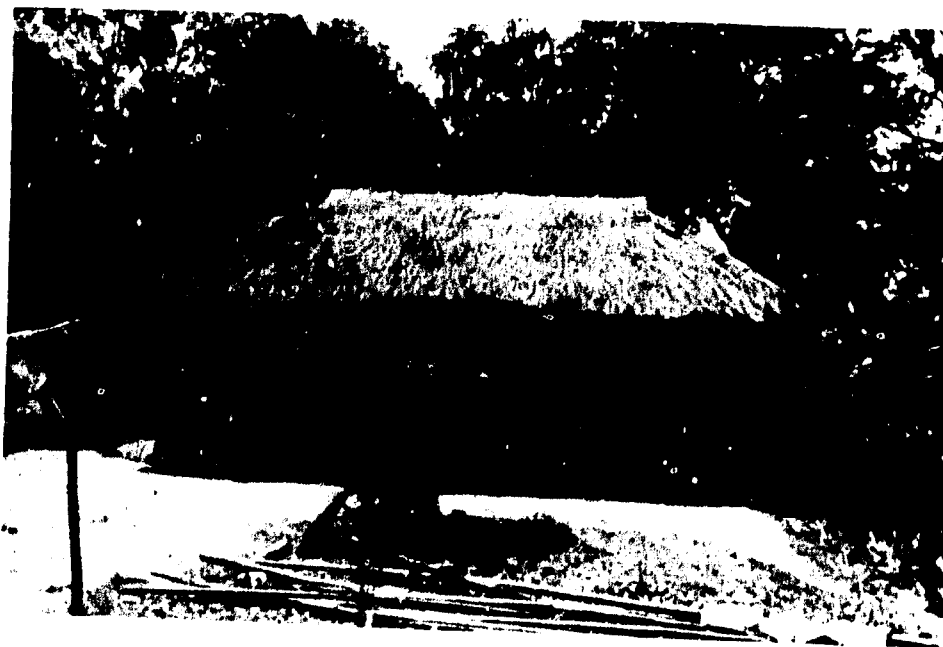
Figure 16  
CDF Housing Project

All units were constructed in two Thanas, Rangunia and Mesarai, both in Chittagong District. All recipients were responsible for building their structures and, as no technical or design assistance was provided, units varied in size and design. A typical structure would be a bamboo frame built on a raised plateau of earth stabilized with cow dung. The roof was made of thatched sungrass, the walls of woven bamboo mats. Erection time averaged three days per unit. Total cost of each unit was approximately \$70.

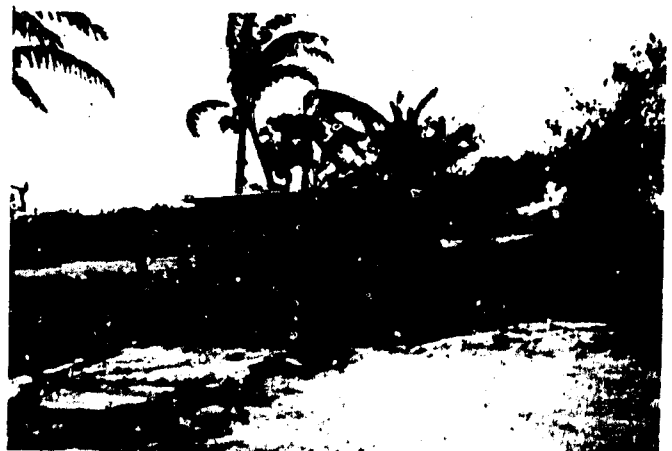
Figure 17

Australian Baptist Housing Project

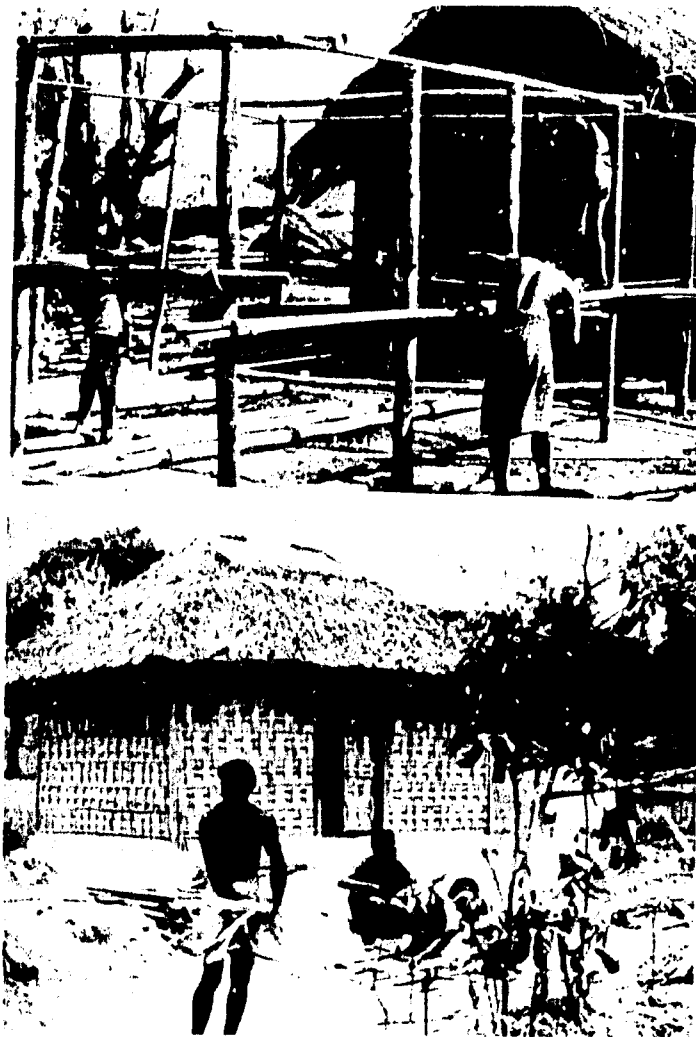
Figure 18  
MAP Housing Project

MAP Housing Project - The Medical Assistance Programs (MAP) Wheaton, Illinois, received a grant of \$900,000 from the U. S. Agency for International Development, Obligation #6226317, early in 1972. During April and May, 1972, twenty-four MAP team members carried out a variety of relief and rehabilitation projects in Bangladesh, including a housing project. The group improvised the construction of thousands of bamboo and thatch houses. AID provided \$522,025 for this part of the project. The type of house selected was the standard village home. Work concentrated in the high risk Chittagong District; over 4,000 homes were built.

The approach did not attempt to improve or strengthen existing housing designs, thus the same type of housing was constructed which failed before in the high exposure environment. It should be pointed out that the project was concluded well in advance of the Carnegie Mellon University team arrival. Therefore, a detailed evaluation of the performance of these houses was not possible, since they are not distinguishable from indigenous housing.

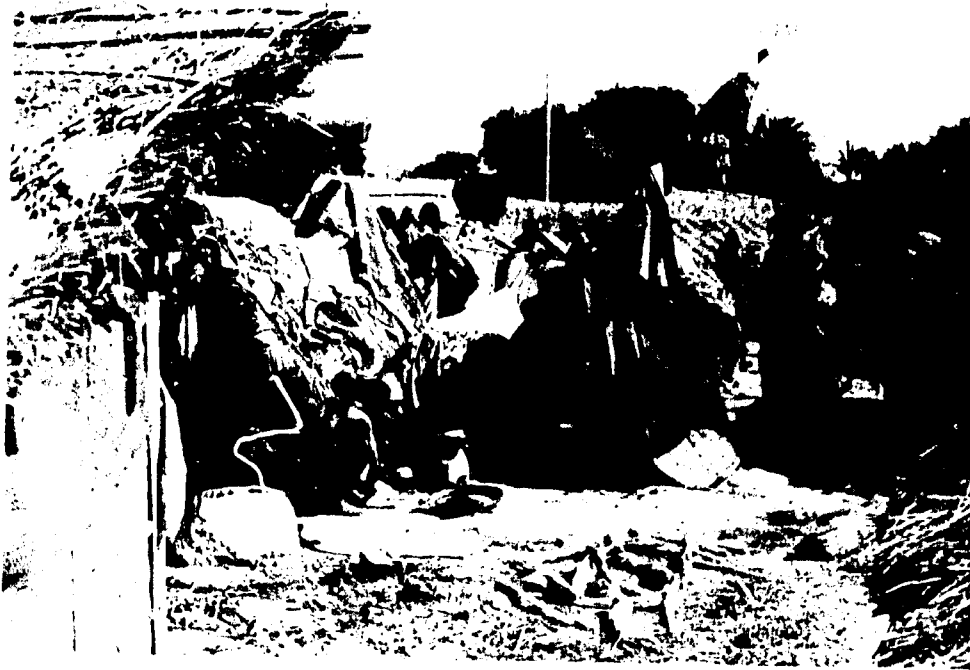
Figure 19 - Bahai Bustee Camps

A number of structures have been built in the Bahari Bustee Camps by the VOLAGS in Bangladesh, but the vast majority have been built by the refugees themselves with materials provided them with little or no technical assistance. Two programs are worth mentioning here as they are representative of the programs on-going during the field test.

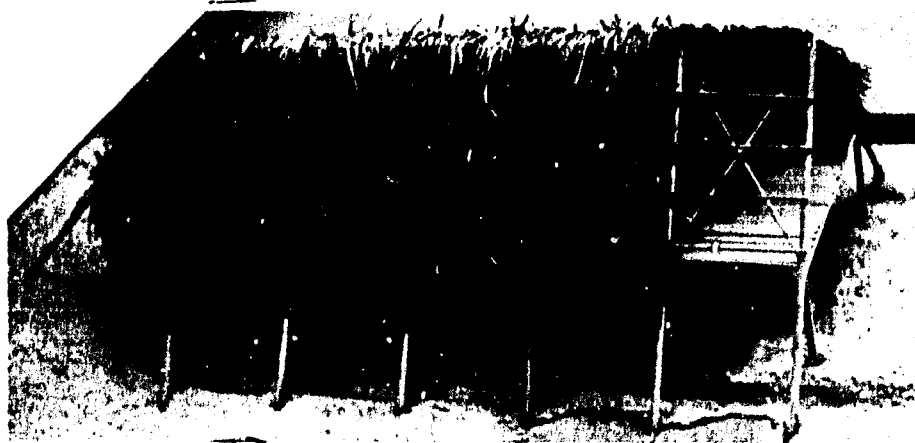
The Carnegie-Mellon University Shelter consists of three groups of components: the frame, the floor, and the roof.

Each of these groups has been designed so it is structurally independent of the others. For example, the frame does not depend on the floor for strength; the floor can be built by itself either before or after construction of the frame; and the roofing material can be any one or combination of materials -- either natural, such as thatch, or synthetic, such as corrugated tin or zinc. This enables the structure to be built either one at a time or en masse. The frame and the flooring systems can be pre-fabricated at one place and delivered to the construction site, or all the

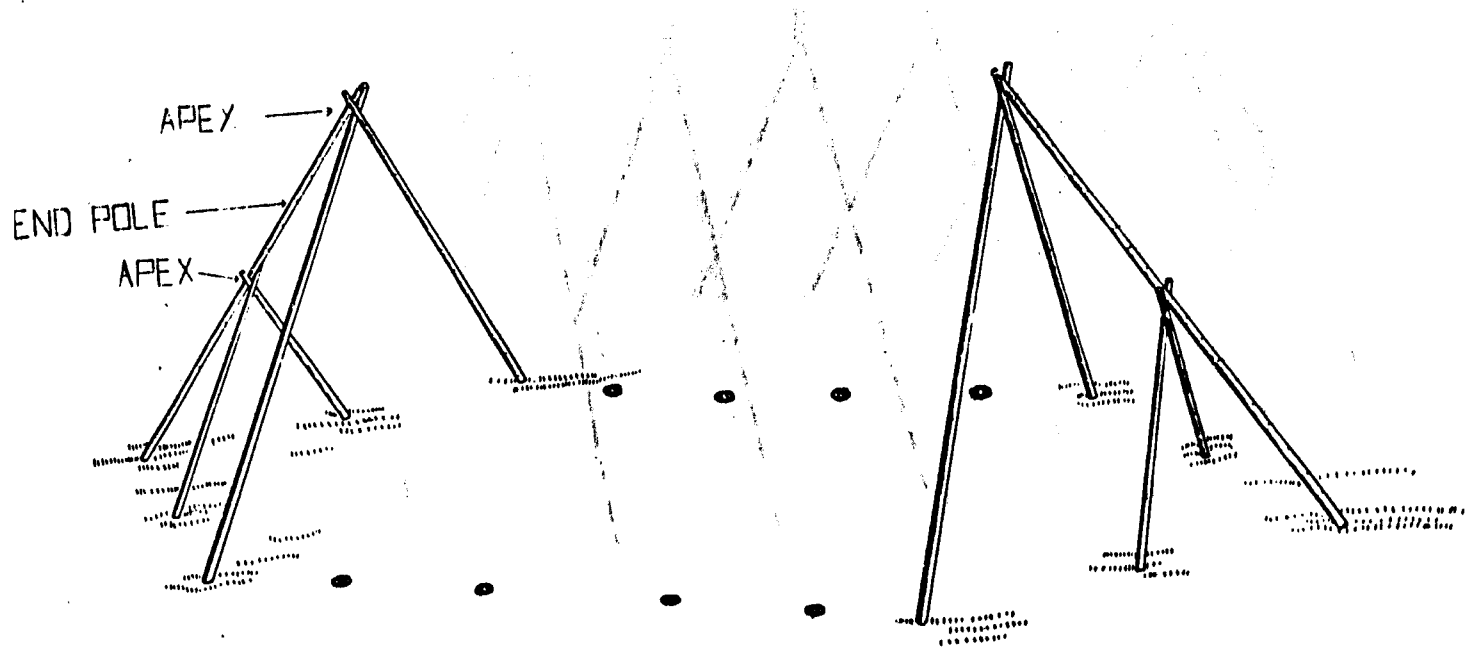
**STEP 6 - Tie the A-frame members together at the notch connection. Construct the end assembly by placing one large and one half size A-frame in the proper holes as shown. Lay one end pole over the apex of both and place its base in the proper hole. Tie components together and back fill the holes. Repeat at opposite end of shelter.**
