USDA Forest Service Technical Assistance Trip

**Virunga – Bwindi Region:
Republic of Rwanda, Republic of Uganda,
Democratic Republic of Congo**

**In Support to the International Gorilla Conservation Programme in
Analyzing the Region's Watersheds for Water Supplies to Local
Communities**

Mission Dates: March 4 - 21, 2005

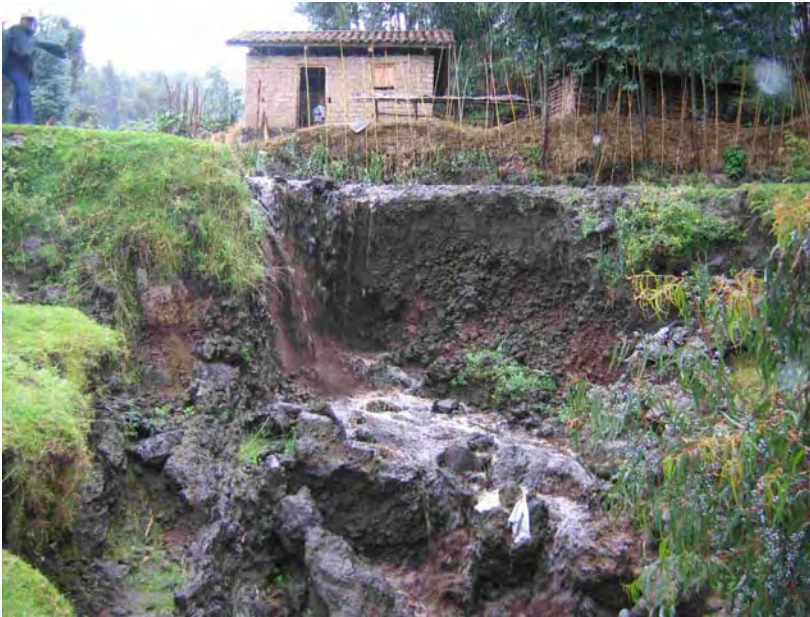
Figure 1: Severe erosion of volcanic soils in Rwanda. The steep pouroff is a headcut migrating up stream and across a road.

Forest Reserve), streams flow with relatively little sediment, while in adjacent deforested watersheds, channels are dry, entrenched, and wetlands show signs of high sediment deposition. Tropical forests form an exceptionally effective screen or filter between the atmosphere above and the ground below. Infiltration rates are usually high under forest cover where the forest floor layer is well developed. Where deforestation occurs, soil protection is decreased leading to overland flow and erosion. Decreased infiltration depletes ground-water reserves. Deforestation and widespread agriculture surrounding the national parks has increased the rates of erosion along stream banks, gullies, and roads. This rapid erosion is threatening to migrate upstream across the park boundaries, threatening soil stability in the forests. Wide spread land conversion from native forest to agropastoral land surrounding the national parks and the building of roads in newly inhabited areas has initiated chronic erosion in areas previously unaffected. The consequences of increased overland flow were observed in the formation of substantial gullies in grazed and cultivated areas, and incised stream channels. These problems are exacerbated in places where runoff is collected and channelized by roads. These erosional features tend to propagate headward, and have the potential of entering the parks, threatening soil stability, depleting groundwater, and decreasing biological productivity (fig. 1).

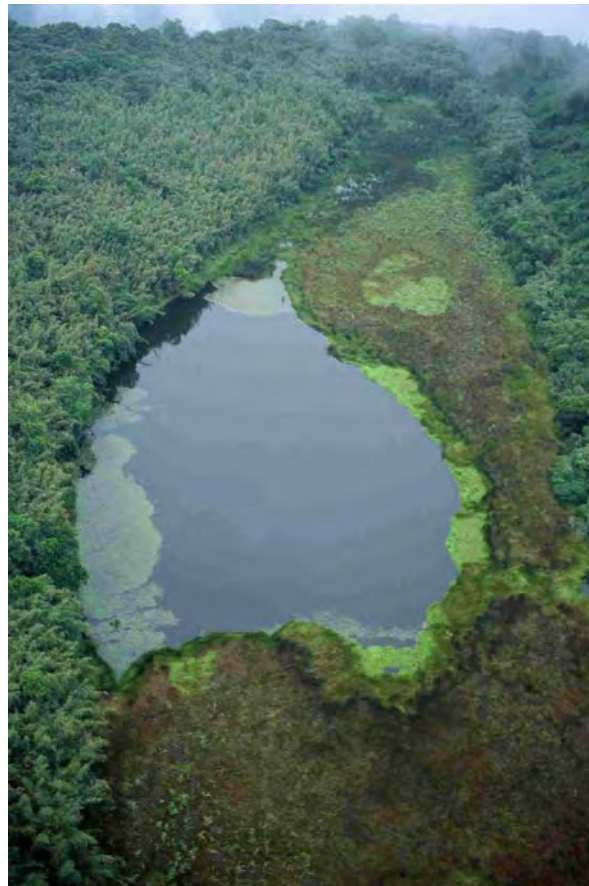
Figure 4. Ongoing transition from open-water to wetland ecosystem at Lake Ngezi.

Some of the most conclusive evidence of drying climatic conditions was observed in closed basin lakes within the parks. Lake Ngezi, in particular, is in transition from an open-water habitat to a wetland (fig. 4). Since Lake Ngezi is in a closed basin (no inflow or outflow streams), lake levels are very sensitive to rainfall and evapotranspiration. Decreases in rainfall and increases in evapotranspiration from warmer temperatures would cause the lake level to drop. In the area where the transition from open-water to wetlands is taking place, several large tree stumps were found (fig. 5) indicating that historically, the lake has experienced extended dry periods that lasted long enough to grow substantial size trees. When wetter conditions returned, the trees were inundated and died. This evidence would seem to support the idea that local lake and wetland water levels are being controlled primarily by cyclical climatic factors rather than man-induced factors.

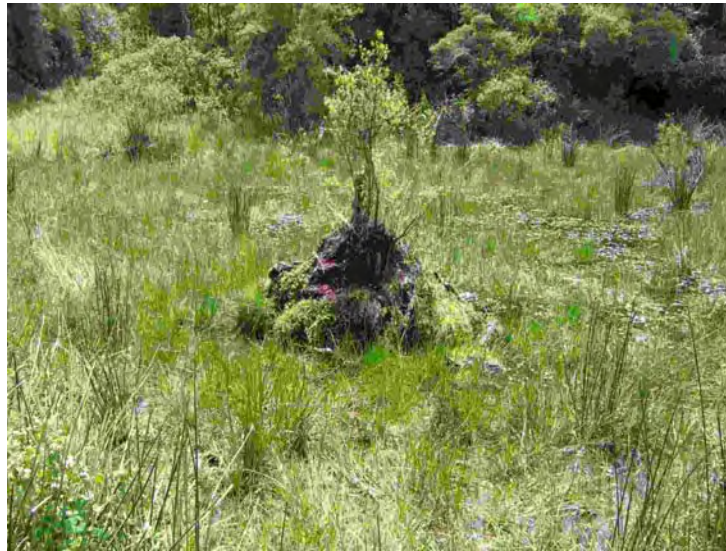
Figure 5. Large tree stump among wetland successional species indicates extended dry periods in the historic past.

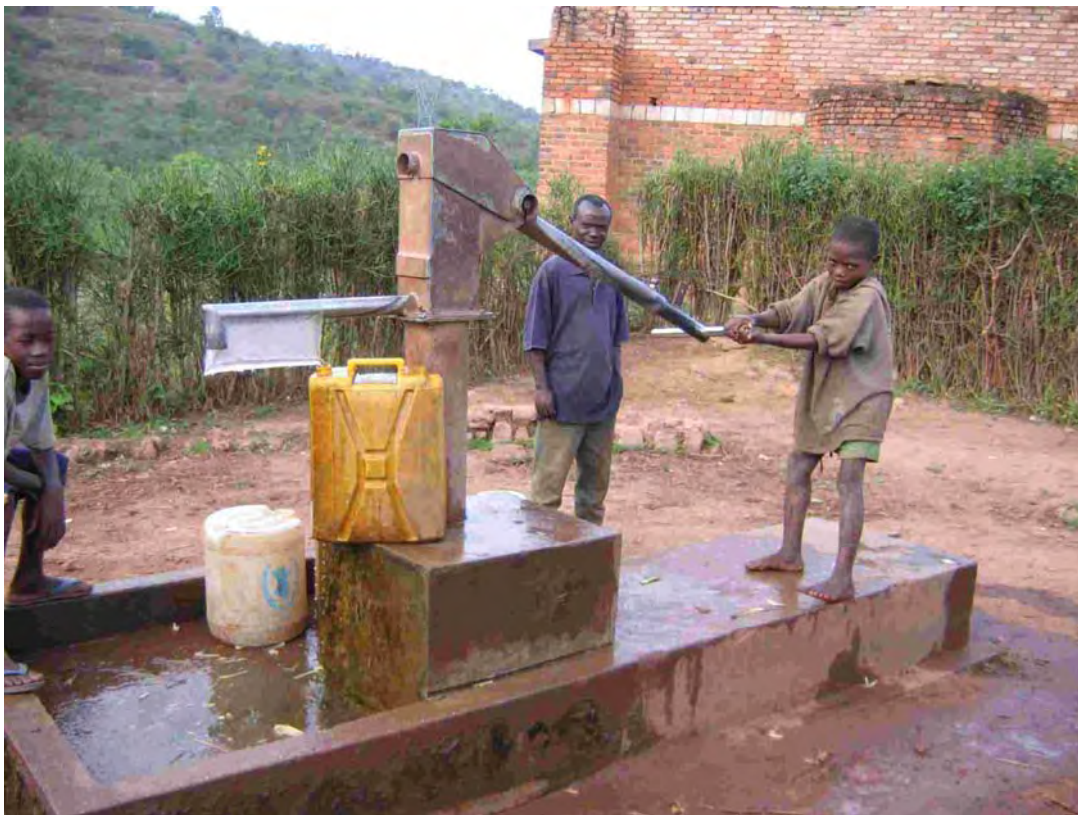
Figure 8. Borehole operated with a hand pump supplies water to a village near Akagera National Park, Rwanda.

Boreholes are used for water supply in many parts of Africa including Rwanda (fig. 8) and Uganda. Boreholes are used primarily in areas where ground water is the only water available. Several boreholes have been drilled in the Kisoro area with mixed success. Some are still operating successfully, and some are non-operational. Boreholes suffer from the same failures as other water supply schemes including pump breakdown, lack of replacement parts, and lack of maintenance. In areas with variable aquifer conditions like the volcanic rock aquifers of the Virunga region, several exploratory boreholes may have to be drilled before one with sufficient yield from a reasonable depth can be located.
