POWERING HEALTH

OPTIONS FOR IMPROVING ENERGY SERVICES AT HEALTH FACILITIES IN ETHIOPIA

AUGUST 2008

This publication was produced for review by the United States Agency for International Development. It was prepared by Pamela Baldinger of the Office of Infrastructure and Engineering's Energy Team and Walt Ratterman of SunEnergy Power.

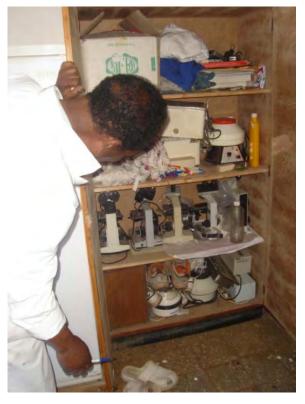
ABOVE: A closet full of non-functioning equipment at a health center in Amhara.

BELOW: The lab in the same health center had to jury rig an exterior light bulb in order to use its one partially functioning microscope.

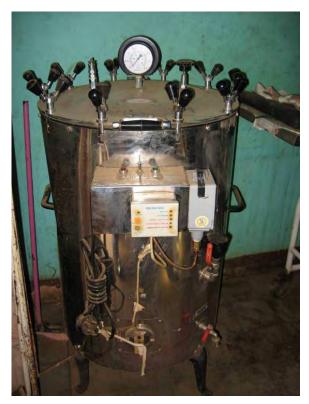
A new sterilizer unable to be used because the health center lacks the proper wiring.

Assume, for example, that a room designed to be a lab is installed with 10 amp outlets, but the facility receives a piece of equipment that requires a 30 amp outlet. Even though the equipment will have a plug that doesn't fit the outlet, the users likely will figure out a way to connect that piece of equipment, at least temporarily. The result may be a destroyed outlet, burned up wiring, and quite possibly, a damaged piece of medical equipment. We saw numerous examples of

equipment plugs boot-legged onto improperly sized outlets and wired with tape in order to be able to turn on the equipment. This practice is unsafe both for people and equipment.
