Egypt LIFE Red Sea Project Hamata Existing Condition Report (Profile)

TECHNICAL REPORT

OCTOBER 2006

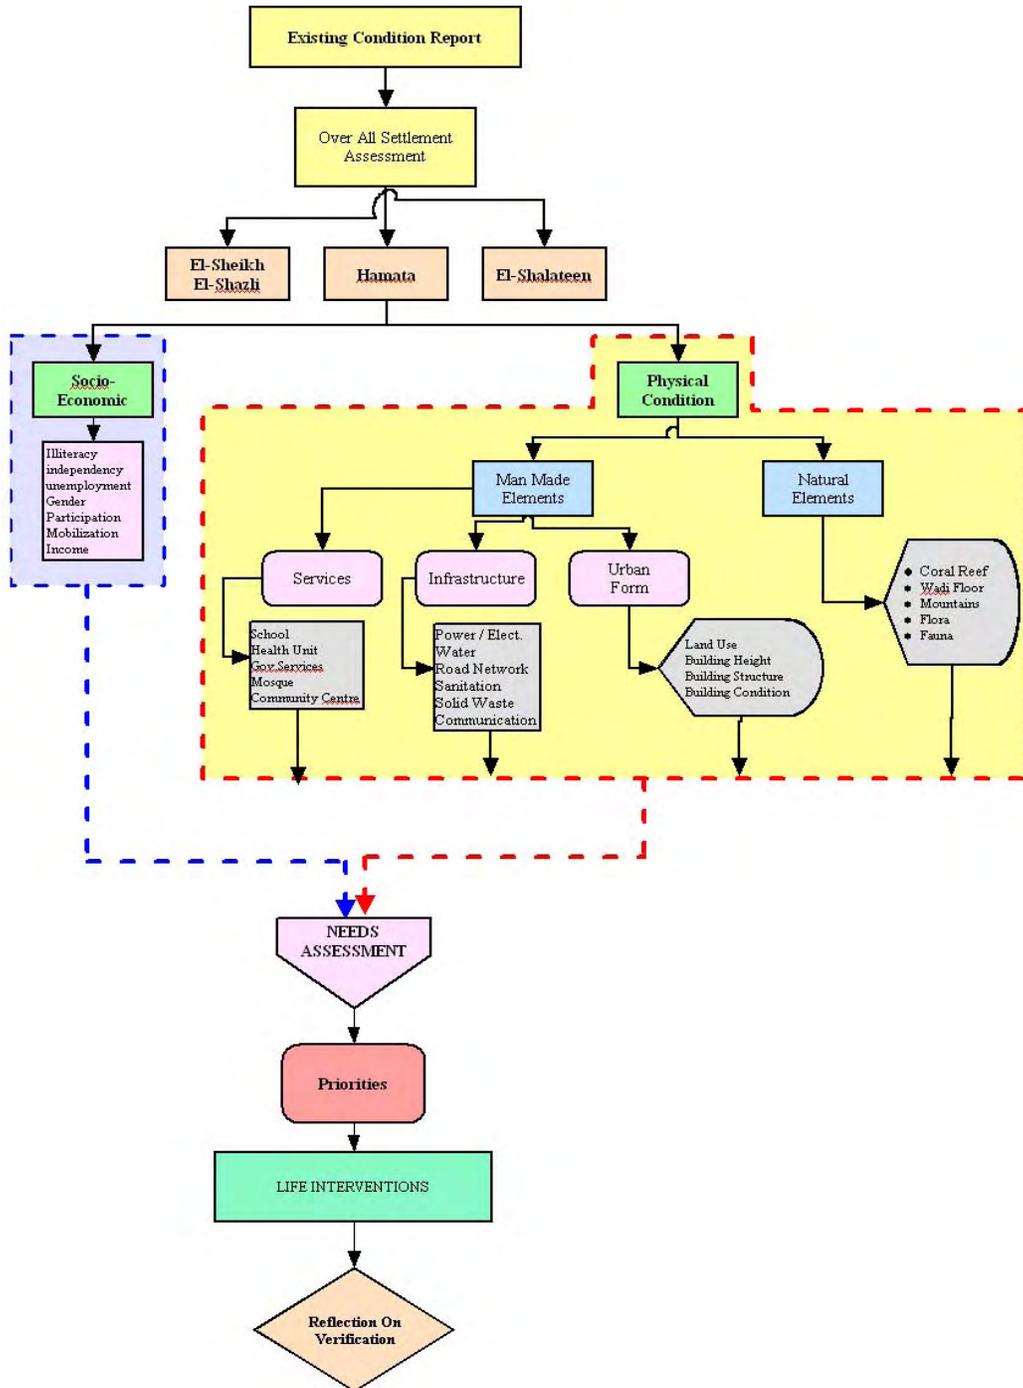
Figure 3 the methodology used in the report

The diagram below shows the sequence in which this report was conducted and the methodology used to describe the process.

The process simply divide the village component to natural elements and man made elements, then conduct a need assessment which identify the project intervention

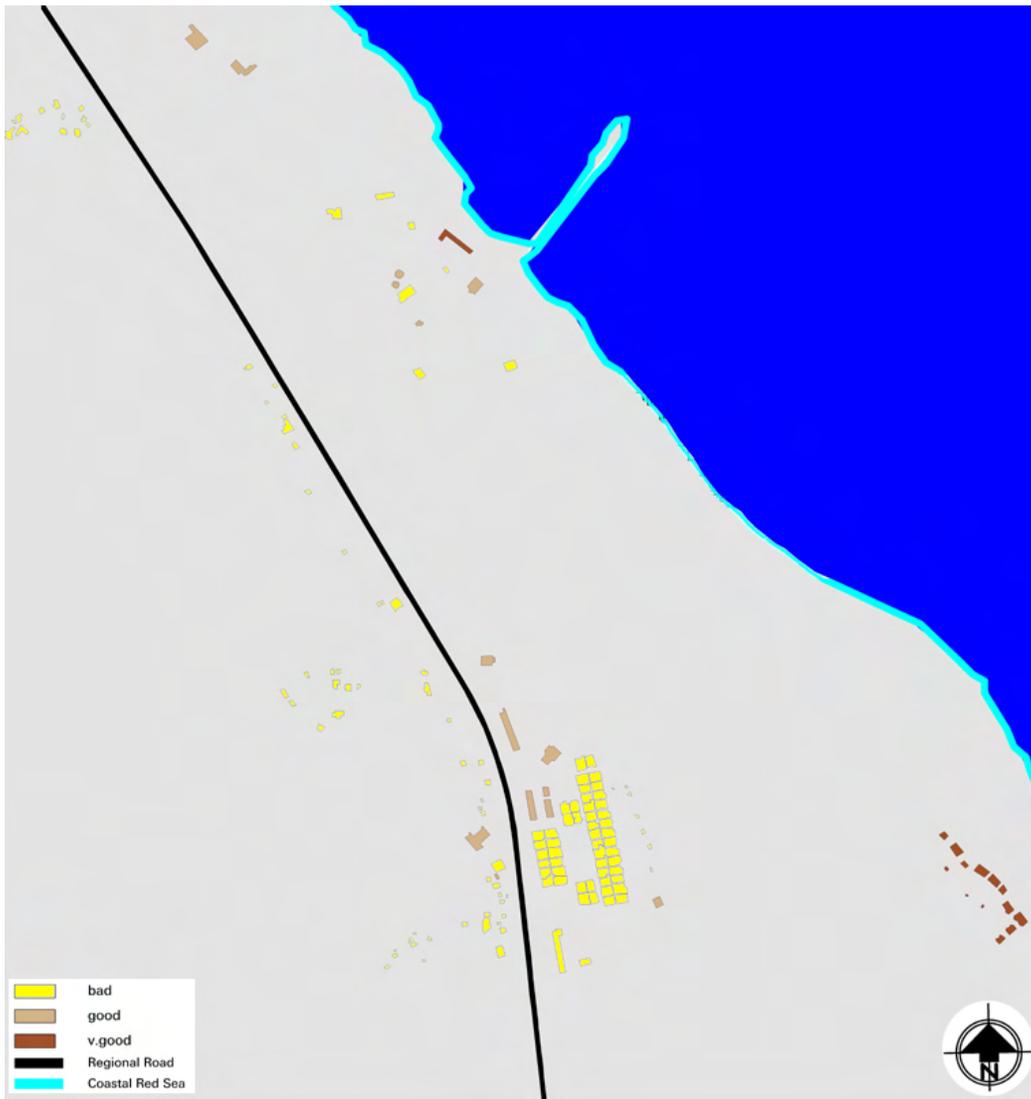
Figure 10 Building Condition of Hamata village

Most of the buildings in the village are in medium or bad condition. The map above shows some buildings in good conditions in the south east of the village (near the coast line) and these are hotel rooms under construction and owned by an investor.

The “Tawteen” building structure is in a very bad condition (located adjacent to the highway-on the east side), together with the shacks spread all over the village, east and west of the road, requires immediate renovation as it does not provide adequate shelter for the residents of the village.

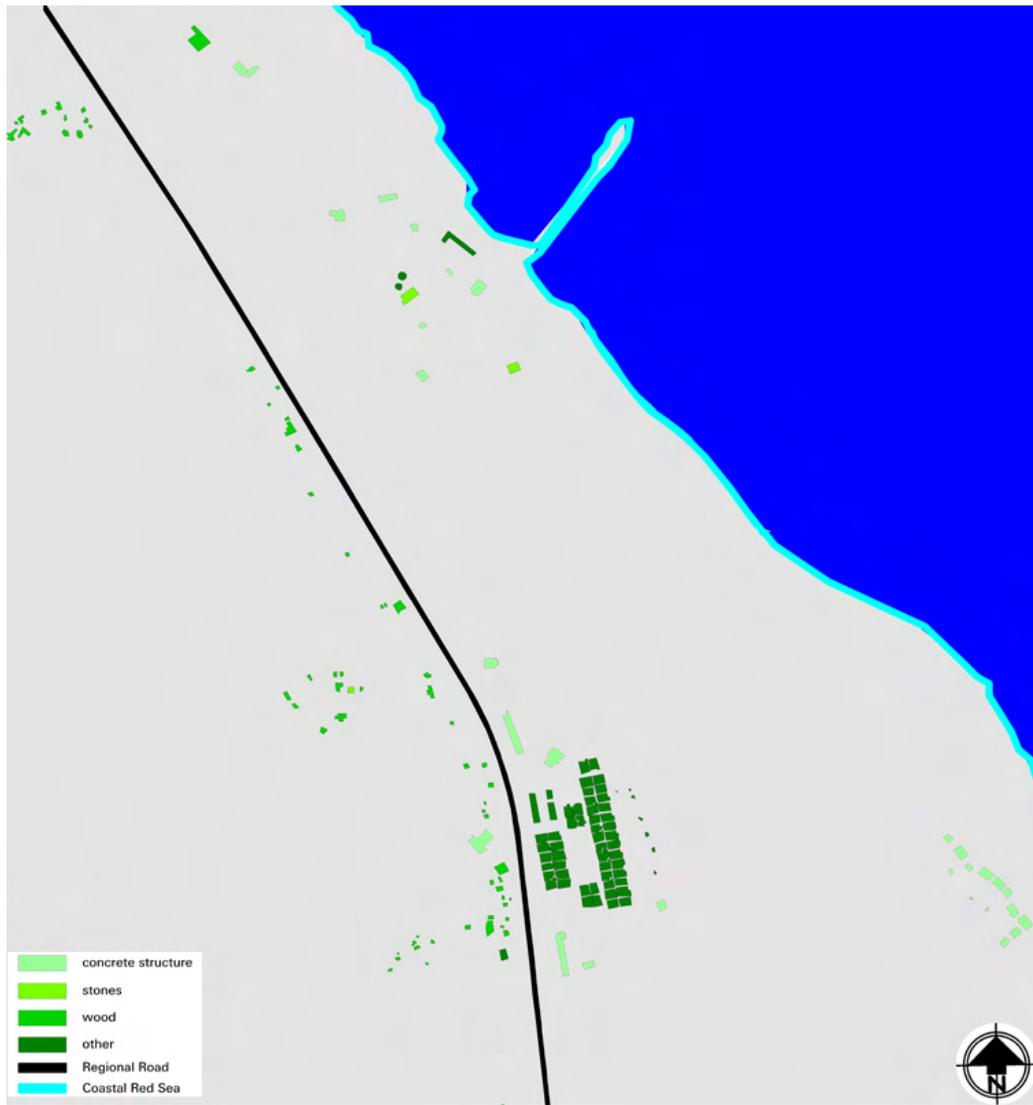
Figure 11 Building material / structure of Hamata Town

The buildings in the village are either built of concrete structure which are the government building, the school, the mosque and some of the buildings associated with the marina (i.e. the water desalination and the diesel generators room). Apart from that, the shacks are built of different combinations of materials, mainly steel sheets and wooden panels and grass mats.

The “Tawteen” buildings are built of stones and its ceiling is made of asbestos.

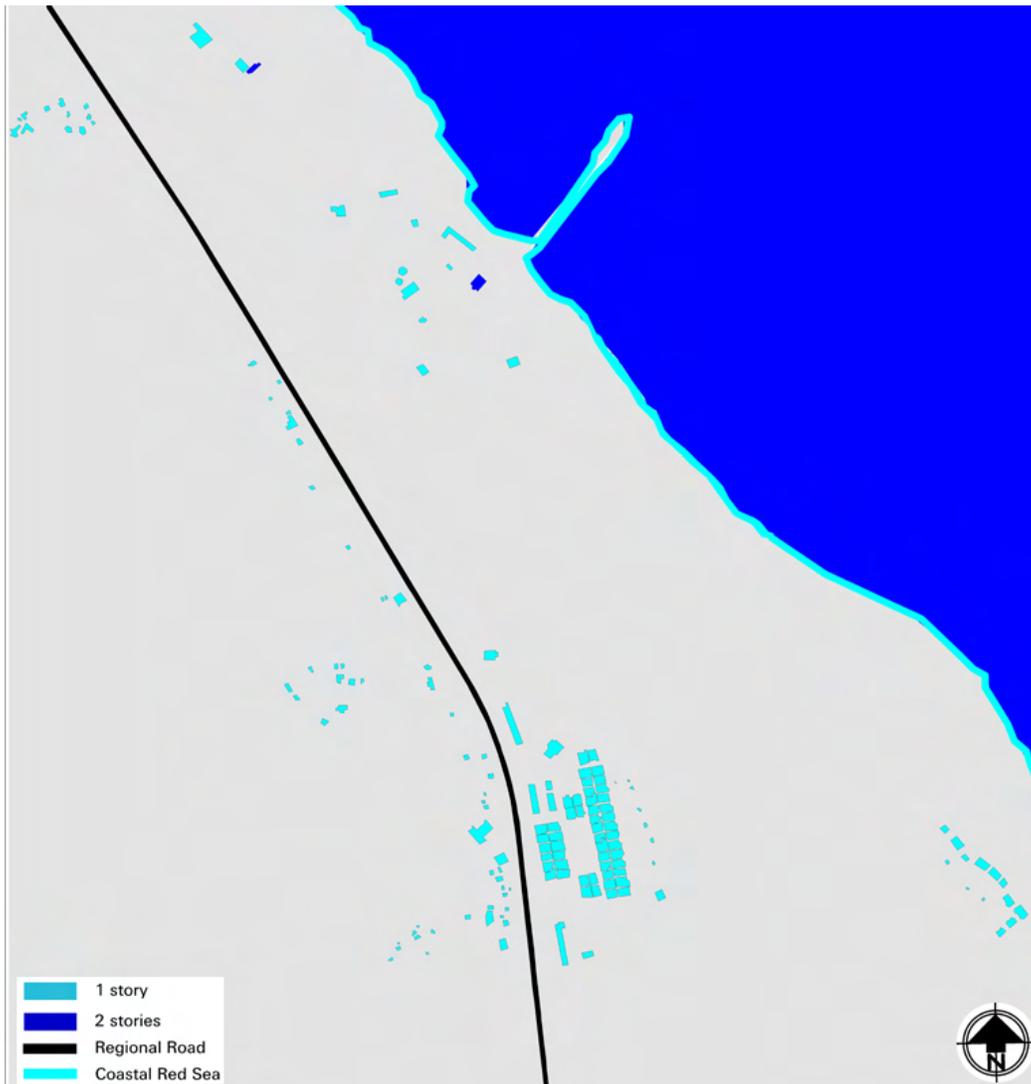
Figure 12 the building heights map

All the buildings are one story in the village (except for the mosque minarets and another services building adjacent to the marina. That makes the topography of the town very visible and makes a very semi-straight skyline.

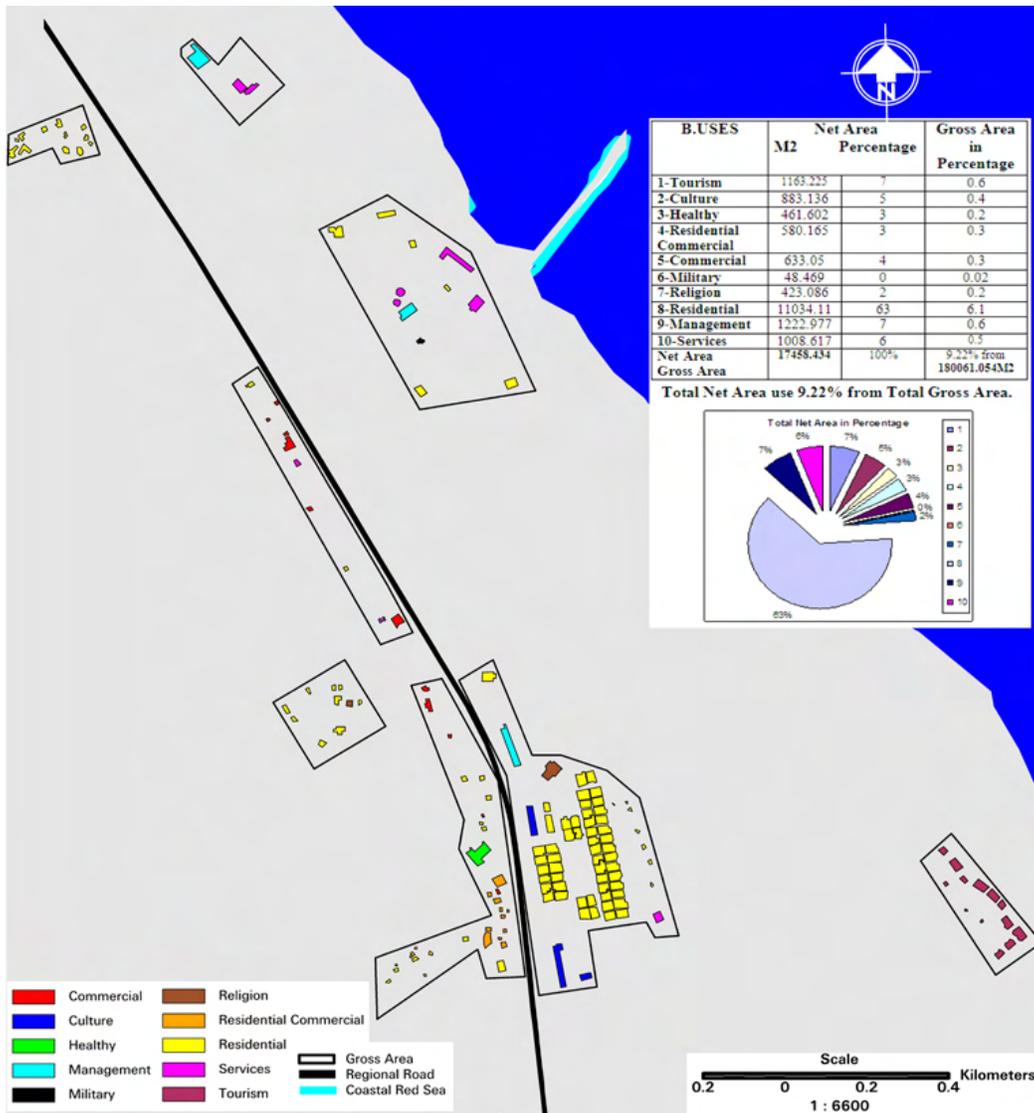
Figure 13 the current land use map of Hamata Village

Apart from the official land uses, some hidden uses were found in the informal shacks that contribute to the day to day activity and the economy of the village.

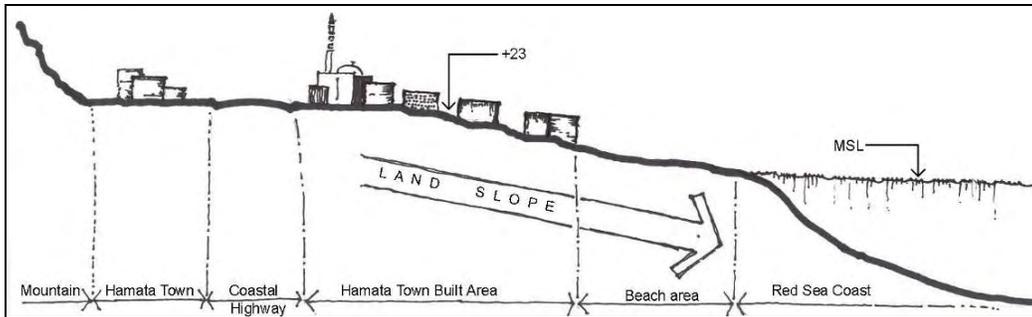
Figure 14 Conceptual Cross section in the village perpendicular to the coast showing the slope direction

The current situation assessment reveals that the current method of excreta disposal and domestic waste water disposal is a sort of a primitive trenches that are locally constructed and needs to be evacuated periodically (some times once every two months). This is costly and the existing level of service (if there is any) needs to be improved.

There are many environmental hazards from the wastewater seepage towards the sea due to the natural topography of the village

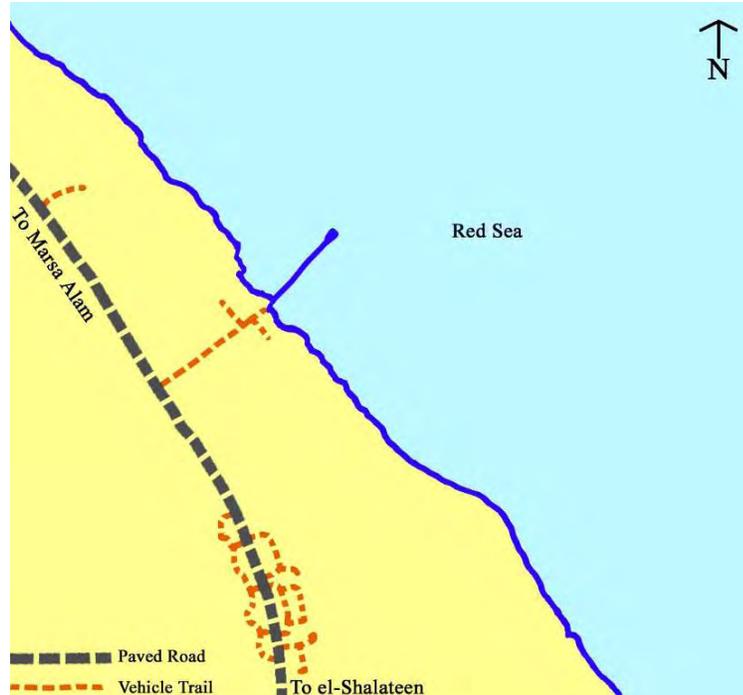
Figure 15 Local Road Network (Paved & Trail)

The street network in this village is extremely simple; there is just one asphalt road, which is the main coastal highway. Residents have developed some local tracks perpendicular to that road. These tracks are mainly used to link the highway with certain activities (i.e the marina, the “Tawteen” units the locust combating unit and the ranger outpost)

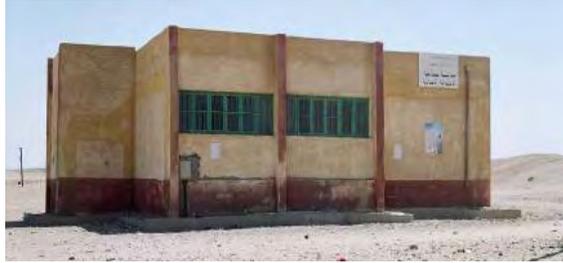
Figure 16 Hamata primary school

The picture to the right in figure (17) shows the building of Hamata school looking from the south. As the picture shows it is a one story concrete building in a medium conditions and require some restoration work to accommodate the students activities comfortably

The school has 5 elementary classrooms and 2 preparatory ones with total number of students of about 47.

- Remove existing lime layer
- Restore the cracks between the walls and the concrete columns by applying coating materials or extended wire net before applying the plastering layer
- Plastering the damaged parts
- Apply oil painting at 1.5 m high from the window level and apply plastic painting on the remaining height
- Remove the existing wooden “backings” and apply another 4 x 1 inch “backings”
- Install 3 wooden “backings” sized 2 x 1 inch for using the educational support means on the opposite side of the blackboard with an intermittent separating space of 25 cm, and a height of 1.5 m from the floor

- Replace all power lines including main distribution panels, switches, support and distribution racks,
- Provided illumination inside the class composed of 2 searchlights, 2 lamps and one fan

- Replace all existing doors and windows
- Install protective steelworks (frames) on interior and exterior windows

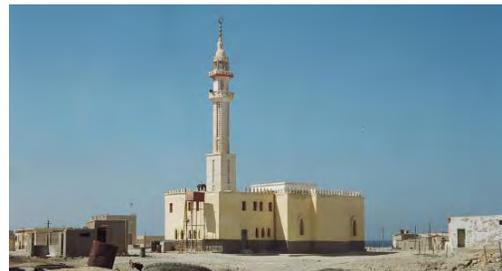
Figure 17 The village main mosque

The mosque of Hamata is situated in the middle of the town and it is built of concrete. During the Friday prayer, it serves Hamata and all other shacks that is within walking distance from the village.

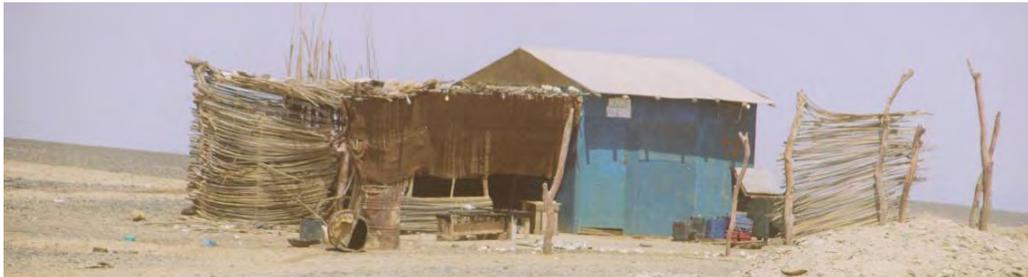
Shacks designs vary from a family to another but it generally has a sleeping space (bed room), a cooking space (kitchen) a living space, a toilet and a “Madiafa” (which is a small external room to receive guests).

Figure 21 example of the shacks in the village of Hamata, (built by wood, steel and grass-mats)

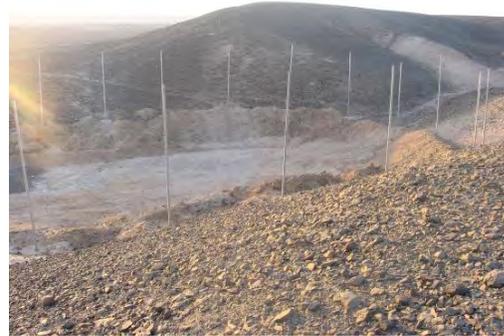
Wadi El Gemal- Hamata rangers had identified a location to establish a controlled dumpsite, but after implementing the Wadi El Gemal transfer station model, they will make it a similar station for waste recovery. The posts have been installed, and only half of the mesh required for fencing is provided by Lahmy bay (a coastal resort), but other items are still needed, in addition to processing equipment and a small budget to prepare the station site.

Figure 22 the fenced area near Hamata for solid waste collection (waste recovery)

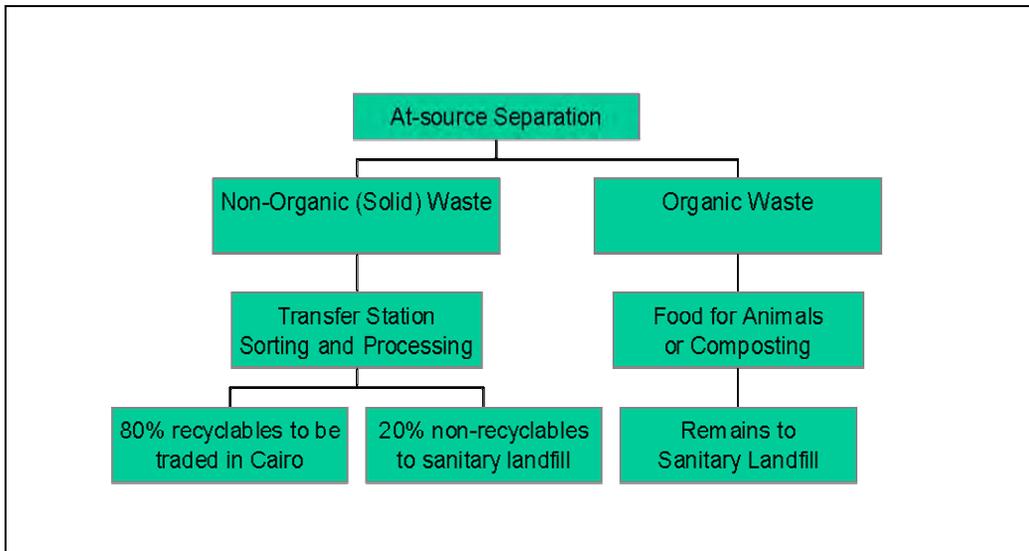
Figure 23 Solid waste management processing flow chart

- Establish fee for service which the entity takes over the management responsibility, will charge resorts, boats, ..etc. for the service of collecting and transporting waste, processing it and ensuring a clean environment exists in the region to promote the interests of the same resorts and tourism at large.
- Draw up contracts between the operator and resorts & boats for the provision of the full integrated service.
- Train the new institution that will take charge of this activity in operation and management

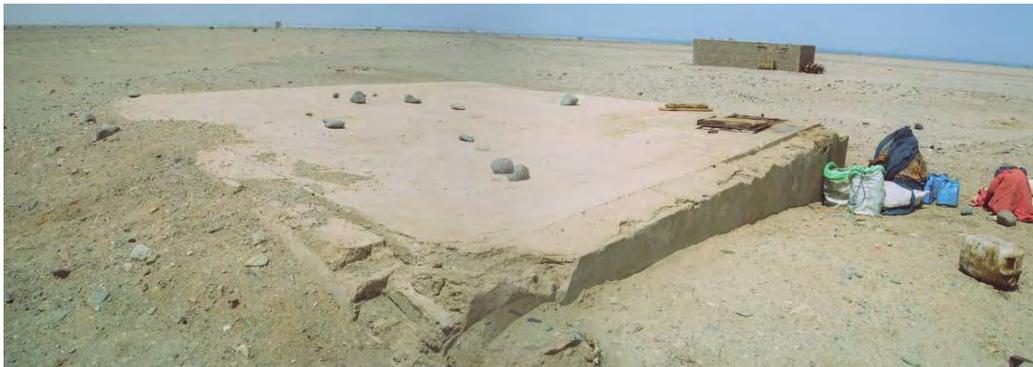
Figure 24 Communal concrete water tank

The picture in figure (24) shows the concrete storage tank. It is usually a box with an opening in the top that has a steel cover, rope and a bucket, it is the main water collection point for the settlement, which means that the water trucks discharge at this tank and the locals use barrels to fill their own small plastic tanks

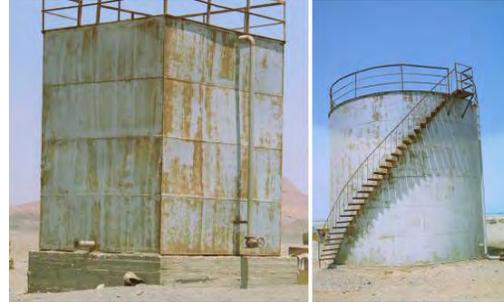
Figure 25 main steel communal water tank

To the right in figure (25) is also another type of main storage for the settlement, it is a huge steel tank that is often fitted with a water pump to help the water truck discharge, and it is also fitted with a water tap to be used to fill the individual tanks. These collective tanks should be maintained and cleaned from inside as their openings allow a person to get in.

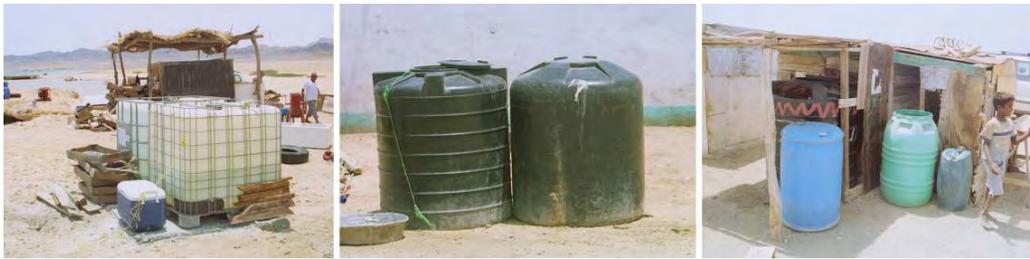
Figure 26 individual families plastic tank (cylinder or cubic shape)

The above pictures in figure (26) show the individual unit (family) tank which is mainly in the shape of a black plastic cylinder as in the picture in the middle (sometimes it comes in white Quebec form surrounded by steel mesh for protection). There are also some plastic barrels that are used if the single tank is not sufficient for the family.

In addition to this increase, there has been specific recommendation by the LIFE Red Sea about the best practices of maintaining the current water tanks and identifying the best routs in the best order to truck the water from the source to the origin.
