DISASTER  
RELIEF

CASE REPORT  
Peru-Landslide & Flood  
April-June 1974

# PERU

## Landslide/Flood—April 25 - June 8, 1974

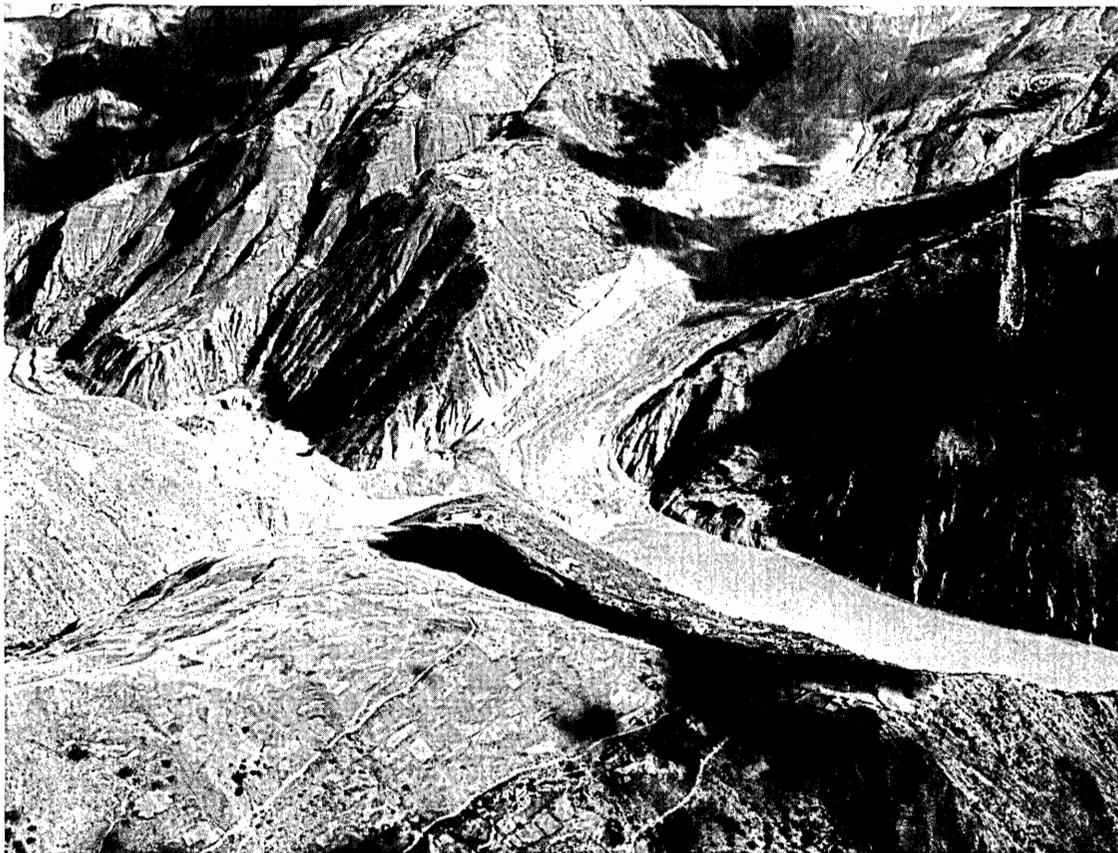
*The massive landslide on the Mantaro River destroyed eleven settlements killing 310 people.*

Shortly before 9:00 p.m. on April 25, 1,600 million cubic meters of rock and earth slid with a speed reaching 85 miles per hour down a 30 degree slope burying numerous settlements and killing 310 people. The location of the slide was at 56 kilometers on the La Mejorada-Ayacucho road at the village of Huacoto, Andabamba District, Acobamba Province, Department of Huancaavelica. The geographic position of the site is latitude 12° 38' 12" S, longitude 74° 40' 32" W. Unusually heavy rains along a fault line may have triggered the landslide.

Rushing on into the Mantaro River from the right bank, the slide's momentum carried part of the material up to the slope of the opposite bank, from which it crashed back. A huge mass of rock and earth blocked the river's flow and behind this dam a deep, long lake formed. Among the largest avalanches ever to occur in Peru, this displaced mass formed an inverted trapezoid approximately 4.2 miles long, with an average width of .6 of a mile and a depth of 328 to 492 feet. Measured along the bottom of the river, the deposit was 2.1 miles in width
