Finding means to promote the integrated management of natural resources in the sub watershed of the Chimbo River, Ecuador

**Earth University, Costa Rica
February, 2010**

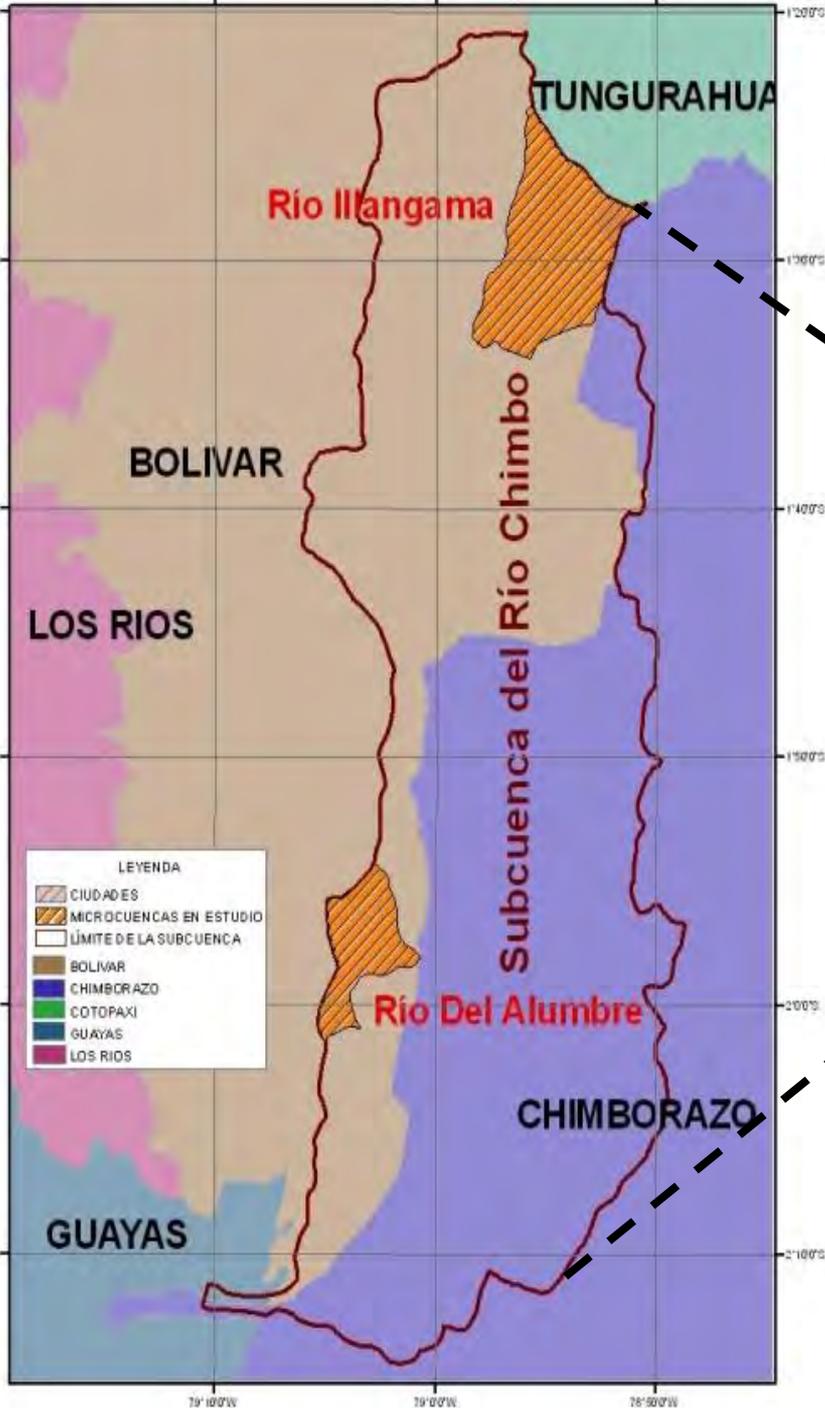
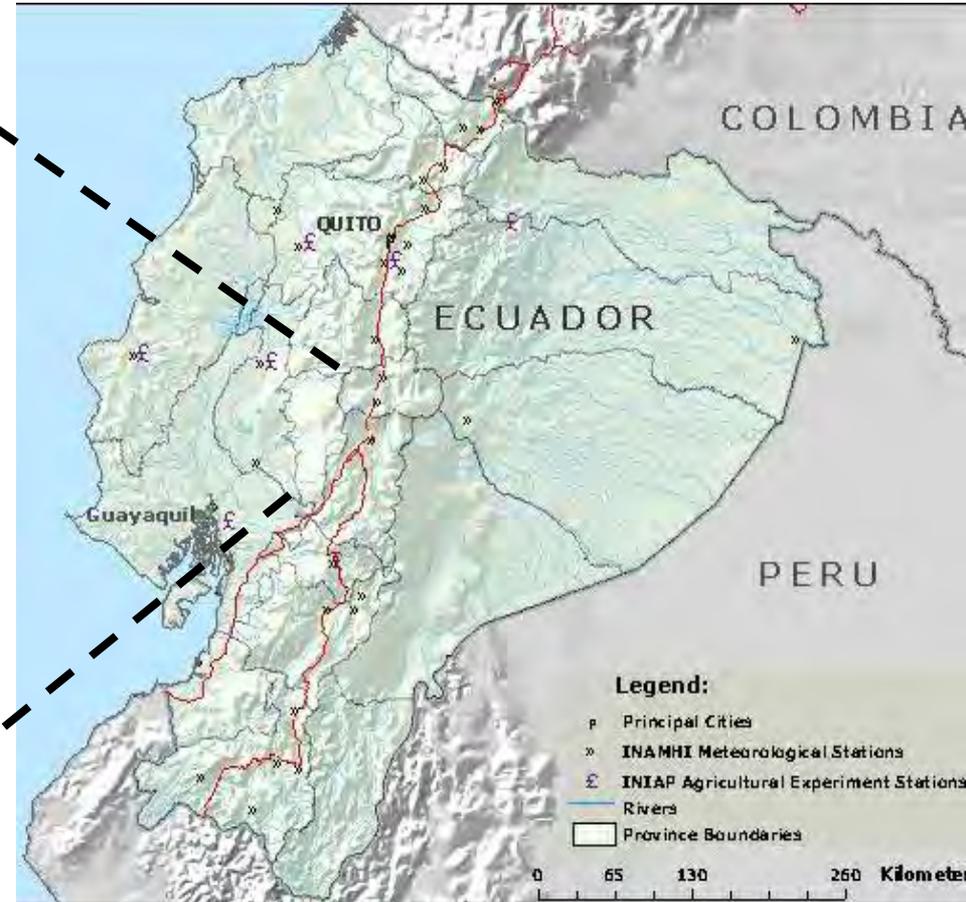
Sub watershed of the Chimbo River, Ecuador

Sub watershed of the Chimbo river: 3635 km²

Micro watershed of the Illangama river: 130 km²

Micro watershed of the Alumbre river: 65 km²

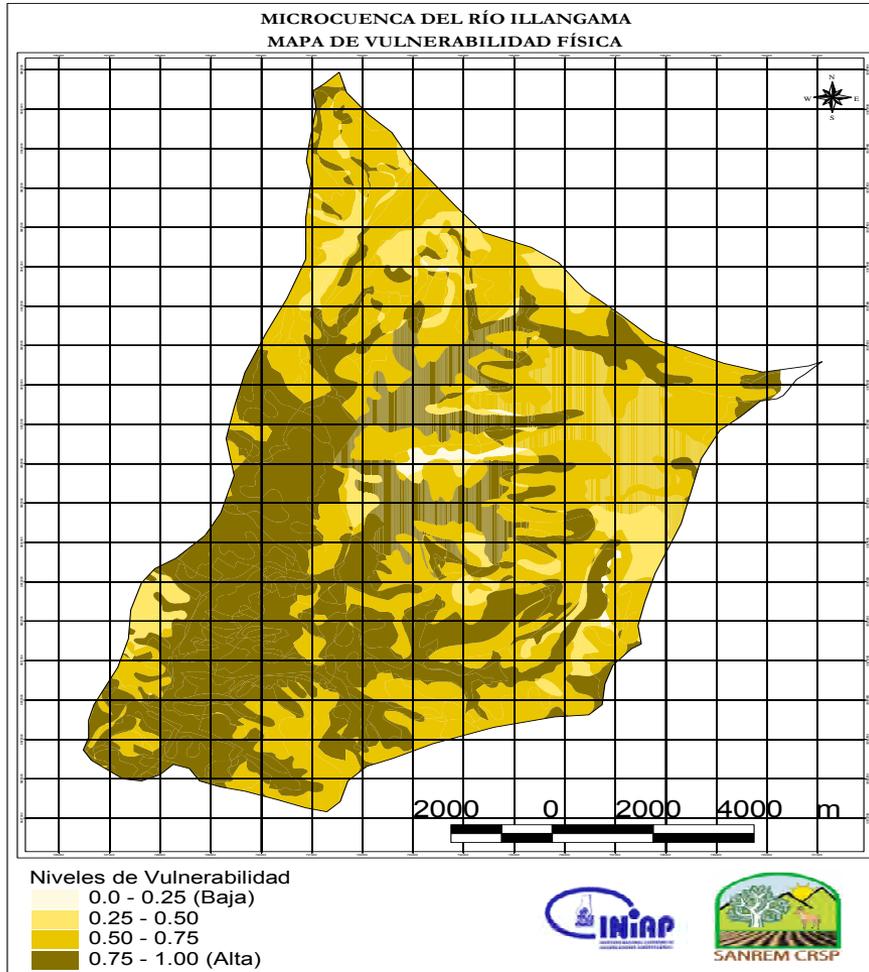
Vulnerability mapping

- **Based on GIS overlays of variables including: slope and erosivity, current land uses, soil cover, population pressures, others.**
- **More than 3664 ha in Illangama and 2259 ha in Alumbre are “highly vulnerable”.**
- **Local governments have begun process of reforestation in vulnerable areas and water-sensitive areas.**

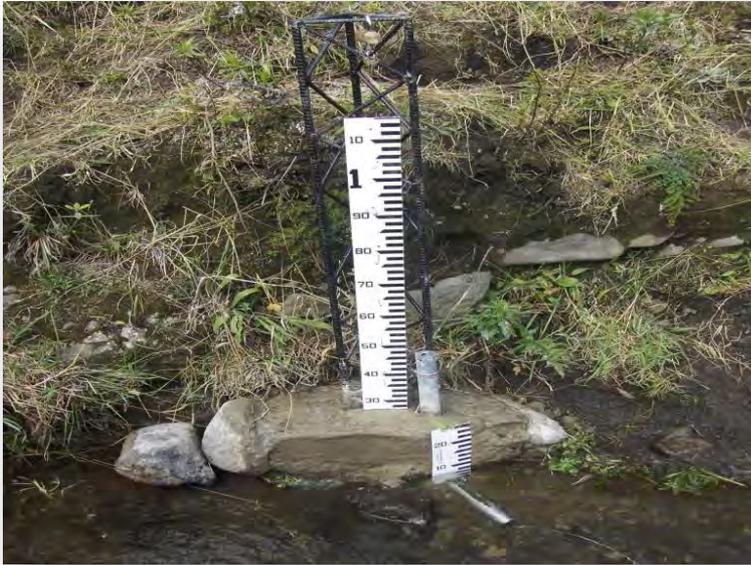
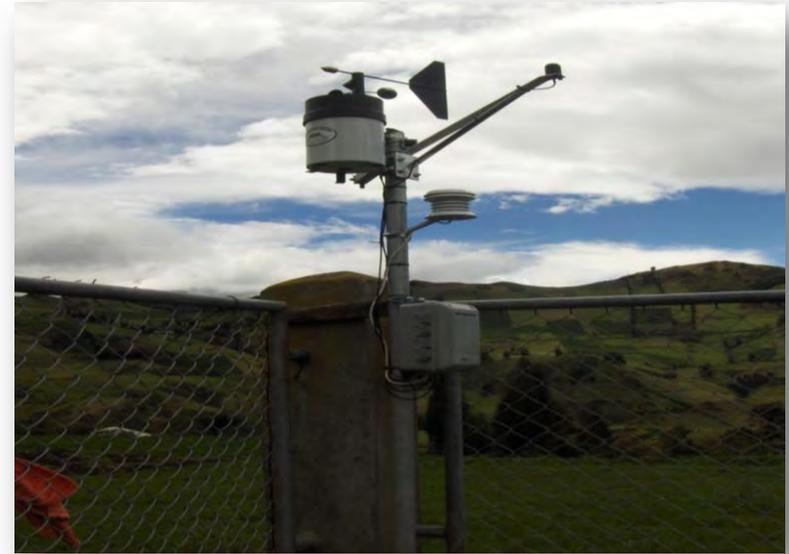
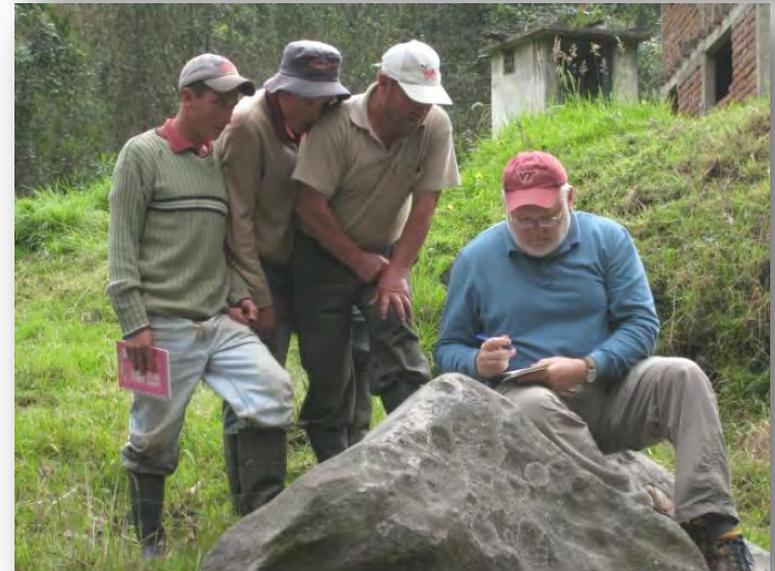
Monitoring physical processes

- Seven meteorological stations installed in the sub watershed.
- Seven water flow measurement sites.
- Training project personnel and local stakeholders.

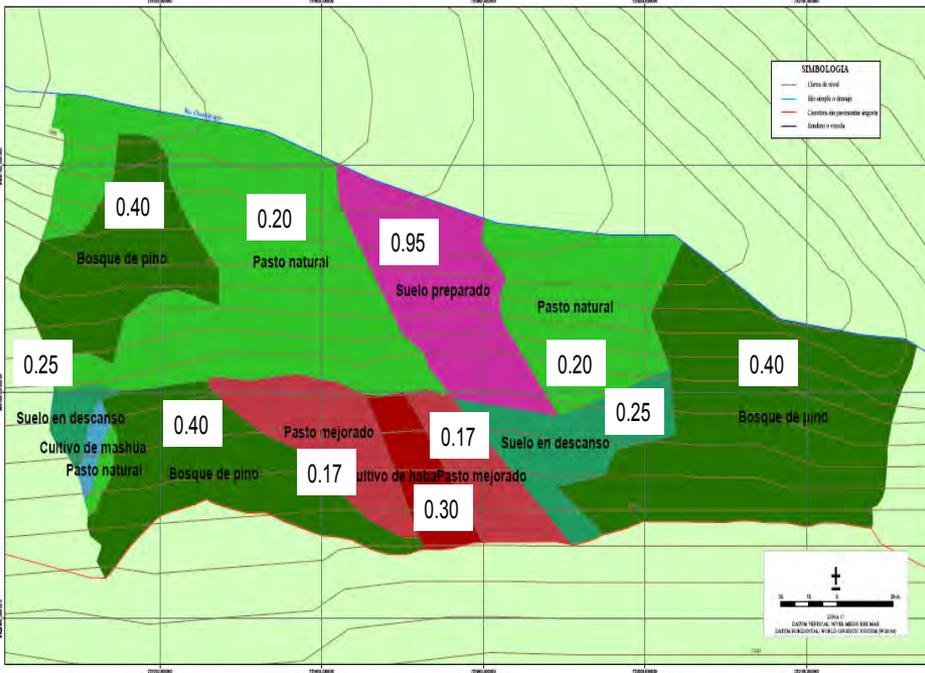
USO Y COBERTURA DE LA TIERRA
PROPIEDAD DE MATÍAS PAGUAY

SÍMBOLO	USO	Área planimétrica m ²	%
[Green]	Bosque de pino	29375.36	39.31
[Red]	Cultivo de haba?	1938.57	2.59
[Blue]	Cultivo de masha?	395.82	0.54
[Purple]	Pasto mejorado	5921.02	7.92
[Light Green]	Pasto natural	25521.75	34.15
[Dark Green]	Suelo en descanso	4900.52	6.56
[Pink]	Suelo preparado	6673.28	8.93
TOTAL		74726.32	100.00

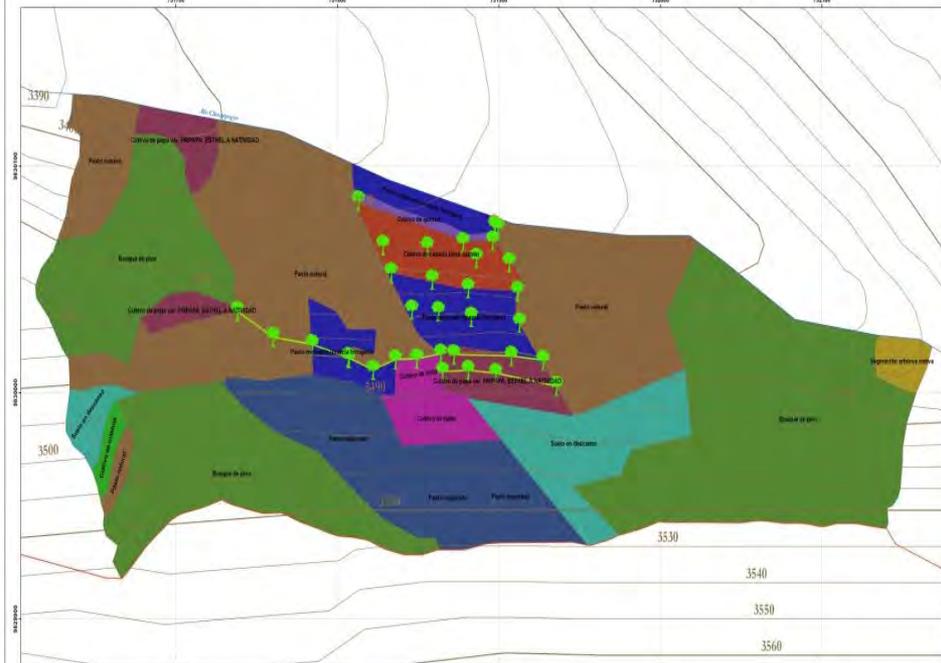
IMPLEMENTACIÓN DE BUENAS PRÁCTICAS PRODUCTIVAS - AÑO DOS
PROPIEDAD DE MATÍAS PAGUAY - COMUNIDAD MARCOPAMBA

Símbolo	Uso	Área planimétrica (m ²)	(%)
[Green]	Bosque de pino	28722.42	38.41
[Red]	Cultivos de rotación (maíz y haba)	2825.27	3.72
[Blue]	Cultivos de haba (Ecopar y Conchumbi)	1278.18	1.70
[Purple]	Cultivos de masha	395.82	0.53
[Light Green]	Cultivos de papa var. FRAPPA, ESTHELA NATIVIDAD	3146.11	4.21
[Dark Green]	Cultivos de quinua	3303.91	4.41
[Light Blue]	Pasto mejorado	7469.29	9.97
[Medium Blue]	Pasto mejorado (mezcla forrajera)	4535.70	5.96
[Green]	Pasto natural	21228.78	28.41
[Dark Green]	Suelo en descanso	4900.52	6.56
[Pink]	Suelo preparado	6724.61	8.92
[Yellow]	Vegetación arbórea nativa		
TOTAL		74726.32	100.00

Especies arbóreas nativas:
Quercus, Ficus, Quercus, Liquidambar, Alnus, Ligustrum, Pterocarya.

Cultivos en curvas de nivel:
Especies arbóreas nativas

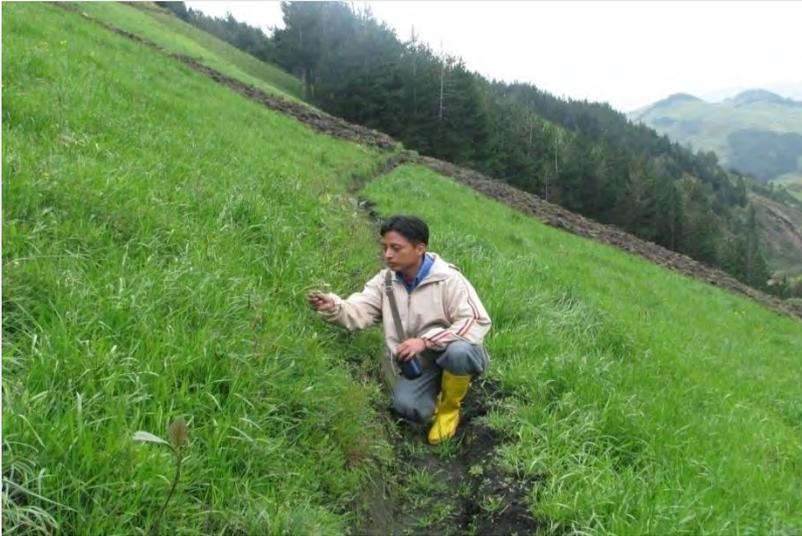
Improved pastures with deviation ditches

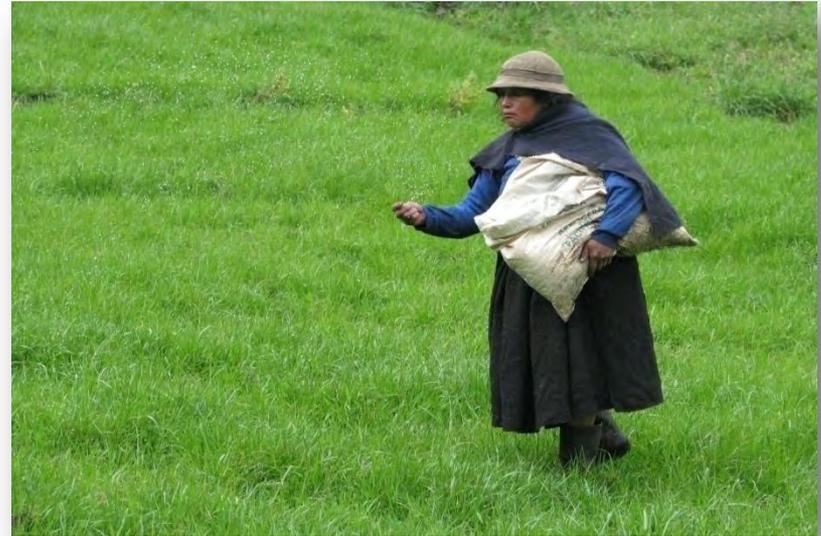
Management of improved pastures

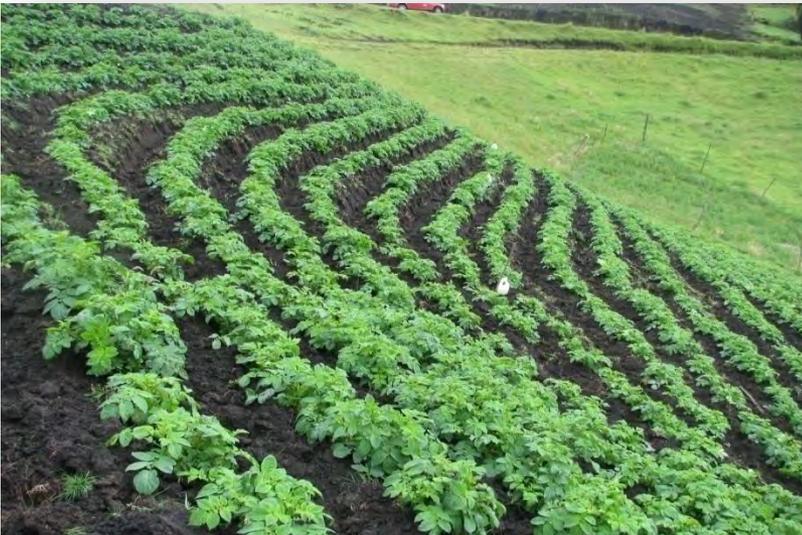
Potato cultivation in contours

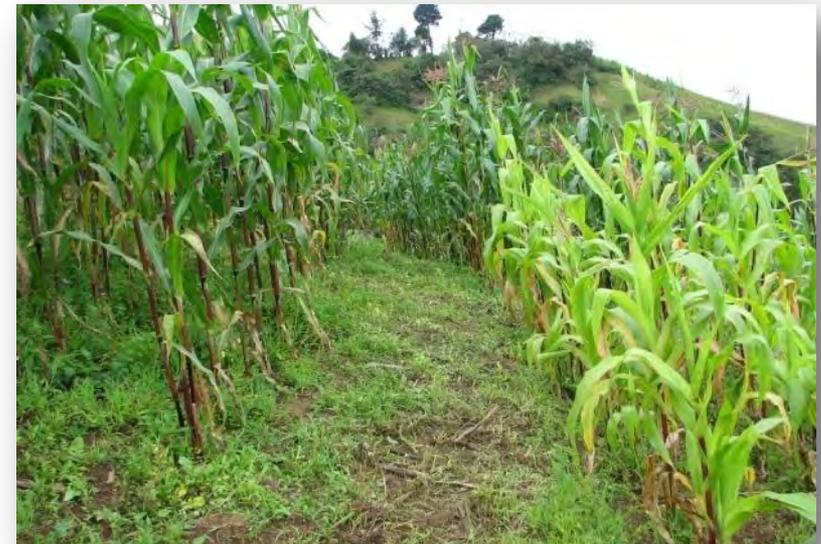
Reduced-tillage maize

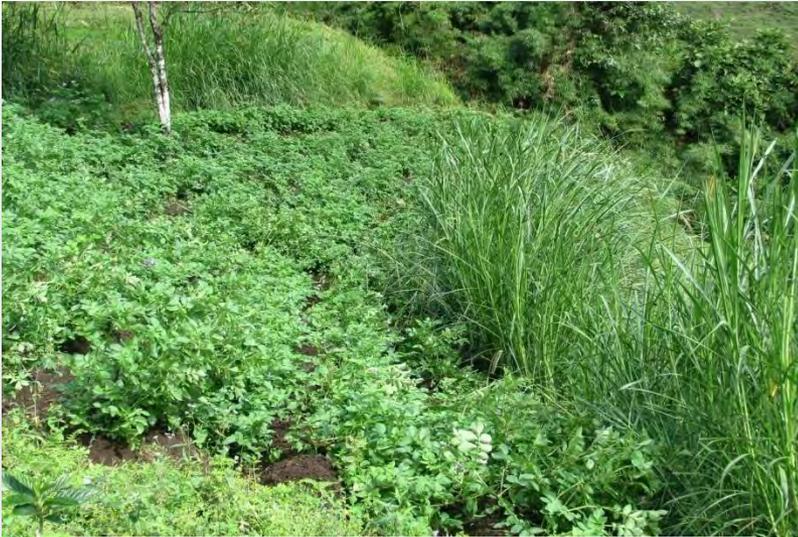
Strip cultivation

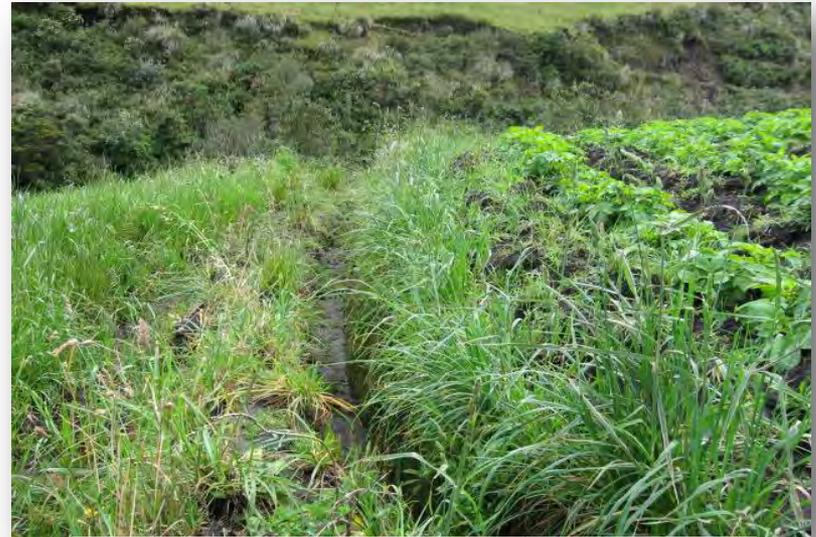
Deviation ditches

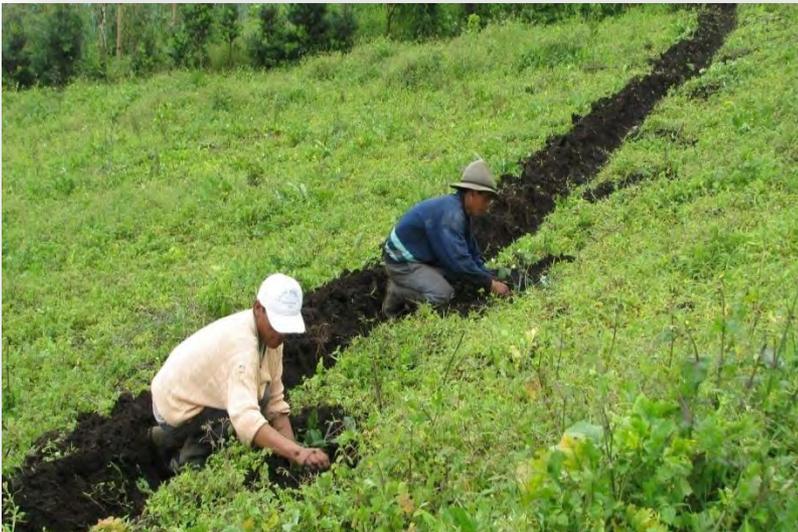
Native plants as live barriers

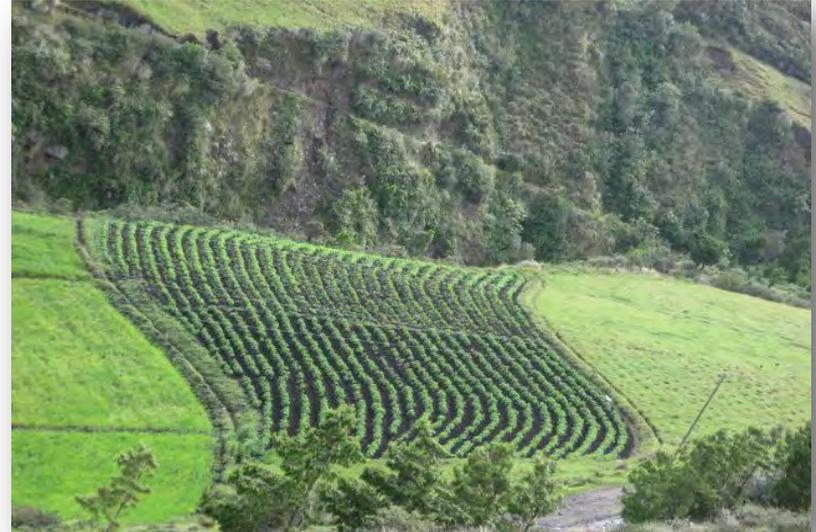
Contour planting
