# EVALUATION OF CAIRO SEWERAGE I REHABILITATION

~~United~~ States Agency for International Development  
(USAID)

**ENVIRONMENTAL QUALITY INTERNATIONAL**  
18 El Mansour Mohamed Street, Zamalek, Cairo, Egypt.  
Tel: 3401924 / 3413296 Telex: 23172 NAOOM UN

February 1988

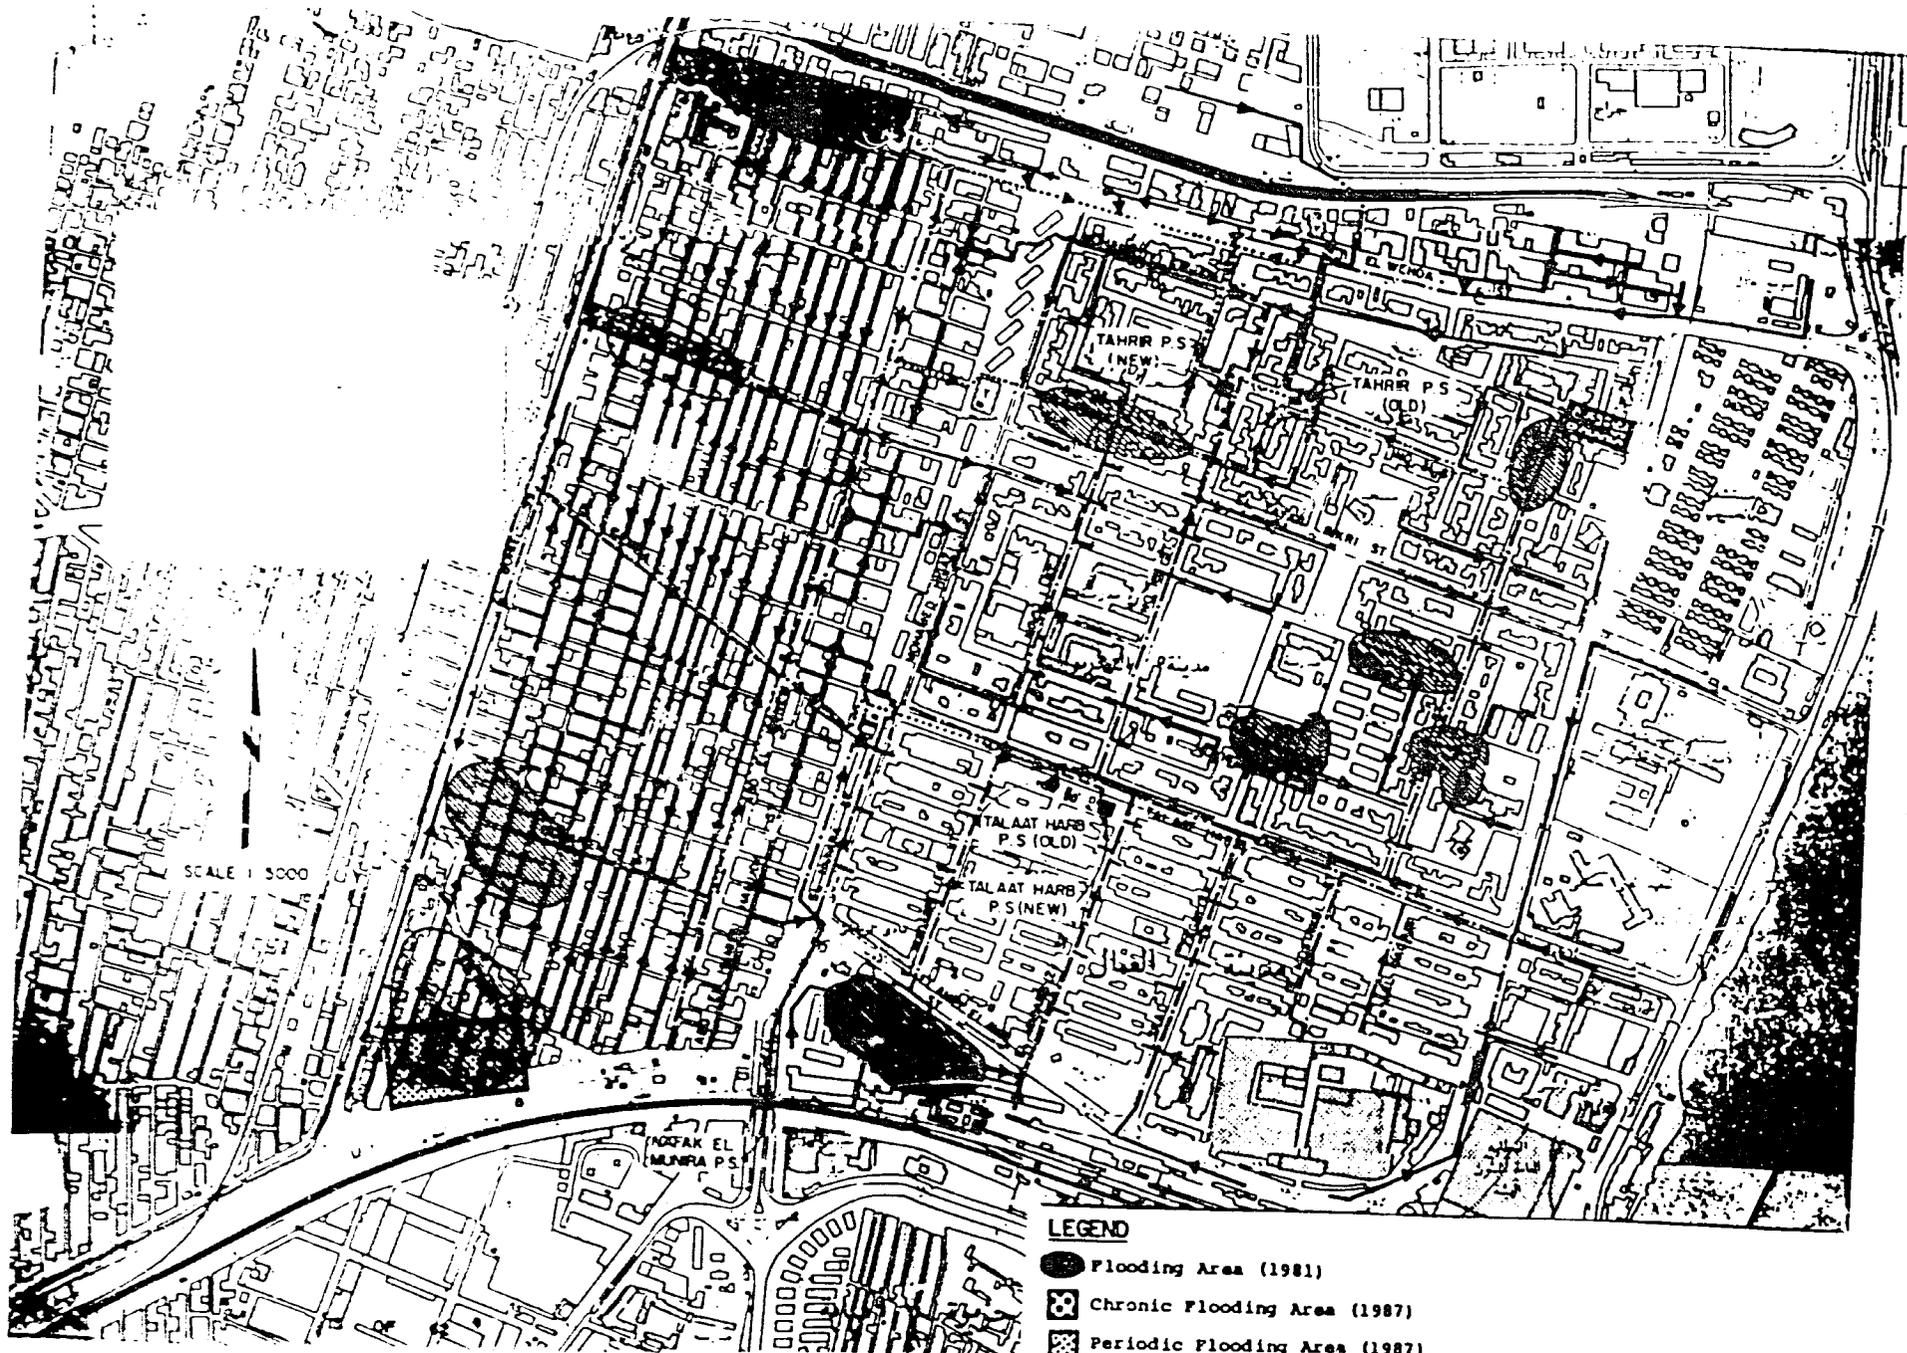
MAP 1

In 1981, 10 chronic flooding areas were reported. After the rehabilitation of the two pumping stations in 1984, only 6 flooding areas remain and only 4 of these are chronic. In Abou Ouf Street, the continuous dumping of earth and stones has turned the ground floor flats into basement flats about one meter below street level. Many people are said to have abandoned their shops and flats.

EL MOUNIRA EAST

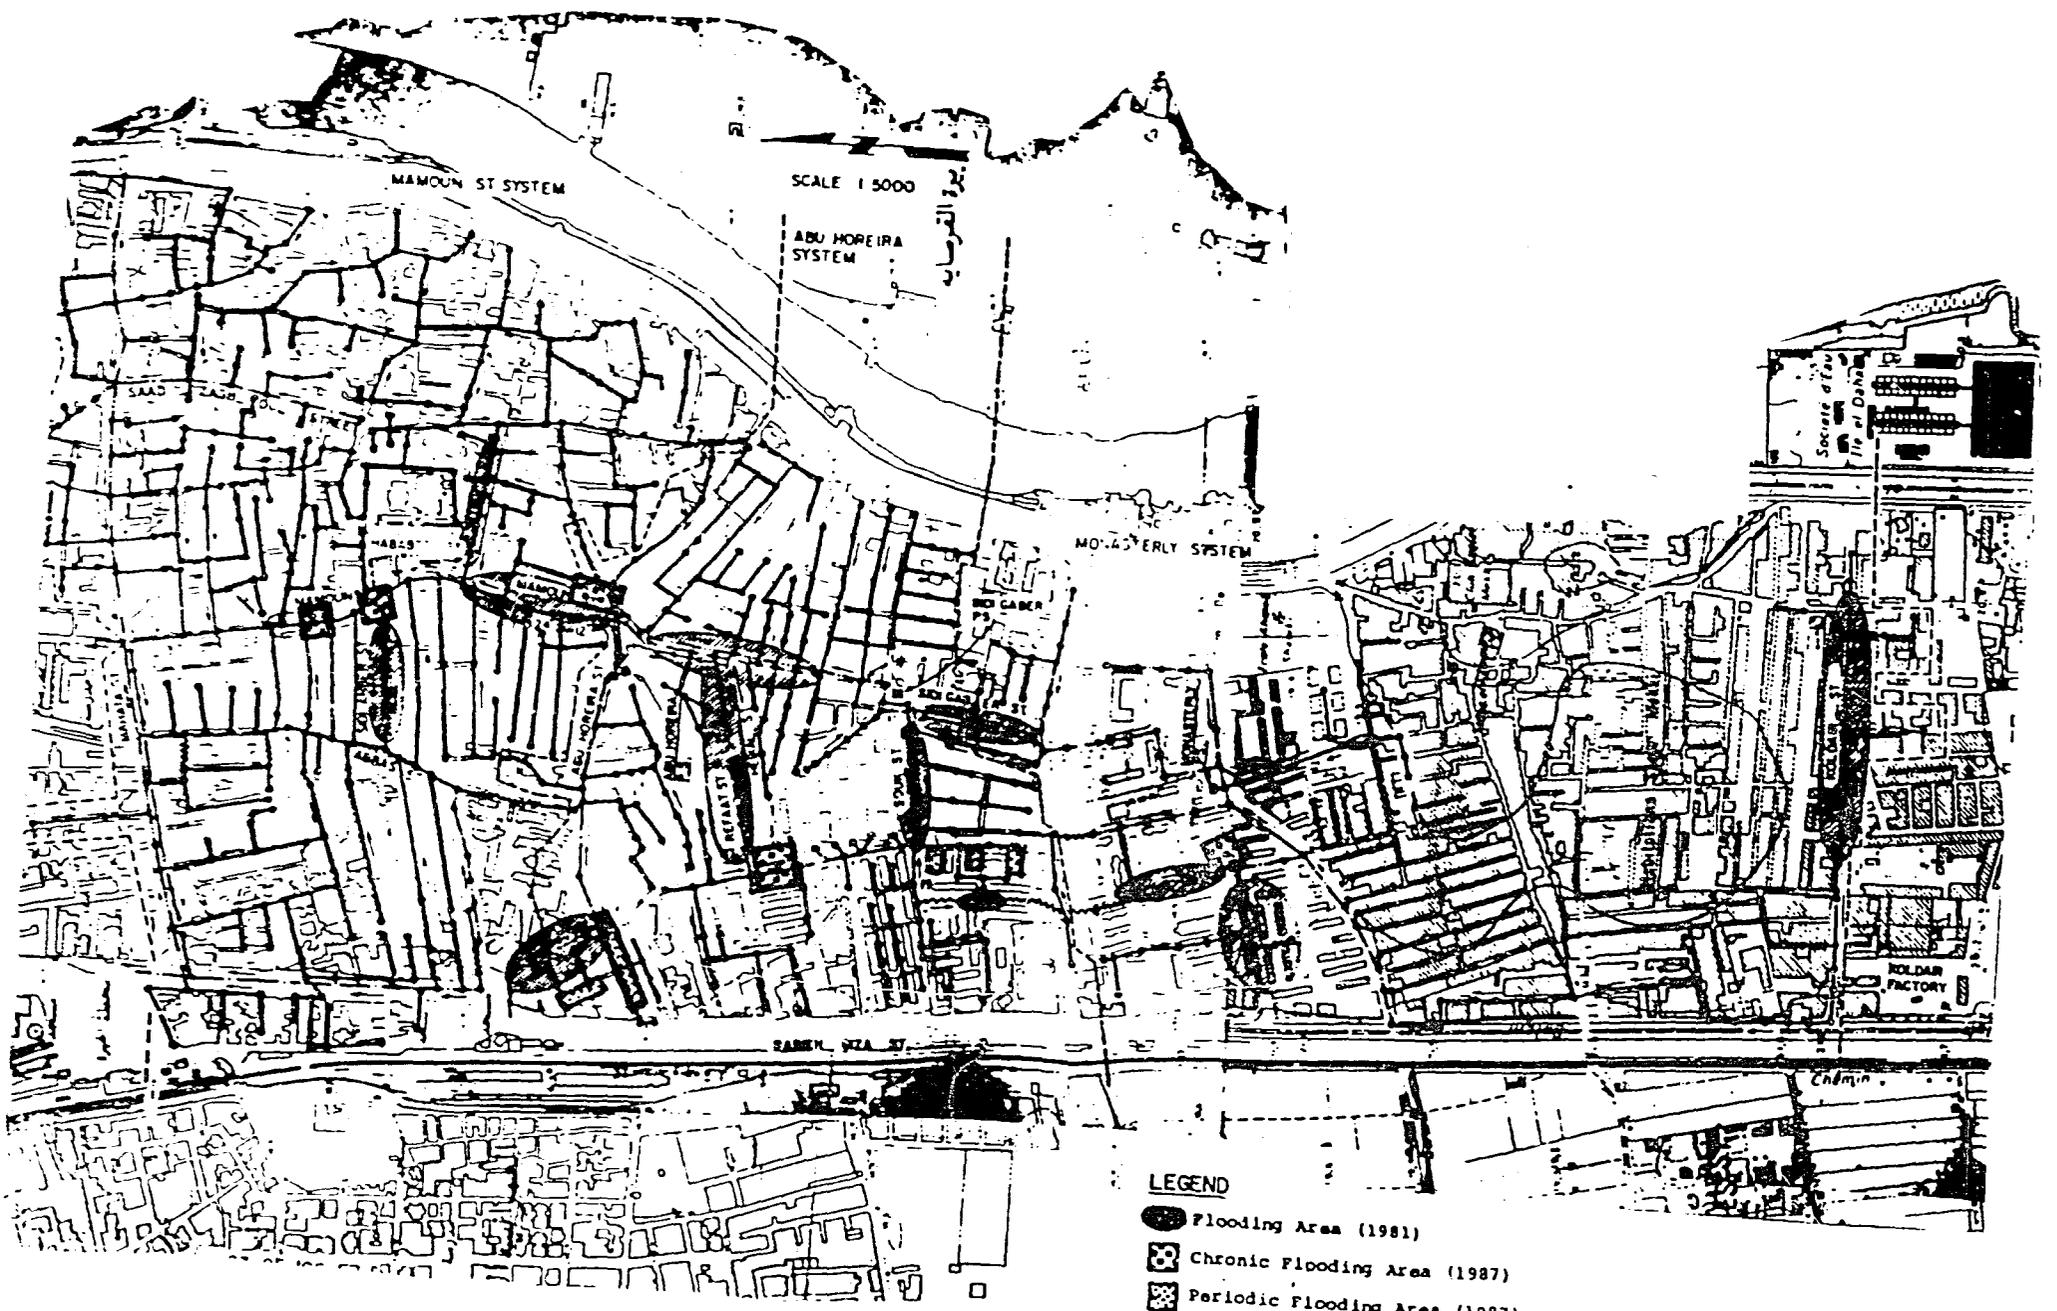
Map 2

In 1980, it had 14 flooded areas. After the rehabilitation of its pumping stations in January 1984, only 5 flooded areas remain. Two of these are chronic.

A municipal bus garage located at the end of the market street in Sakiet Mekki disposes of its mazots, waste oils and lubricants into the sewerage system. Three bakeries on the same street similarly abuse the sewers. The houses and shops along this long street are now below street level and continuously flooded. The street has been raised by the dumping of earth and stones. Residents complained to no avail.

The second chronic area is located in Abou Heriera. The problem there is caused by solid waste discharge from the Om El Masreen Hospital. The situation is better in the other four areas identified. Several streets have been paved and others remain to be done.

ABU HUREIRA/SAKIET MER
